**PRESSURE FIELD EXTENSION USING A PRESSURE WASHER****NEW JERSEY DEPE SPONSORED PROJECT  
INNOVATIVE MITIGATION RESEARCH AWARDS**

Bill Brodhead  
WPB Enterprises, Inc.  
Riegelsville, PA

**ABSTRACT**

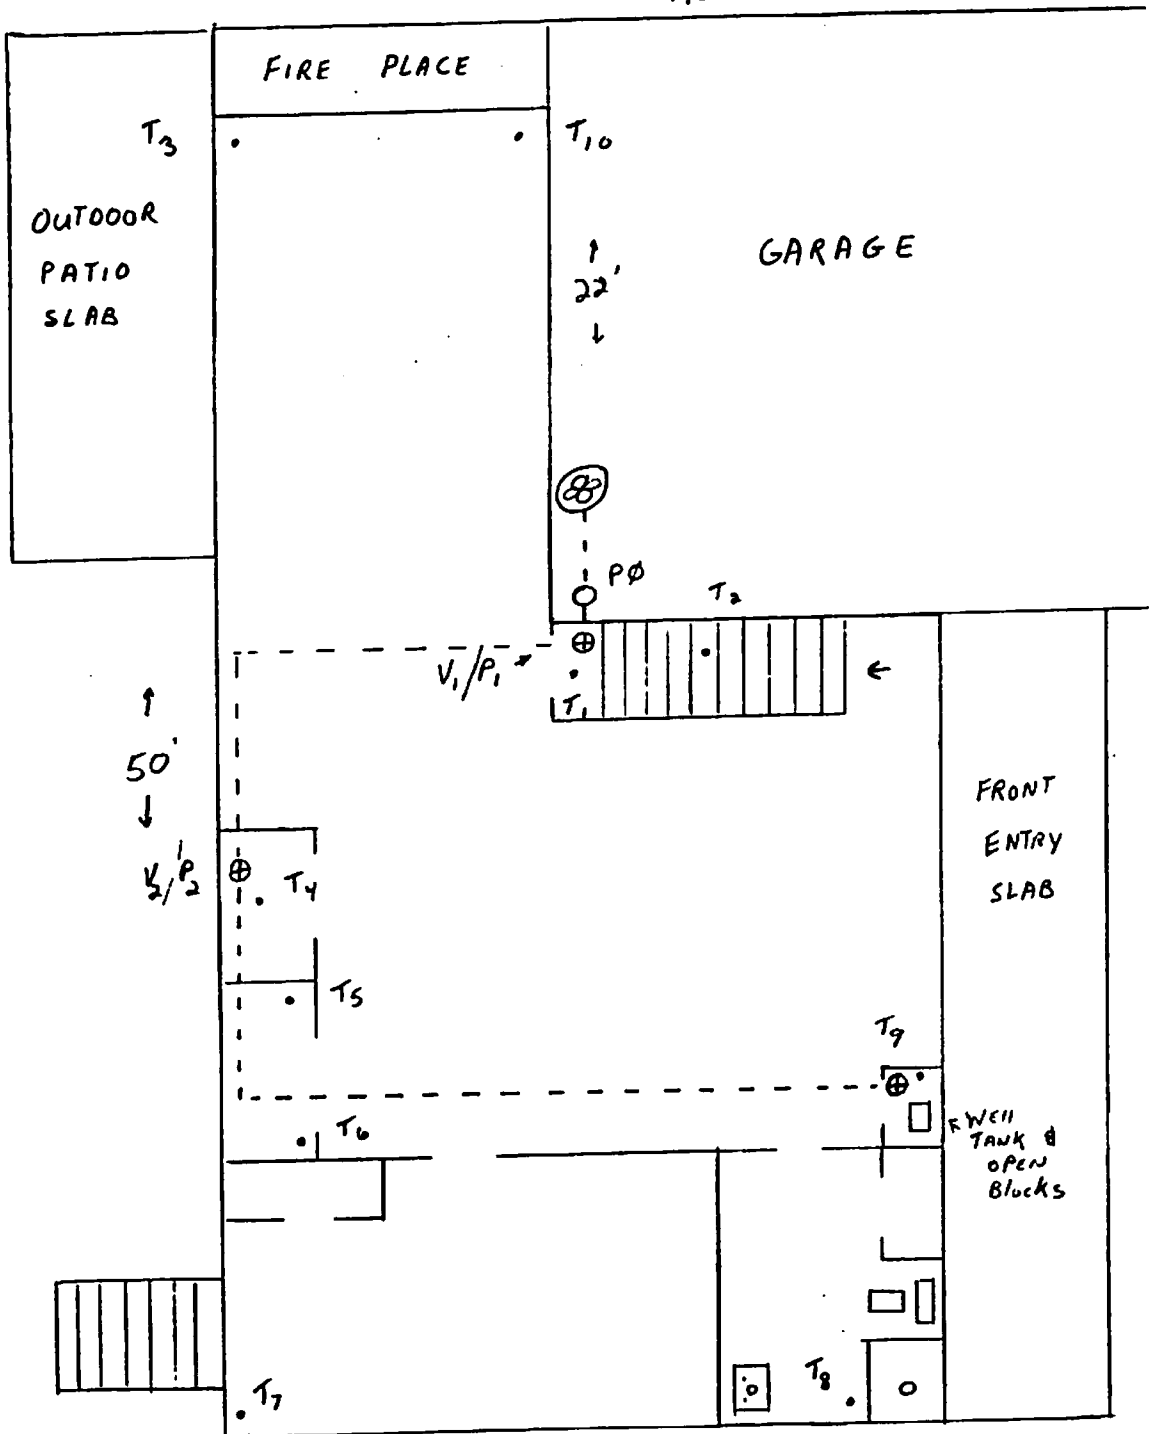
HOUSE - WJ3

Ten new test holes, 5/16" in diameter, were drilled around the perimeter of the basement. The slab was approximately six inches thick. After all test holes were drilled they were vacuumed to remove concrete dust. No sub-floor radon measurements were made. Refer to accompanying drawing for test hole locations.
