MONITORING AND EVALUATION OF RADON MITIGATION SYSTEMS
OVER A TWO-YEAR PERIOD

Richard J. Prill, William J. Fisk, Bradley H. Turk
Indoor Environment Program
Applied Science Division
Lawrence Berkeley Laboratory
University of California
Berkeley, California 94720

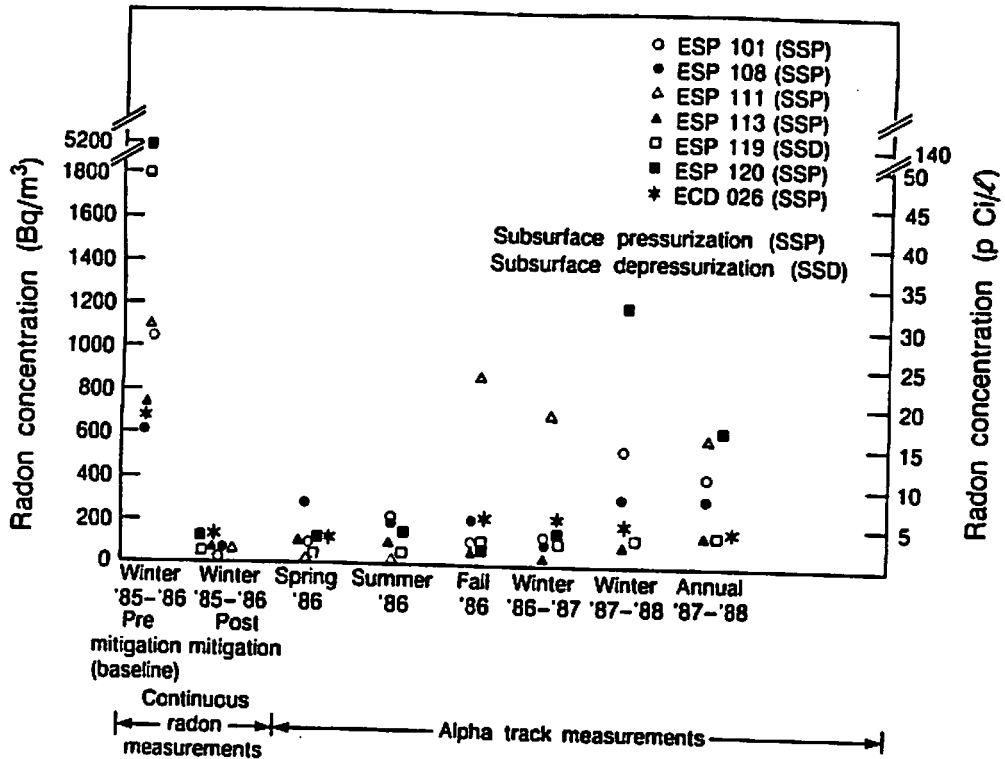
The results from the alpha-track measurements indicate that the SSV systems have maintained radon concentrations significantly below the original baseline, i.e., pre-mitigation, levels (see Table 1 and Figure 1). However, radon concentrations measured during this follow-up study are frequently higher than those reported at the end of the original study and are also occasionally significantly above the EPA guideline of 4.0 pCi/l. All homeowners report that they did not always operate their SSV fans during the late spring, summer, and early fall. In one house with SSP (ECD026), vents in a partial crawl space were closed during the heating seasons.

Measurements performed before modifications show that pressures in all of the SSP systems had increased (i.e., the pressures in the SSP pipes just upstream of the points where they penetrated the slabs) and flows had decreased, with the exception of one system in which the fan speed had been reduced and the pressure also decreased (see Table 2). SSP pipes that were accessible in Houses ESP108 and ESP113 were cut off near the slab and the soil surface at the pipe outlet was inspected. Substantial dust and lint-type debris was found. This was vacuumed out, the pipe reattached and the flow and pressure measurements repeated. These measurements show an increase in air flow and substantial drop in pressure after this cleaning process. Thus, the increases in radon concentrations in houses ESP101, ESP108, ESP113, and ESP120, where fan speed settings were not changed, may be caused in part by reduced subsurface ventilation due to a build up of debris on the soil at the SSP pipe outlets.

Figure 1. Radon concentrations in the main occupied level of seven houses with subsurface ventilation systems.

Based on the results of this follow-up study, we suggest that SSP systems be fitted with washable/reusable and easily accessible filters upstream of the fans. We also recommend that SSV systems have pressure gauges installed at appropriate locations in the pipes so that substantial changes in pressure can be identified to allow the occupants to initiate prompt remedial action. Fans should be mounted carefully to minimize the possibility of vibration or noise transmission. High quality sealants should be used at all joints and connections to ensure permanent air tight seals. Finally, fan speed controls should be protected from casual tampering.

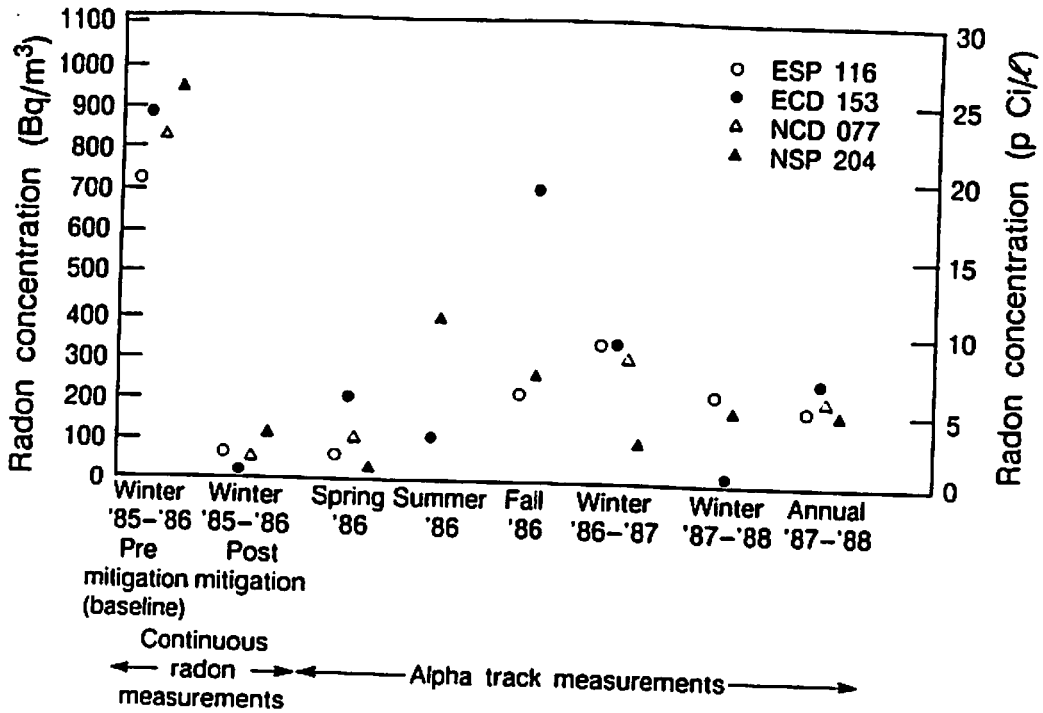
These systems have maintained the main level radon concentrations substantially below the baseline values despite periods when some systems were not operated continuously (see Table 1 and Figure 2). However, the radon concentrations in the basements approached pre-mitigation levels in all of the homes during at least one of the alpha track follow-up measurement periods and many of the measured radon concentrations are above both the original post-mitigation concentrations and the EPA guideline. Some of these increases in radon can be explained. For example, during the winter 1986-1987 the system in house ESP153 was turned off at the discretion of the homeowners, while the system in house NCD077 was not operated because the new occupants had not been appraised of the purpose or operation of the system. Also, the crawl-space vents in these homes were closed during these measurement periods. In all of these houses, increased radon concentrations during the summer may be due to the fact that the systems were not operated and adequate natural ventilation may not have been provided. Some of the fall, spring and even the annual measurements may be skewed since the systems were frequently not operated for the entire measurement period. The increased radon concentrations in houses NSP204 and ESP116 during the winter periods 1986-1987 and 1987-1988 are more difficult to explain since the systems were reportedly operated continuously during the entire measurement periods.

The flow rates through the basement pressurization systems had decreased in all of these systems by 20 to 25%. The effective leakage areas (ELA) of all the basements were essentially unchanged from the original basement ELAs. The amount of air required to maintain a positive pressure in the basement is proportional to the effective leakage area of the basement.

Figure 2. Radon concentrations in the main occupied level of houses with basement pressurization systems.

Based on these findings, future installations of these systems should be made in houses without combustion appliances that might back-draft, with basements or substructures which can be tightened (air-sealed) with a reasonable amount of effort, and fans should be over-sized to provide a margin of performance in case the basement becomes leakier or fan performance decreases. Fans should be mounted in a manner that reduces noise and vibrations and speed controls should be protected from casual adjustment.
