## **LONG-TERM RELIABILITY OF COLLATERAL MITIGATION**

**David Wilson, Oak Ridge National Laboratory, Oak Ridge, Tennessee, USA**

### **ABSTRACT**

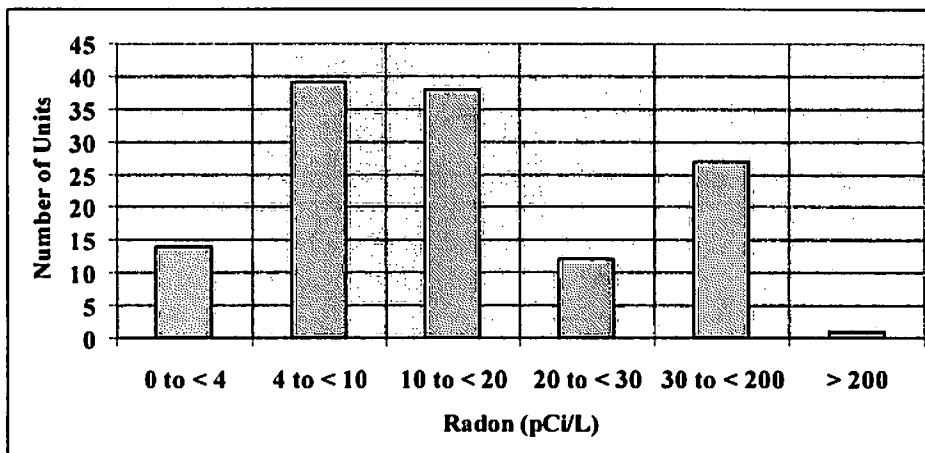
During 1995 to 1996, long-term radon measurements were made using alpha track detectors. Of the 130 units tested, 117 (89%) were identified as having elevated radon levels, ranging from 4.0 pCi/L to 370.7 pCi/L (Figure 7).

**Figure 7. Complex Q radon distribution.**

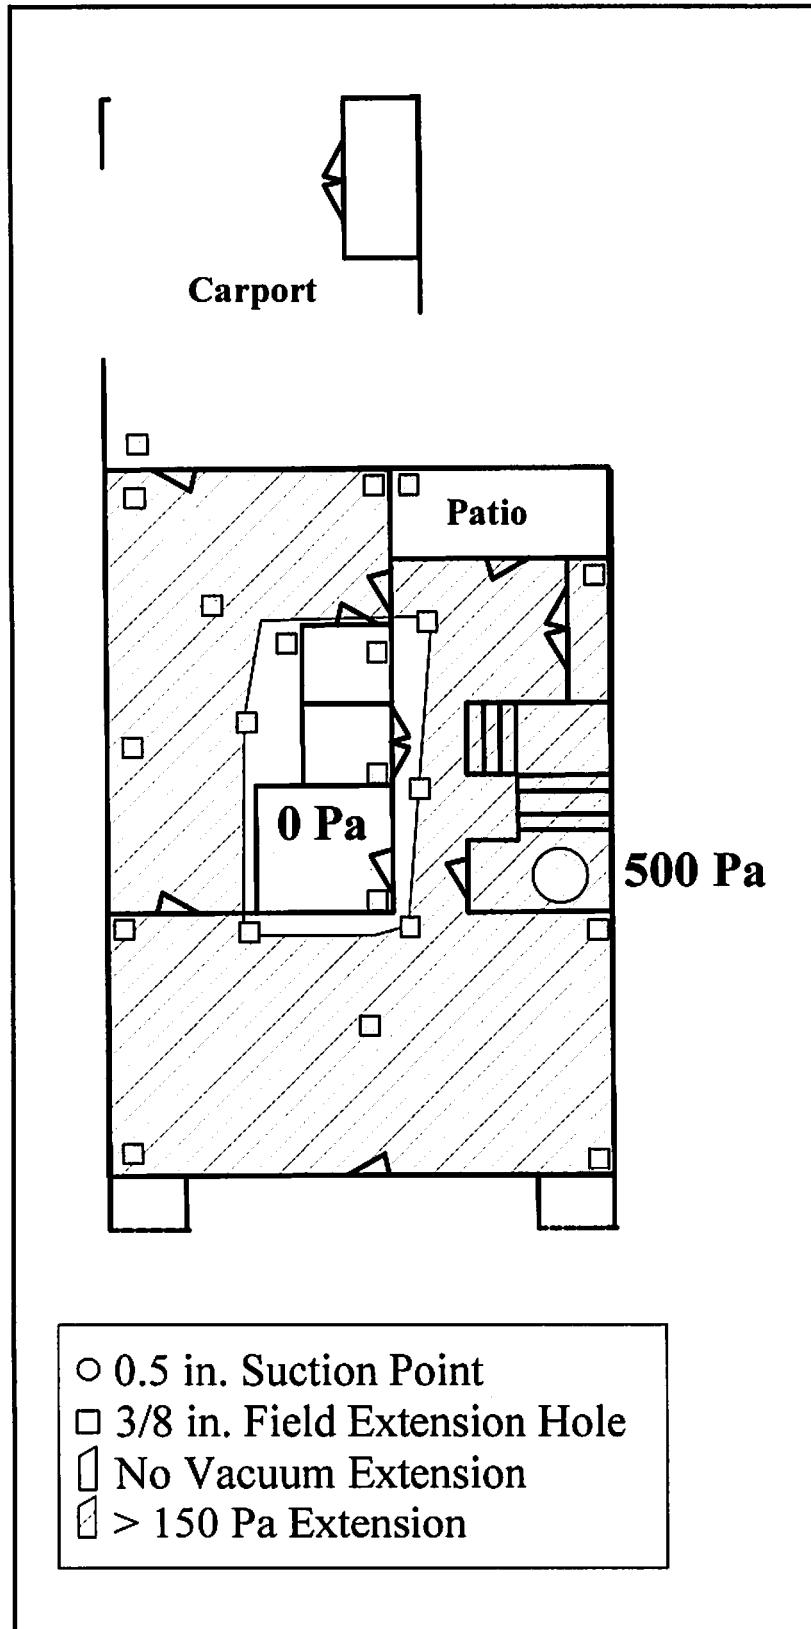
Figure 9. LFE from stairwell closet

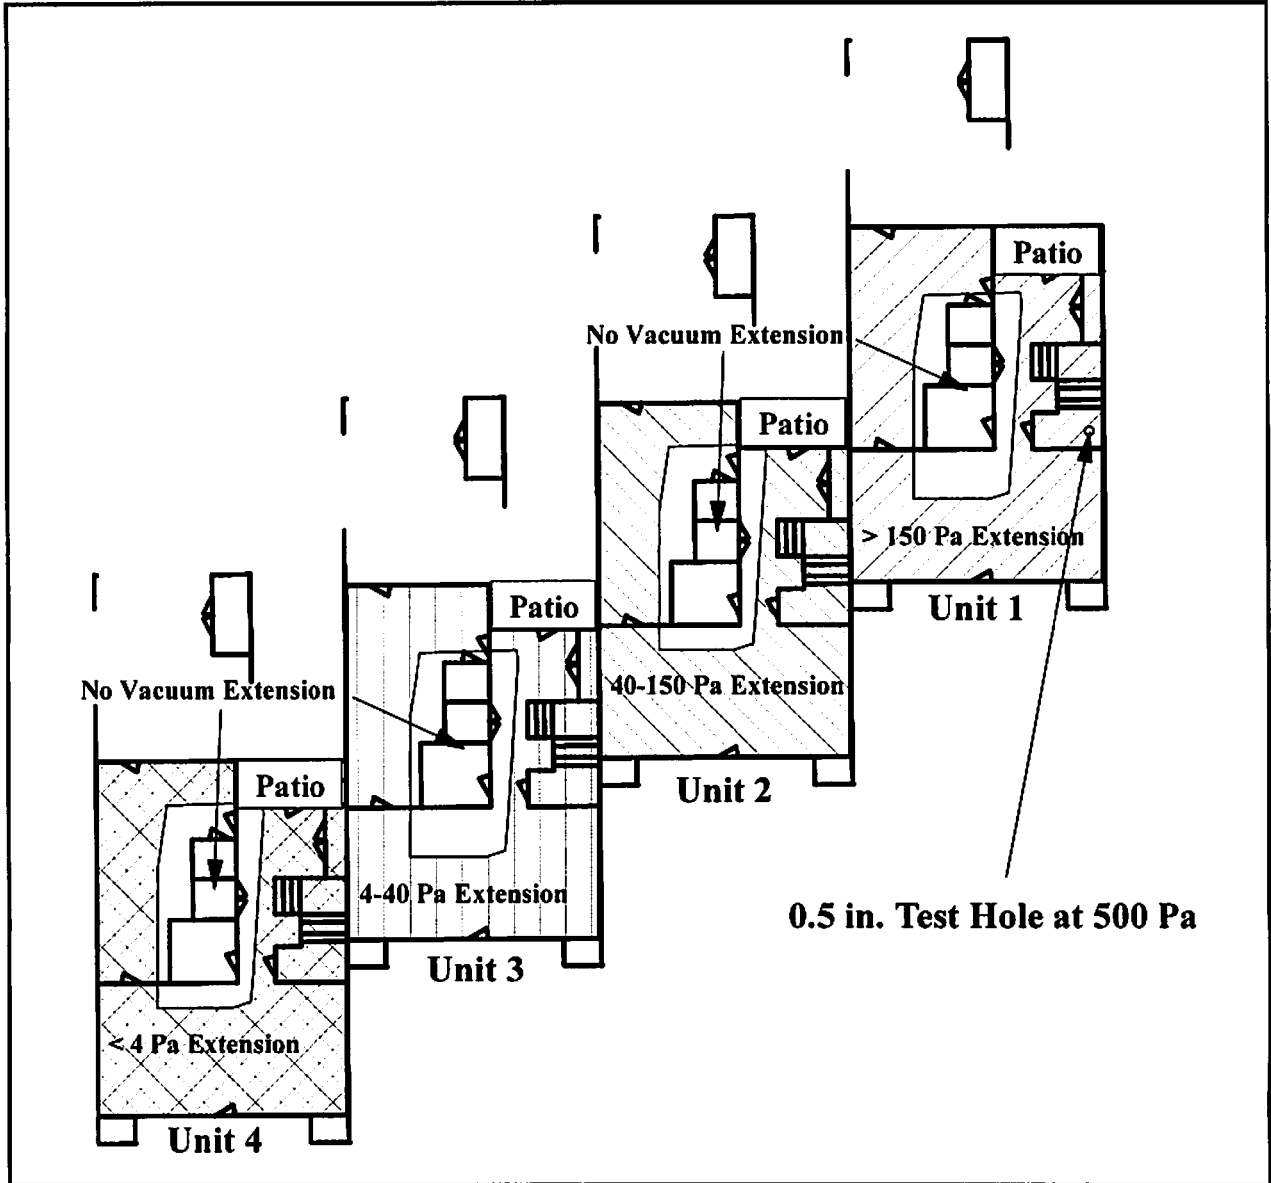
Because the LFE was so high along the perimeter, additional 3/8-in. test holes were placed in adjacent units to determine the full extent of the vacuum field. For fourplex buildings, the vacuum was found to extend about 60 ft, providing vacuum coverage for two additional units (Figure 10). For sixplex buildings, a grade beam between units 2 and 3 (Figure 11) prevented the vacuum from extending under the footings into the next unit (unit 3). However, if the field extension test was repeated in unit 6, the LFE was found to extend 60 ft, as in the fourplex, and to cover two additional units (units 4 and 5). As was observed in the initial test unit (Figure 9), all units had a trapezoid area along the center of the unit with no communication. Excavations in the other three test units found the identical compacted coral conditions. The placement of the suction point within interior units (e.g., units 2 or 3) (Figure 10) to enhance the vacuum field was also examined. However, the LFE extended only into the immediately adjacent units; no combination was found to extend the vacuum into all four units of the building.

Figure 10. LFE extension in fourplex buildings

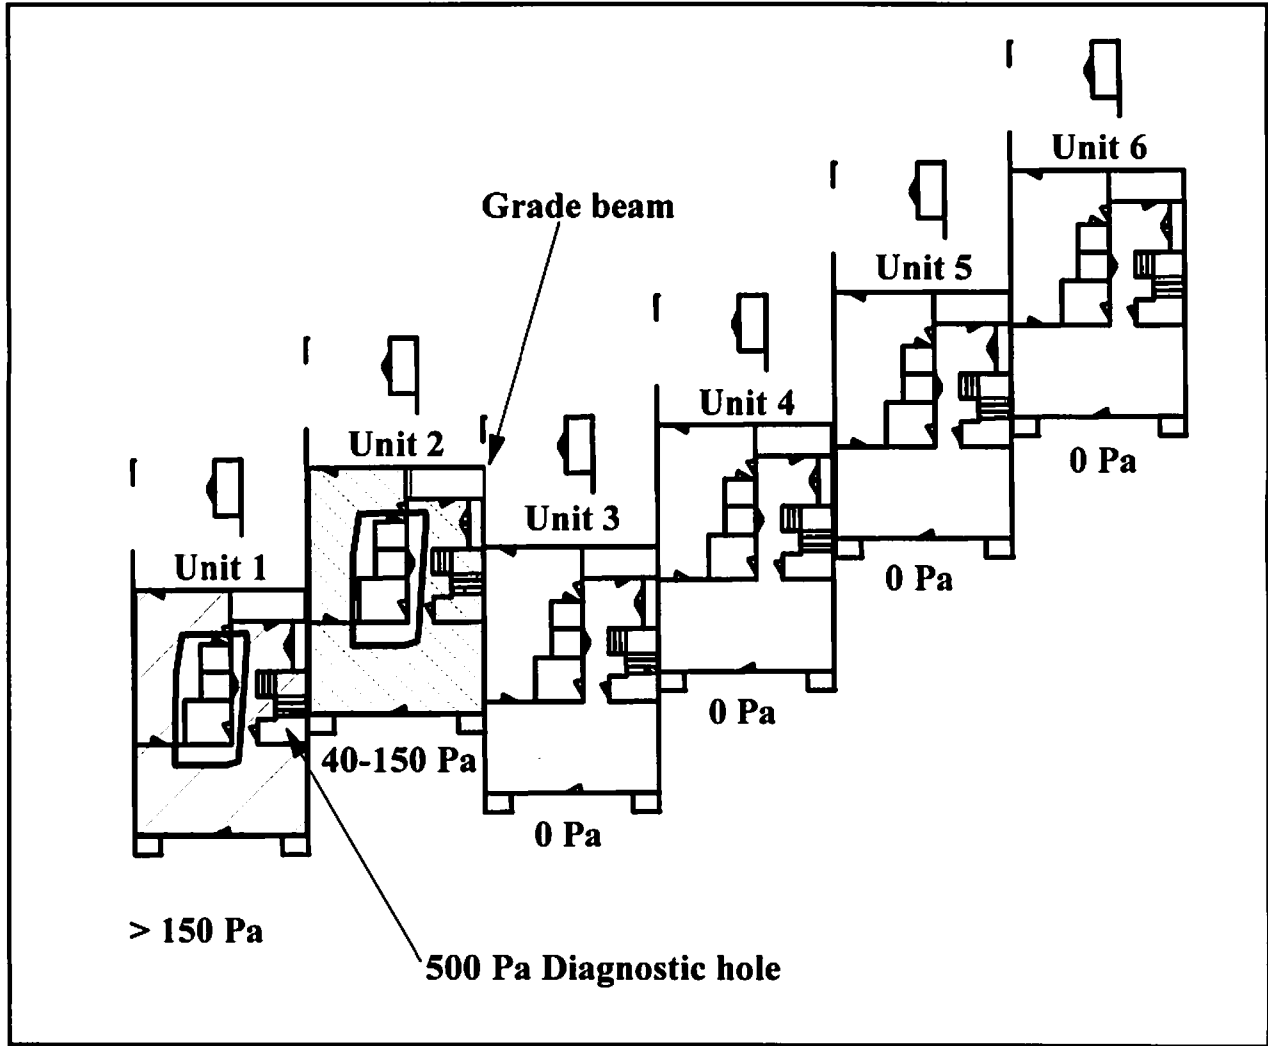
Figure 11. LFE in sixplex units

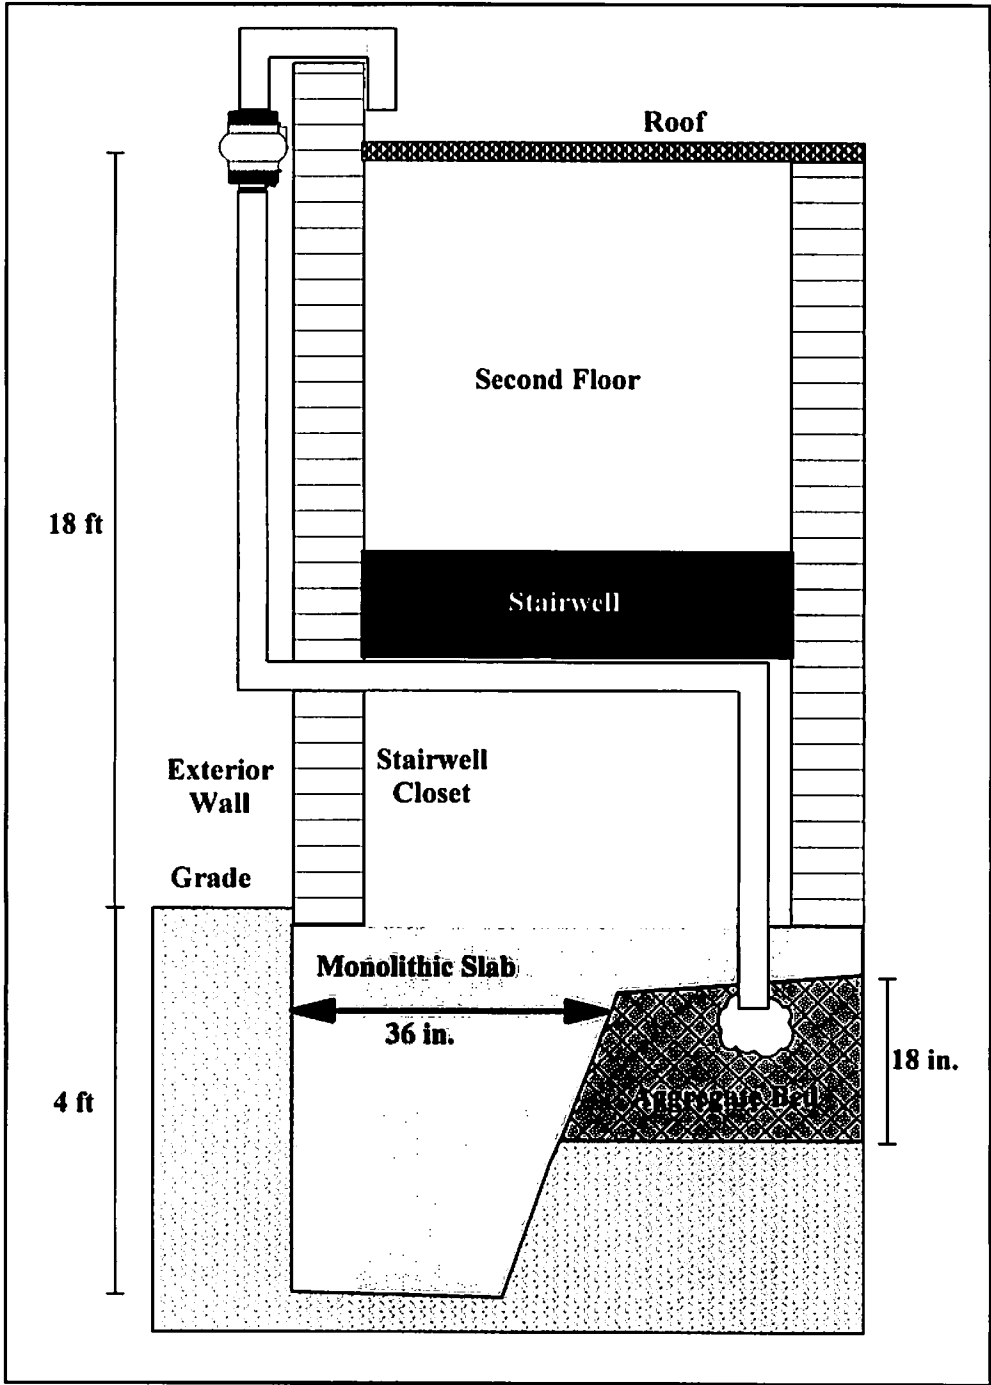
With respect to mitigation design, it was determined that a single suction point located in the stairwell closet (Figure 6) addressed all of the key customer concerns (e.g. aesthetics, loss of functional space, uniformity, etc.) about mitigation (Figure 12). An interior penetration was selected because diagnostics had found that the monolithic slab was about 36–40 in. thick at the point of side coring into the aggregate bed. With respect to fan selection, the diagnostics determined that to mitigate a single unit, the projected vacuum at the suction point would need to be around 250 Pa. However, in anticipation of CM, a larger fan capable of at least 500 Pa was selected and installed.

**Figure 12. Mitigation design**

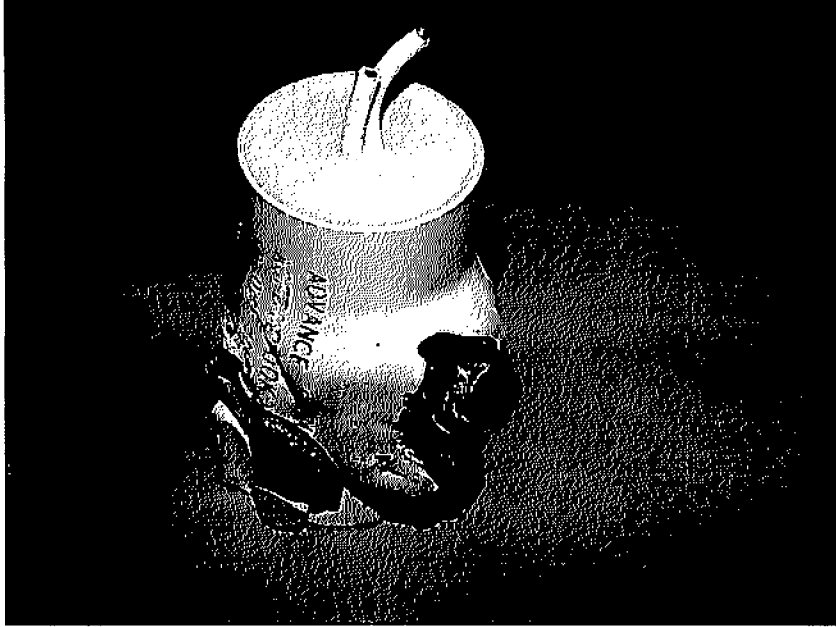
1. Two fans had been hit by something that had destroyed the fan housing, such as during a typhoon.
2. Six of the fans had suffered catastrophic capacitor failure (Picture 2).
3. Upon disassembly, four fans were found to contain bearings that showed excessive wear, resulting in fan lock-up.

After the blown capacitors were replaced and the fans reactivated, a noticeable vibration was observed. Flow measurements in the pipe found that the flow was 20–25% lower than when initially installed. Examination of the bearings found excessive wear when compared with a fan that had been procured at the same time but not installed. All eight fans with reduced capacity were observed to have increased vibration relative to the other nonsuspected fans. Three of these fans were selected at random and disassembled; again, excessive wearing of the bearings was identified as the cause. Using manufacturing dates found inside the 18 fans failed and suspected fans, it was determined that all were manufactured within a three-month period. Examination of the manufacturing date for the remaining 29 fans that were operating properly found that they were manufactured before or after this period. To remedy the situation, ORNL replaced all 18 fans with equivalent fans from a different manufacturer and retested the 24 units. All were found to again be  $< 4$  pCi/L. In addition, LFE measurements performed in four of the CM units were similar to the 1998 measurements. As an added precautionary measure, LFE was also remeasured within eight units that were **not** noted as having fan problems. All of the LFE measurements were within  $\pm 1\%$  of the post-installation value. One year later (summer 2001), the LFE was also rechecked within these eight units and four of the units whose fans had been replaced. Again, all of the LFE measurements were within  $\pm 1\%$  of the post-installation value. A retest (short-term electret) of radon levels in these 12 CM units during 2001 found all still below 4 pCi/L.

**Picture 2. Typical blown capacitor**
