**CREATIVITY APPLIED TO A HARD TO SOLVE
RADON PROBLEM: A RESIDENCE ON MINING TAILINGS**

L. Moorman, Ph.D.
Radon Home Measurement and Mitigation, Inc.
Fort Collins, CO

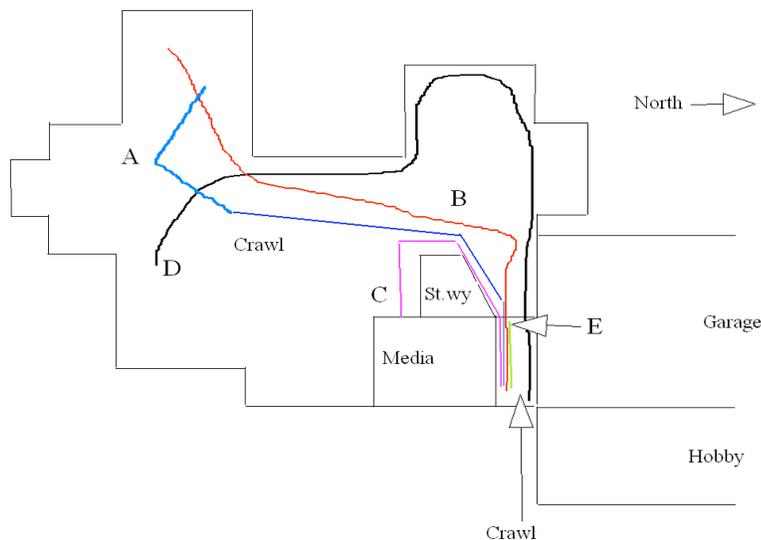
Four ventilators were located in the boiler room which is located immediately above the small section of crawlspace over the slab immediately next to the media room. Three ventilators were placed in the attic of the garage. Fig. 1 gives an indication of the layout of drain tile pipe and geo mat (A) that was used in the crawl space.

Fig 1: Layout of existing system during first visit. Straight pipe lines are solid PVC pipe. curved lines are drain tile pipe. Pipe A marks the Geo-mat.

The first pipe (A) was discharging the radon above the roof through the attic above the media room. All others terminated through a side wall of a garage attic in the same general area immediately above this roof and near the discharge of pipe A. All additional termination points through side wall were within a foot of each other and within five feet of a dryer and furnace vent. Despite the number of ventilators, ballooning of the radon membrane in Southeast side of crawl space was reported at certain times with strong winds.

Vent pipe C was simply placed in a hole under the footer to subslab material from the crawlspace and since this hole was open to the crawlspace no effective removal of air from the sub-slab in media room could be expected. Similarly, vent pipe E from the crawl space with slab section under the boiler room was too close to the footer of crawl space.

The distribution of the drain tile pipe over the area of the crawlspace was not even and the ends of the drain tile pipe were found not capped off. The radon discharge points above the roof were found to be close to re-entry points. In the main crawlspace the radon barrier was attached to concrete walls with insulating foam instead of caulk. EPA,

Many suggestions were made to decrease the radon levels based on improving the original system. In the boiler room a 10 inch rubber connector above the FR250 ventilator had the wrong diameter, was loose and attached with black duct tape instead of a hose clamp. A fitting rubber clamp was to be arranged.

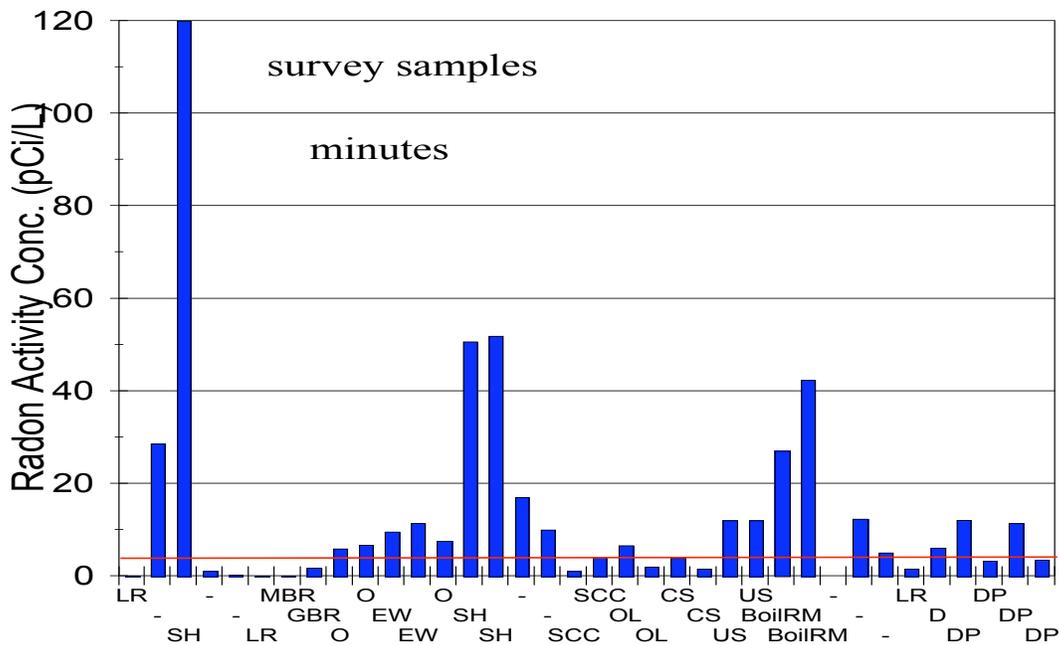
Radon survey test screenings in various areas of the house, in the test hole through the slab and in wall cavities are indicated in figure 1. As part of an initial visit, we performed relative screening flow measurements in various parts of the house. Short three minute test screenings were performed with a femto-Tech CRM410-RS survey instrument capable of taking active air samples with an internal pump. From these screenings we deduced that there are six high radon concentration areas measured as indicated in Fig 2.

Fig 2; Resulting Test survey screenings. Vertical scale in pCi/L

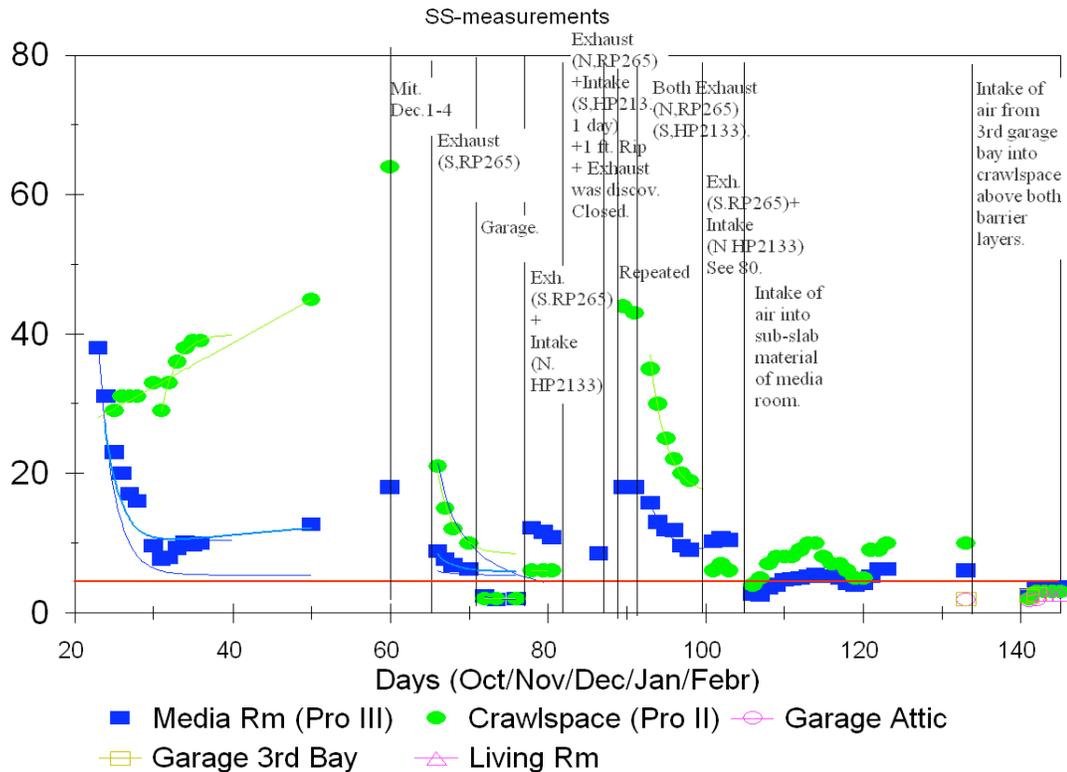
Active removal of radon between barriers did not alleviate high radon levels after phase 2 was completed and monitoring was continued. A modification where active flushing was applied to the small inter-barrier volume showed an asymmetry for the direction of the flow in the inter-barrier volume. A 1 ft long rip in the barrier material was found and repaired. Some ice built up near the Tee of the injection intake inside crawlspace was a concern. Further experimenting in which we verified the working of the monitors continued. Ballooning of membrane still occurred at times, which threatened to damage some of the barrier material. Counteracting this force we proposed a pressurization of the crawlspace. From these experiments we also learned that radon concentrations could be reduced in the media room by diluting the air under the slab by the continual injection of air into the radon extraction hole instead of trying to depressurize the sub-slab material. These experiments are shown in Fig. 3 before day number 134.

Fig. 3: A series of experiments with the residence using two and later three simultaneous safety siren test devices. The horizontal axis scale is referenced to Oct. 1, 2007.

built against the garage and is referred to as the third bay of the garage. Radon concentrations dropped to low levels in the crawlspace and in the media room in the basement next to the crawlspace, as is shown by the radon concentrations below the reference line at 4.0 pCi/L after day number 134 in Fig. 3.

To counteract the ballooning of the plastic we brought air from the hobby area continually into the crawlspace in order to pressurize it. The hobby area is a separate room but is

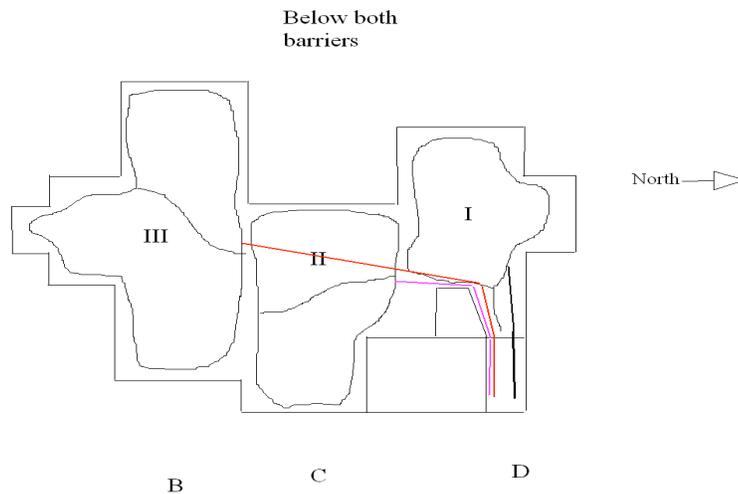
Fig 4: Three independent sub-membrane loops of drain tile pipe under both membranes. Straight pipe lines are solid PVC pipe. Curved lines are perforated drain tile pipe.

2) three flexible drain tile pipe loops below both layers of radon barrier material. (I: nearest to the entry into crawlspace under boiler room into crawlspace (north); II: mid section; III: far end section from entry (south))

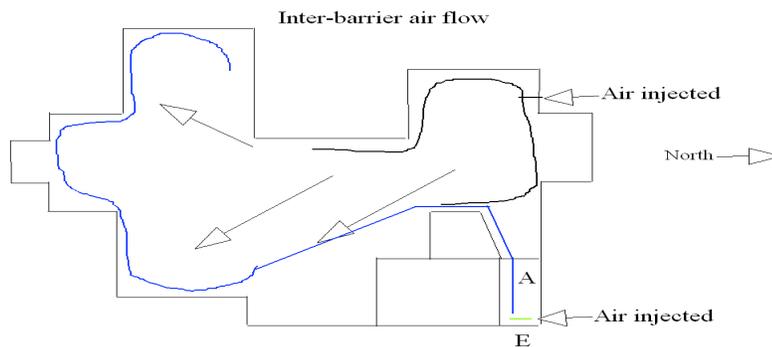
Fig 5: Drain tile pipe layout to dilute and remove radon that makes it past the lower barrier and the corresponding air flow. Through vent pipe A the air is removed. Straight pipe lines are solid PVC pipe. Curved lines are perforated drain tile pipe.

Experiments with this showed that airflow from north to south between the two layers of radon barrier could be increased by adding a few short sections (5 ft) of drain tile pipe in certain areas in the inter-barrier in order to help separate the top and bottom layers of the barrier material at those locations

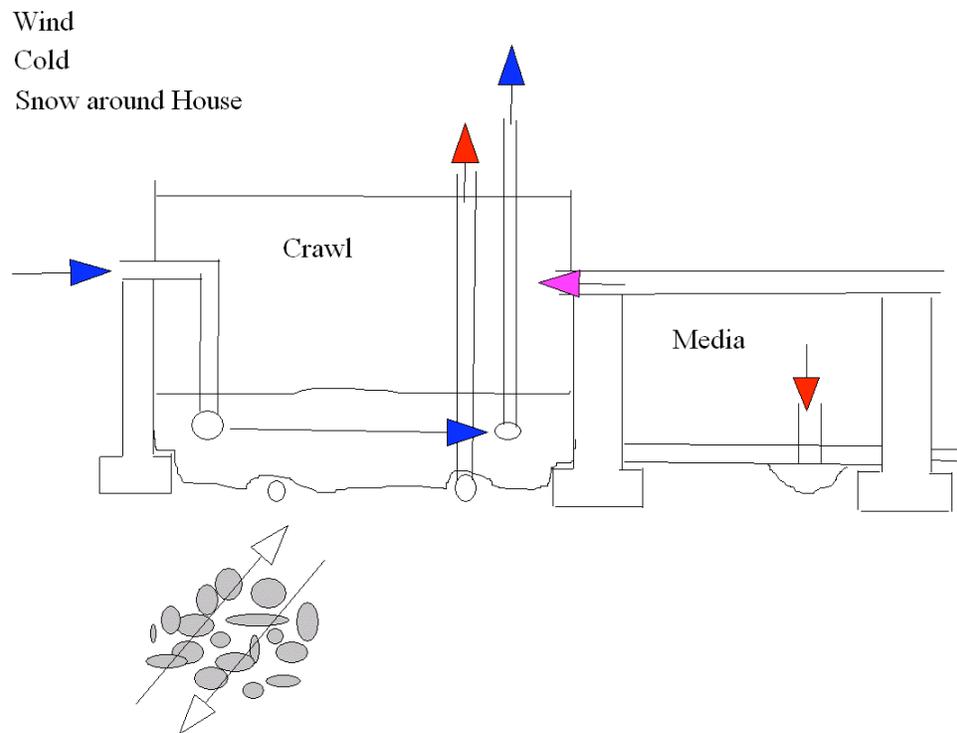
Fig. 6: Final configuration of the radon system in this residence on dredge tailings that even during unfavorably weather conditions maintained a radon level below EPA's guideline. The configuration of four radon reduction mechanisms is given in table 3 and the sub-membrane drain tile pipe layout is shown in Fig. 4 and 5.

The final configuration of the radon mitigation system is effectively summarized in Table 3: The pipe letter names (A through E) were the same as before, although ventilators in pipes may have been exchanged and vent pipes F and G were added. The order of the vent pipes is here rearranged to group individually related radon reduction mechanisms together as can be seen in the last column.
