RADON IN CONCRETE PASSIVE VENTING MITIGATION

Bill Brodhead*¹ and Omer Zeyrek²

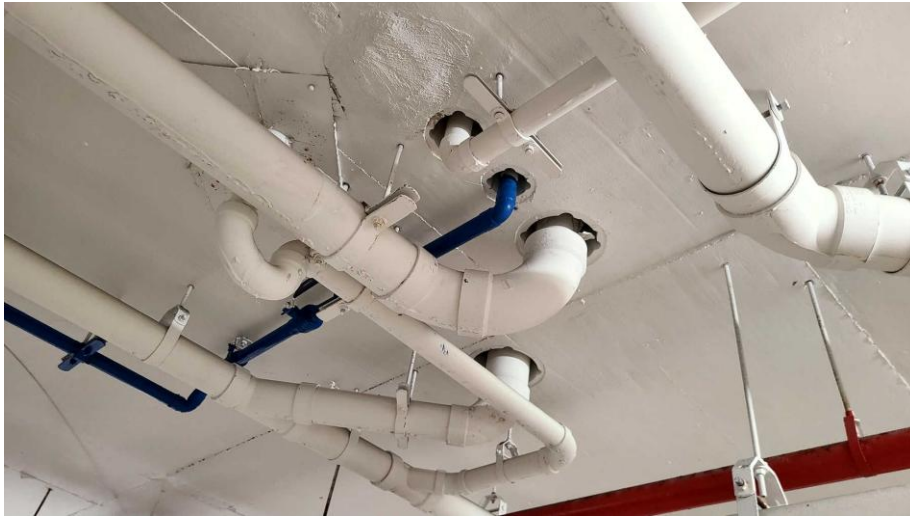
The garage was located directly below the entire first floor units and courtyard. The plumbing pipes passing through the ceiling of the garage into the first floor units typically had large spaces around the pipes that could not be determined if they were adequately sealed. In order to

Figure (5): Plumbing openings in ceiling of garage

Figure (7) depicts the radon results measured in the garage as less than 0.5 pCi/l. This indicates the garage radon levels are close to outdoor radon levels. This in combination with the negative pressure in the garage shows that the garage is not contributing any significant radon to the first floor units. It would be logical to assume that any openings between the garage and a first floor unit would remove air from the unit and increase the ventilation, thus reducing the radon levels induced by the concrete. Unit L which was a ground based unit however had the second highest radon levels.

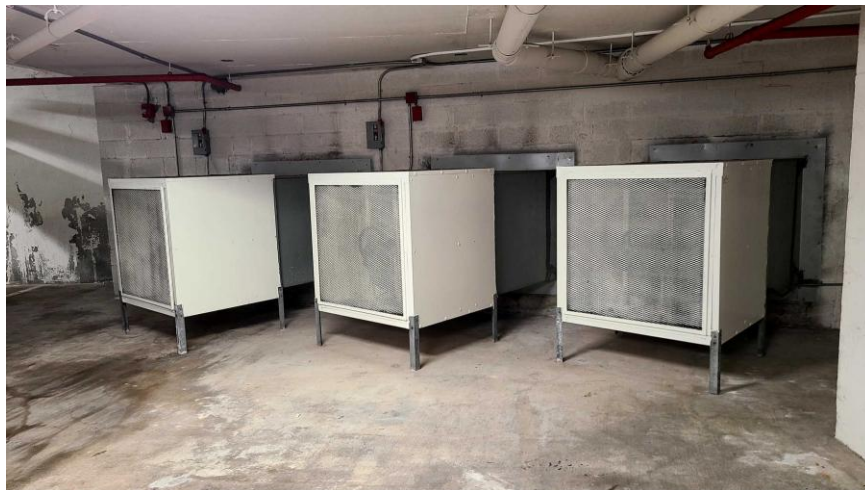
Figure (6): Garage exhaust fans

The garage had five exhaust fans that ran continually to remove carbon monoxide introduced by vehicle exhaust. These fans induce a negative pressure which in general prevents air in the garage from moving up into the first floor units.

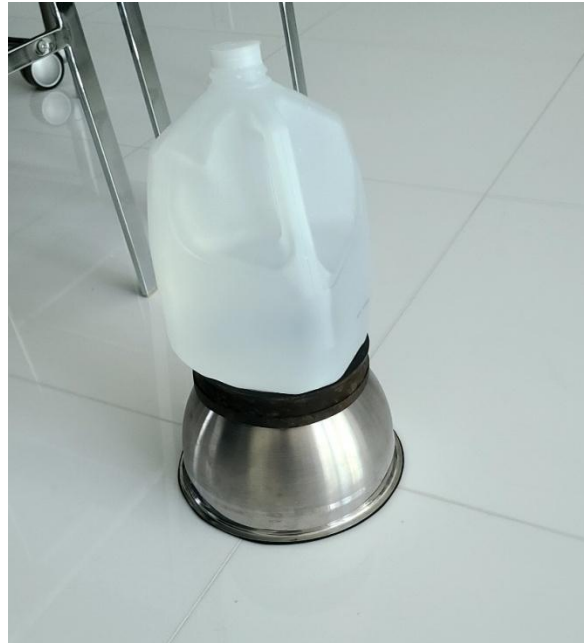
Figure (10). The intersecting grout lines did have significant radon ingrowth into the inverted metal bowls.

Figure (9): Flux measurement over intersecting grout lines

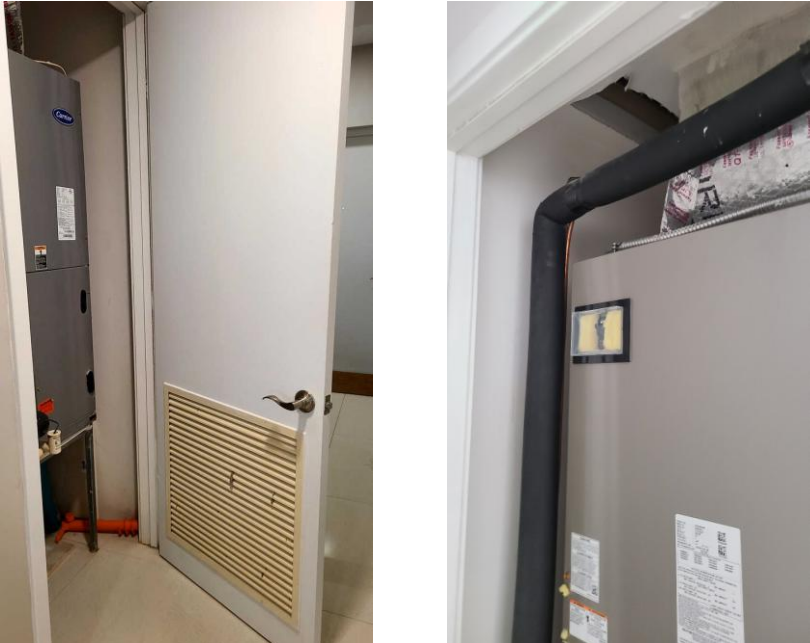
closet and significant ducting and drywall finishing. The HVAC closet in this Condo building has no available space for an ERV. See Figure (17) and Figure (18).

Figure (18) HVAC closet with limited space and return grill.

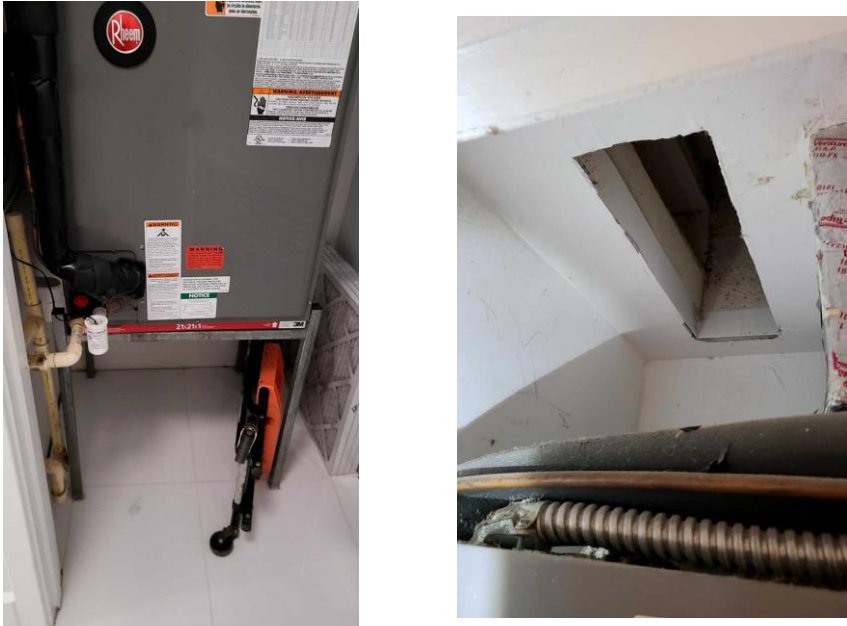
Figure (19): HVAC closet with ceiling return duct to bedroom/office

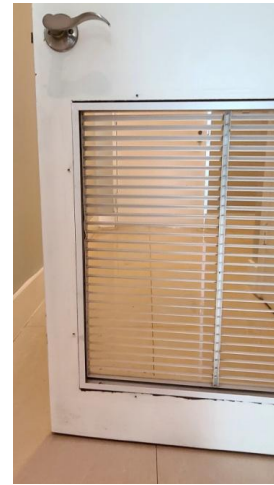
Figure (21): Non restricting return grill

A simple test was set up to measure how much air would be drawn through a four inch PVC pipe if one end of the pipe was installed into the HVAC closet. The open end of a card board box was pressed against the return grill to create negative pressure in the box when the HVAC was running. Note that Unit N had significantly less negative pressure in the AC closet than the other units. The reason for the low negative pressure was the return grill had been replaced with a simple straight through grill that reduced the back pressure as compared to the other units that had double louvered grilles that created more restriction for the returning airflow. See Figure (21).

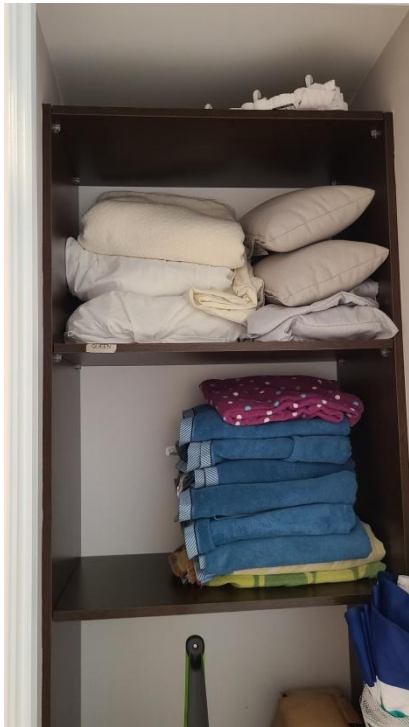
Figure (22): Storage closet

In the study Condo the 4x6 passive duct would need to be routed across the backside ceiling of the storage closet. See Figure (22). The duct would be routed into the entrance hallway just below the drop ceiling level. See Figure (23). In some of the units it will be necessary to move the smoke detector. The duct would be routed up to the ceiling of the hallway and then routed to the outside. The metal duct would be covered by drywall that would be spackled and painted to match the existing wall and ceiling.

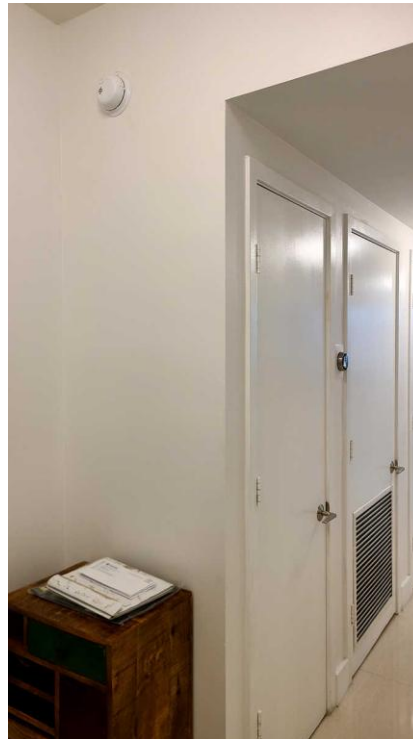
Figure (23): Smoke detector

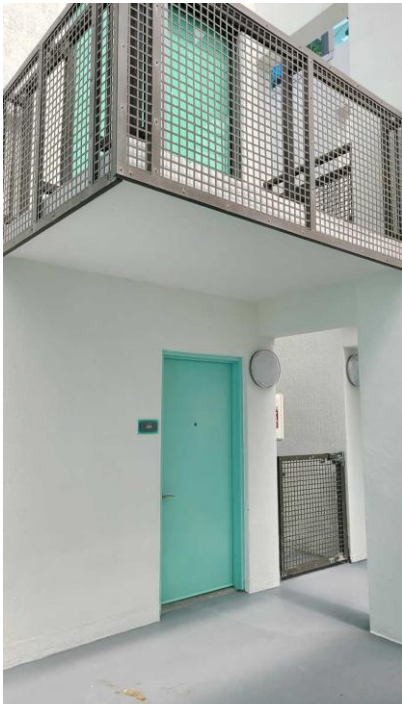
Figure (24): Proposed inlet grill location above and to the left of the entrance door

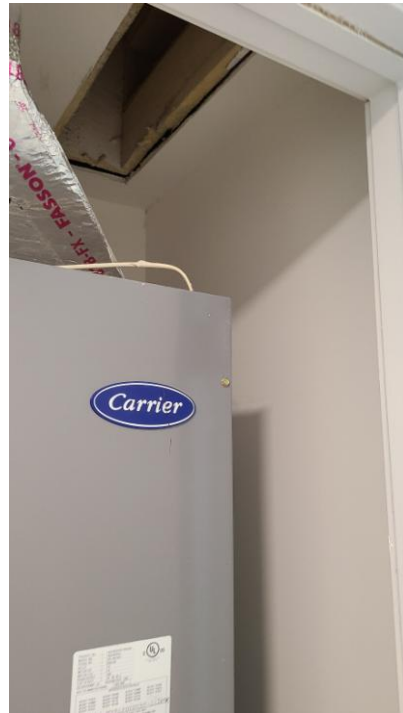
Figure (25): 4X6 duct installed in wall of HVAC closet with adjustable grill

To be able to modify the amount of air drawn into the HVAC closet an adjustable grill would need to be installed inside the HVAC closet at the 4X6 duct closet inlet. This grill would be adjusted as needed to modify the amount of incoming air. Ideally the grill adjustment would be made while using a bolometer air flow measuring tool on the outside grill to set the amount of incoming air. The airflow could also be adjusted by changing the inlet grill on the HVAC closet door to an adjustable grill that would be adjusted to induce a pre determined optimal HVAC closet negative pressure when the HVAC is running.

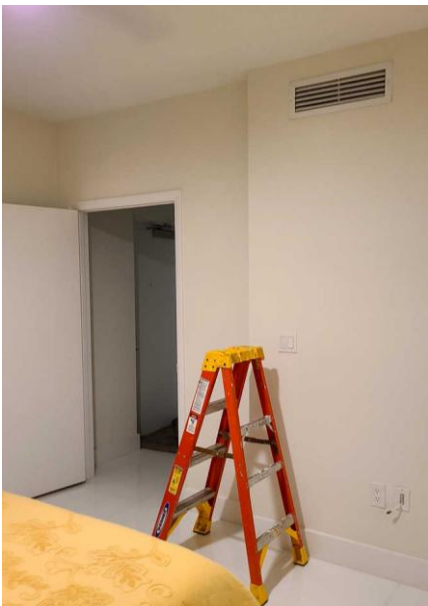
Figure (26): Bedroom/office return grill

The return grill in the guest bedroom appears to be oversized for the size of the bedroom. This grill could be modified if it is necessary to induce more negative pressure in the HVAC closet.
