Durability of Performance of a Home Radon Reduction System

Sub-Slab Depressurization Systems

EPA/625/6-91/032
April 1991

Kenneth J. Gadsby and David T. Harrje

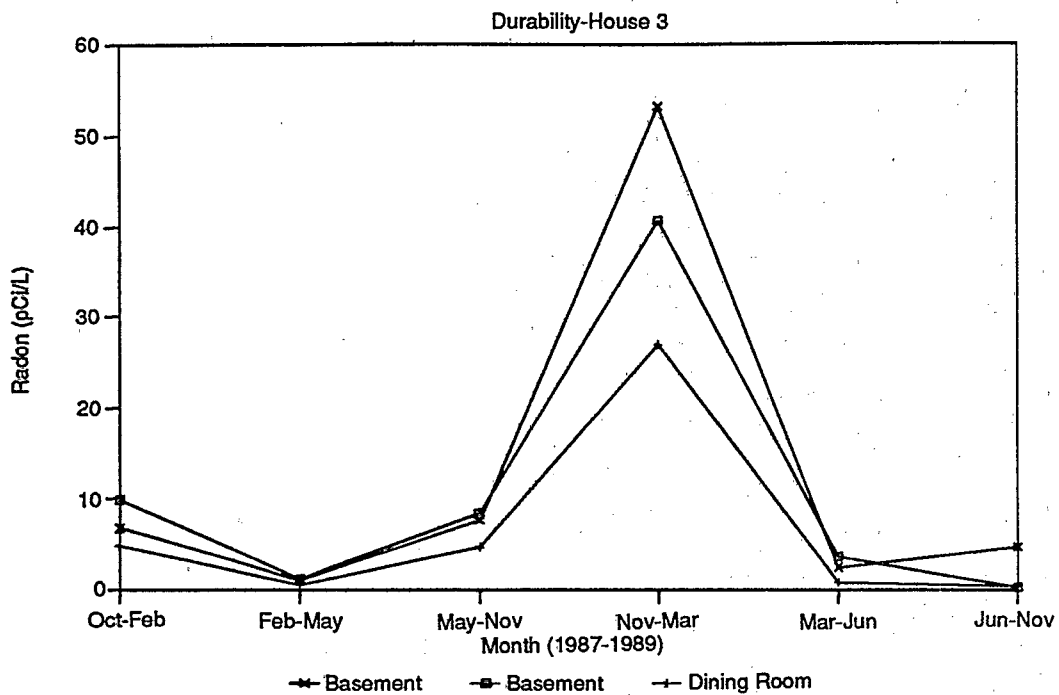
Figure 1. Radon Levels in House 3.

basement values we are seeing a 1.6 pCi/L average versus 1.2 pCi/L for May-November combined with March-June. This 0.4 pCi/L difference is well within the error band.

Based upon diagnostic team observation, only House 3 showed evidence of physical changes. Two cracks appeared in the basement slab near the slab edge extending toward the center of the room. Length of the cracks was approximately 6 ft and the width exceeded 1/16 in. at some locations. Flow from the basement into the subslab area through these cracks was determined with the use of a smoke tracer.

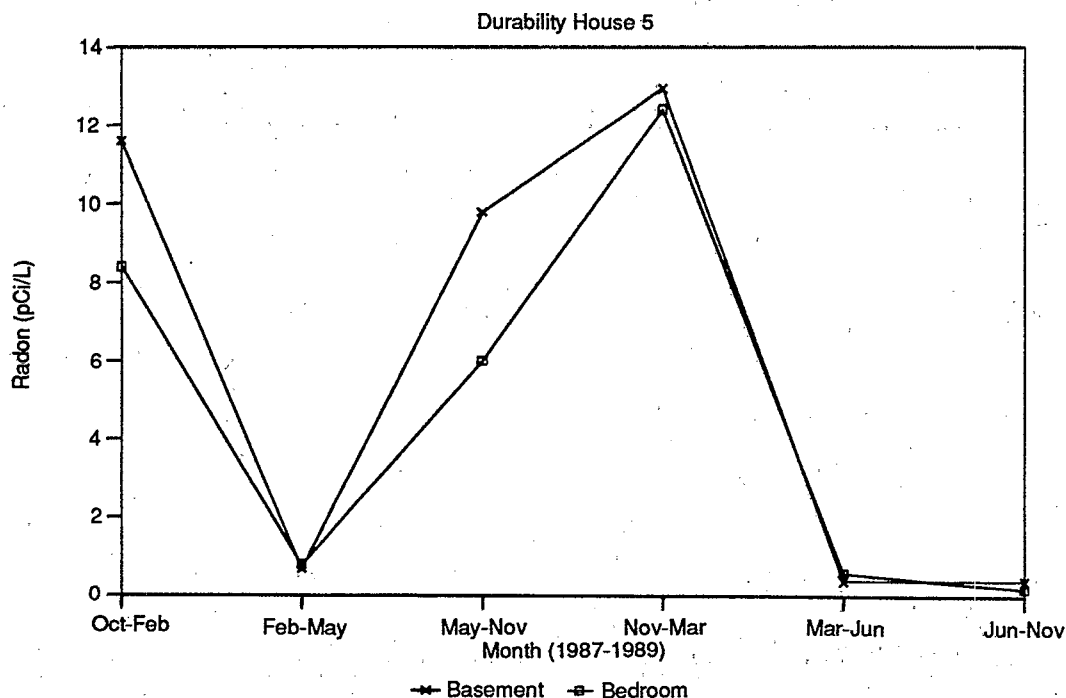
Figure 2. Radon Levels in House 5.

Checking the occupant questionnaire it was noted that the House 5 occupant had turned off the SSD system because of radio interference and because it was felt that, under mild weather conditions with open basement windows, it was wasting energy to operate the SSD system (Ref. 13). After listening to the radio or ventilating the basement, the occupant would then forget to turn on the mitigation system for long periods

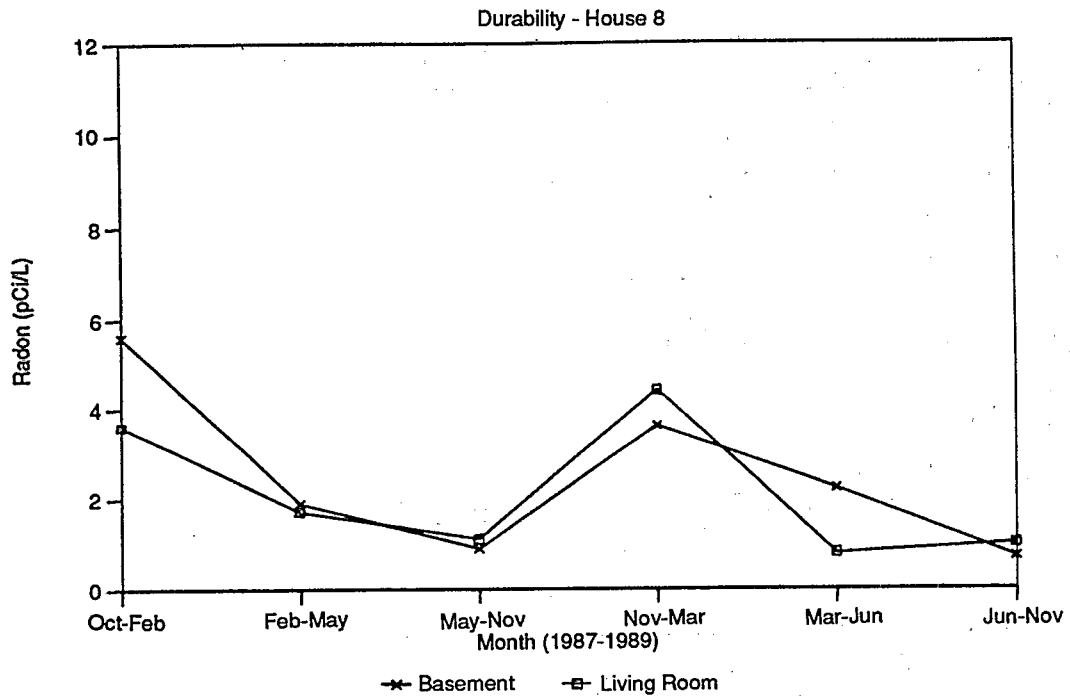
Figure 7. Radon levels in House 8.

We see variations in the November 88-March 89 period that could only be viewed as seasonal influences in Houses 8 and 10. In the case of House 8 similar increased concentrations were measured during the October 87-February 88 period. Averaging the values for House 8 (from Table 1) for the "winter periods" we have averages of 4.6 pCi/L for the basement and 4.0 pCi/L for the living room, a value at or above the EPA action level. If we average "spring, summer, and fall periods" the average value is only 1.7 pCi/L in the basement and 1.2 in the living room. This house illustrates how seasonal influences can bias SSD performance results. The annual average is still below the EPA action level of 4 pCi/L.

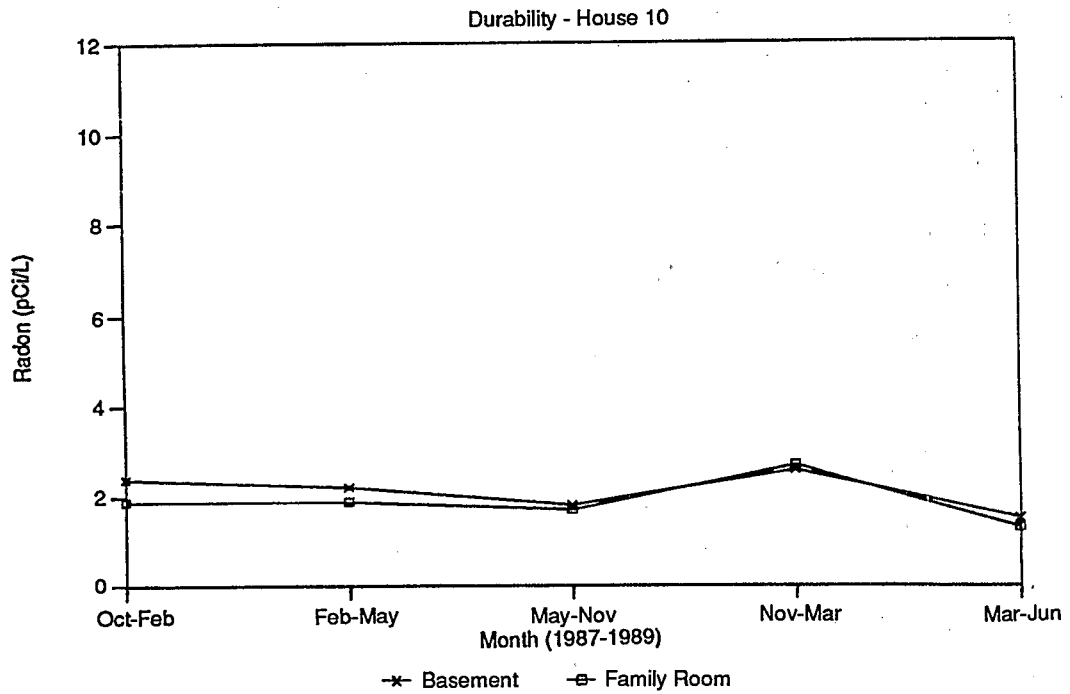
Figure 8. Radon levels in House 10.

House 10 shows only a slight increase in radon concentration in the October 87-February 88 period; i.e., 2.2 pCi/L average

versus 1.5 pCi/L for the "summer periods". However, the increase is more substantial in the November 88-March 89 period when values of 2.7 pCi/L are observed. This house also would appear to exhibit seasonal effects that increase the radon concentrations, but only by about 1 pCi/L.
