RADON REDUCTION SYSTEMS IN SCHOOLS

D. Saum
Infiltec
P.O. Box 1533
Falls Church, Virginia 22041

A. B. Craig and K. W. Leovic
Air and Energy Engineering Research Laboratory
United States Environmental Protection Agency
Research Triangle Park, North Carolina 27711

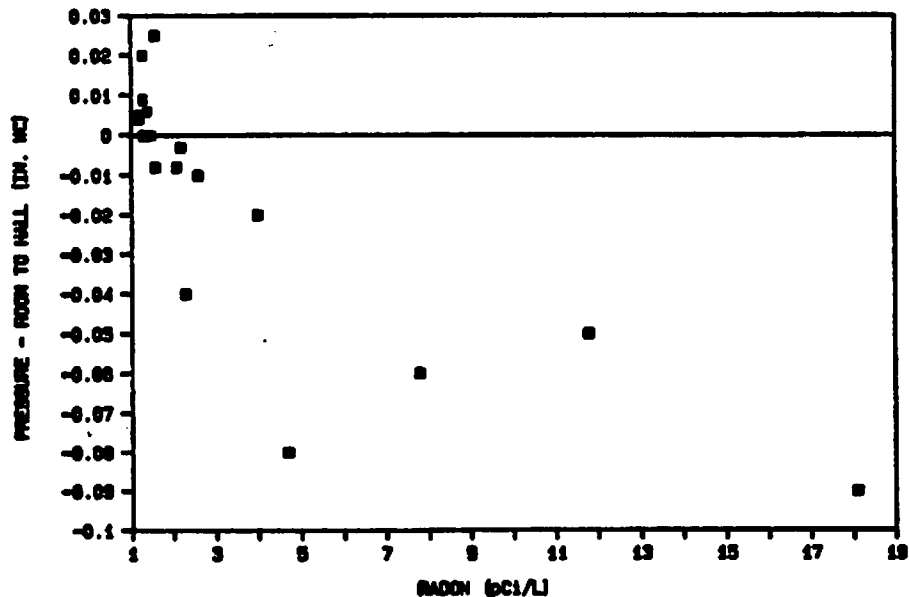
pressure in all rooms if the system were properly balanced. However, continuous radon and pressure measurements with the data logger indicated that many of the rooms were under negative pressure when both the supply and return fans were in operation. The room with the highest radon level measured 15 Pa negative pressure. As seen in Figure 1, there was a good correlation between negative pressure and radon levels in all rooms, with the highest radon levels in the rooms with the most negative pressures. When the return air fan was turned off the pressure in all rooms became positive, and radon levels decreased to less than 2 pCi/L. Examination of the air-handling system showed that the air distribution fan had been damaged and part of the housing cut away resulting in a great loss in capacity. It is believed that the distribution fan was actually supplying less air than the return air fan was removing, resulting in a negative pressure in many rooms.

Figure 1. Correlation Between Radon Levels and Pressure (Case Study A)

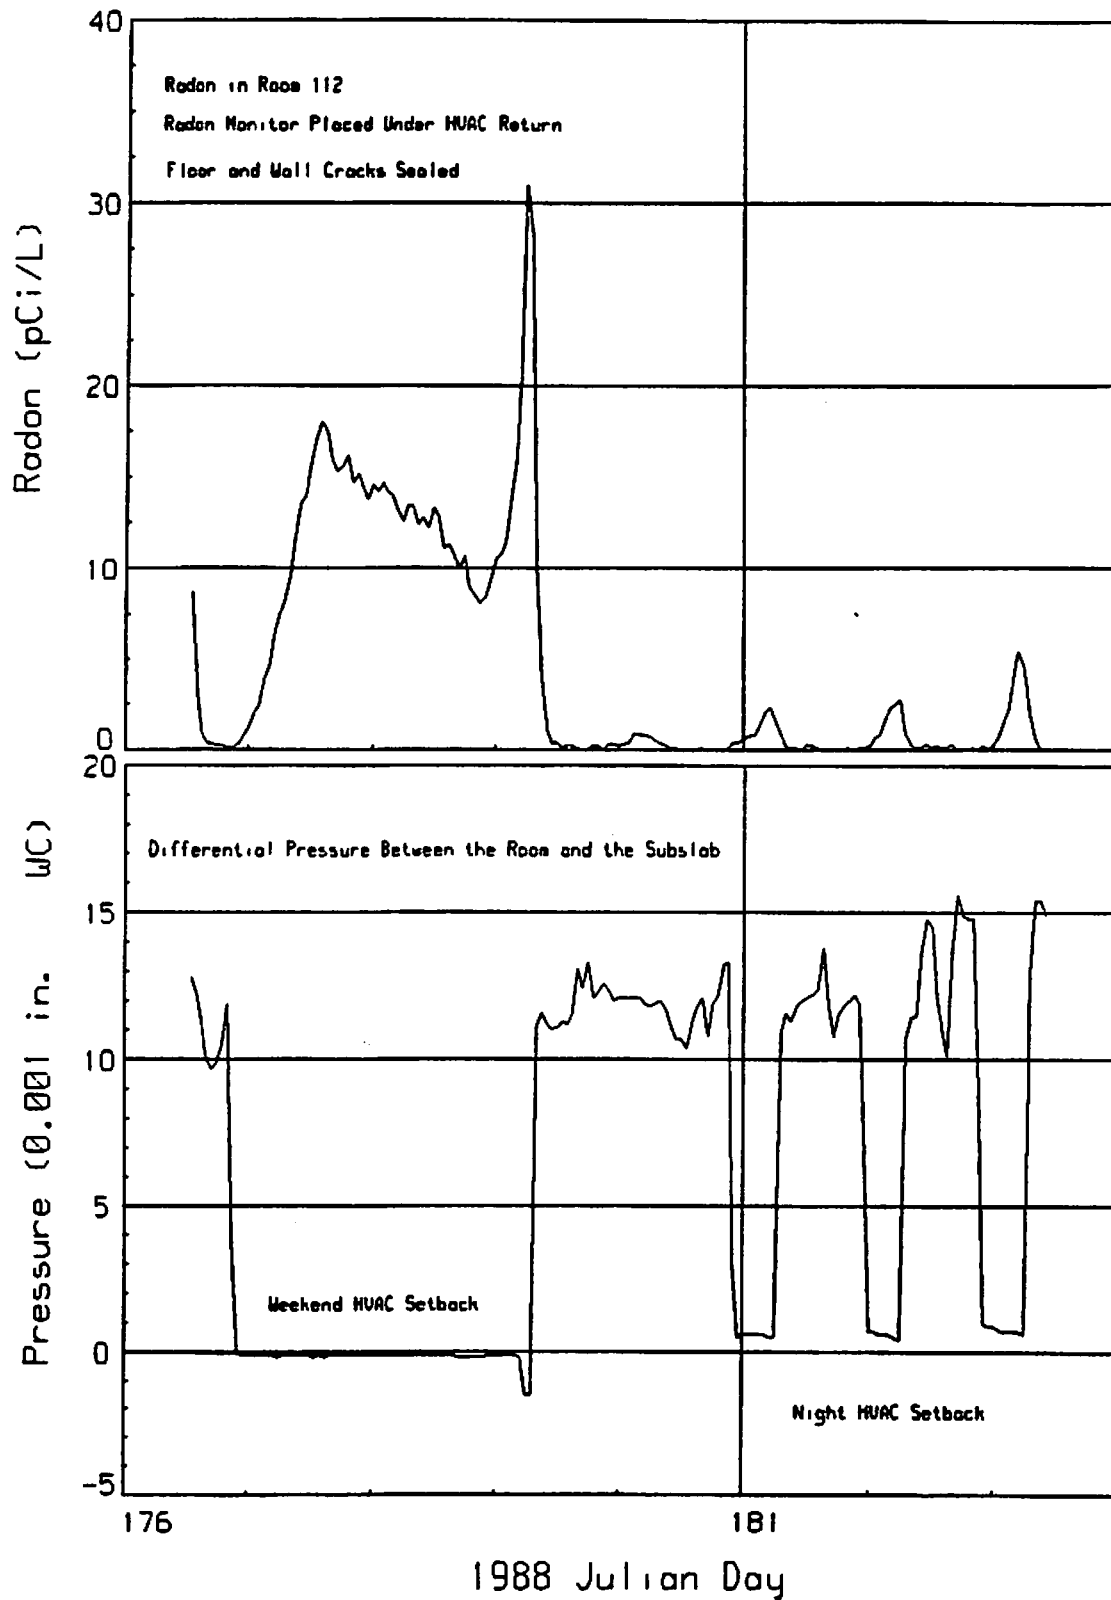
The impact of HVAC operation on radon levels in this room is displayed in Figure 2 for a 7 day period. (The return air louvers were closed during these measurements.) While the HVAC system is operating, the room is at a higher pressure than the subslab area and, consequently, radon entry is reduced. However, when the HVAC system is turned off during night and weekend setback, pressure in the room drops and radon levels increase.

Figure 2. Influence of HVAC Operation on Radon Levels (Case Study A).

As a temporary solution to reduce radon levels, the return air fan was left off and the HVAC system operated with only the air distribution fan. Under these conditions, all rooms showed positive pressure and had radon levels below 2 pCi/L. The damaged supply fan has now been replaced and the air distribution and air return systems are being balanced.

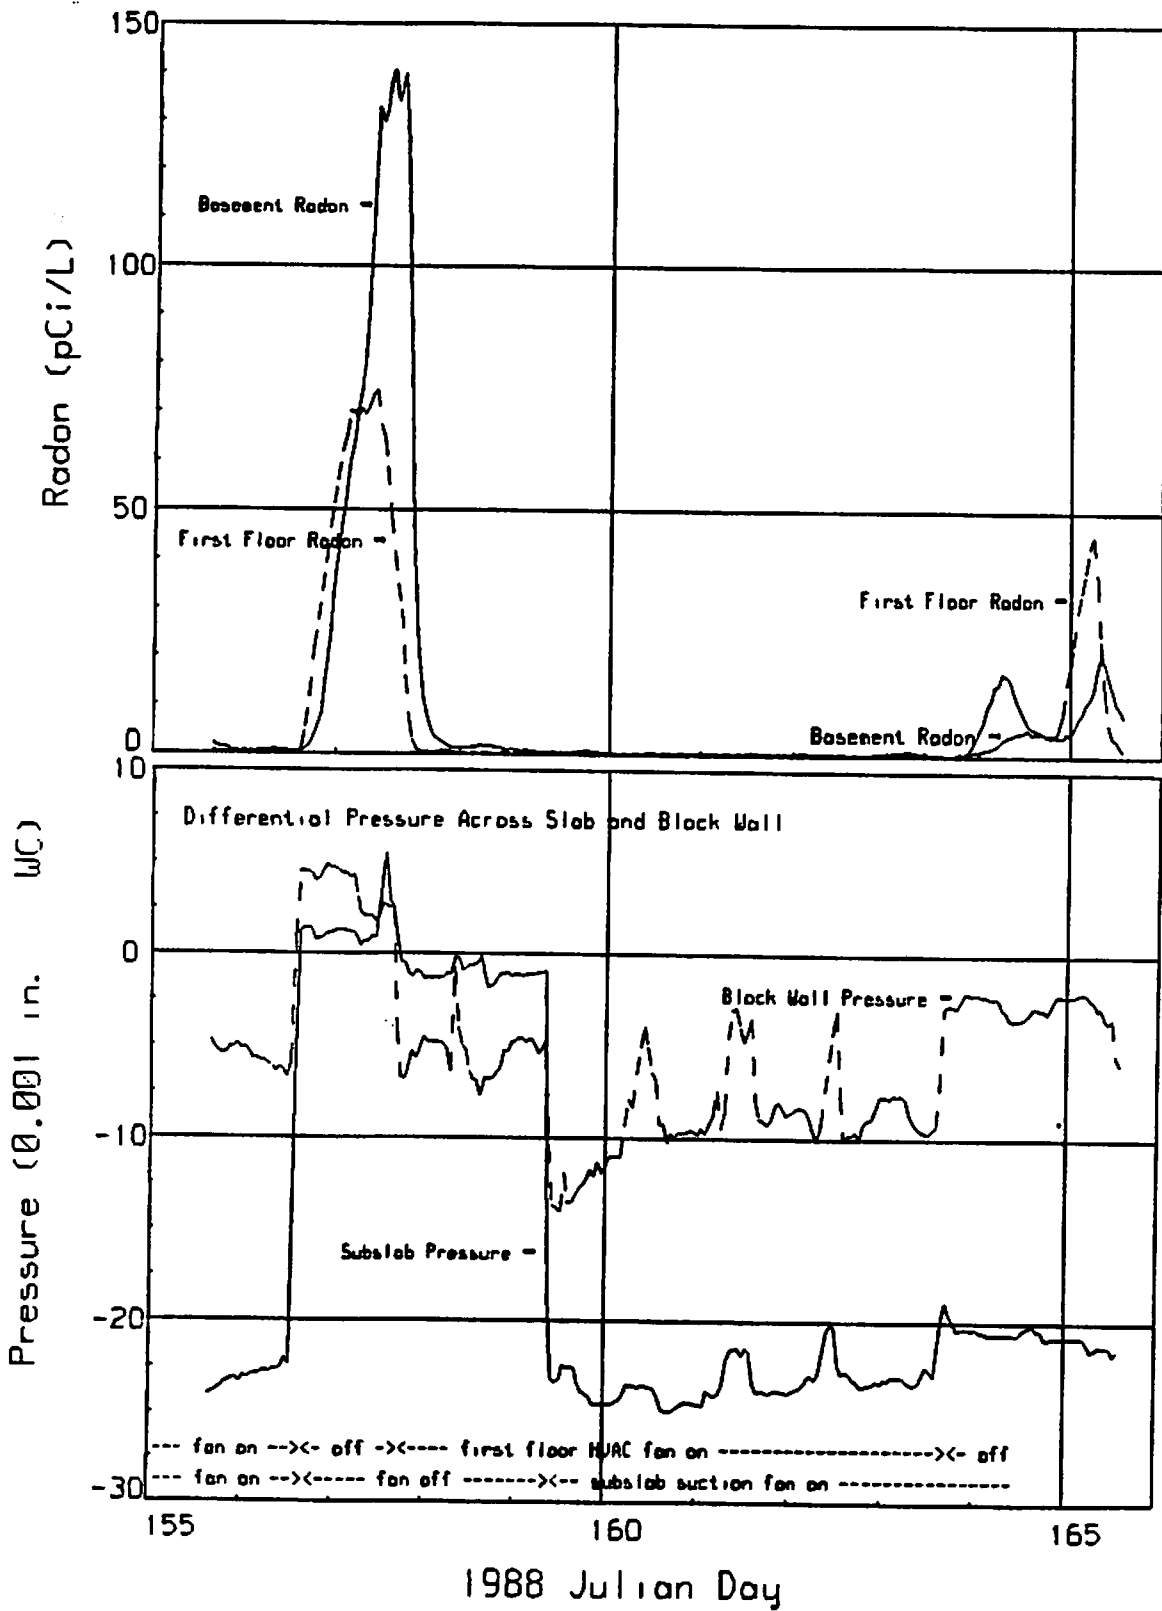
To evaluate the performance of a single-point subslab suction system and to investigate the effects of a single-fan HVAC system on mitigation performance, Figure 3 shows radon and pressure measurements in the school over a 10 day period. The first floor single fan HVAC system was operated continuously during the week to provide mitigation while the school was in session on the first floor. Since the basement was unoccupied during the monitoring period the basement HVAC system was not operated. Over the weekend (day 156), the HVAC system and the single point subslab suction system were turned off, and the radon levels rose quickly on both floors. On day 157 the subslab suction system remained off, but the first floor HVAC system was turned on. Radon levels on both floors dropped, and the differential pressure across the slab and block wall became slightly negative. During the school week (days 158-163), both the HVAC system and subslab suction system were operating, and radon levels remained low. During the following weekend (days 164 and 165), the subslab suction system was operated and the first floor HVAC system was off, resulting in an increase in radon levels. As seen in Figure 3, radon levels on the first floor reached 40 pCi/L under these conditions, so another suction point was installed on the first floor using a Kanafakt T-3B fan (rated at 310 cfm at 0.75 in. static pressure) and a 3 ft diameter suction hole. The first floor suction point was located on the west end of the building because radon levels were always higher there than on the east end. Subslab radon measurements also showed greater source strength on the west end. Addition of this suction point reduced levels on the first floor although radon levels on both floors still rose above 10 pCi/L at night with the air handlers off.

Figure 3. Influence of HVAC Operation and Single Point Subslab Depressurization on Radon Levels and Pressure (Case Study B).

Pressure field extension measurements indicated incomplete coverage of both floors. Consequently, two additional suction holes were installed in the basement, each with a T-2 fan and a 1 ft diameter suction hole. A 1 ft diameter suction point was also installed on the first floor and manifolded to the existing suction point.

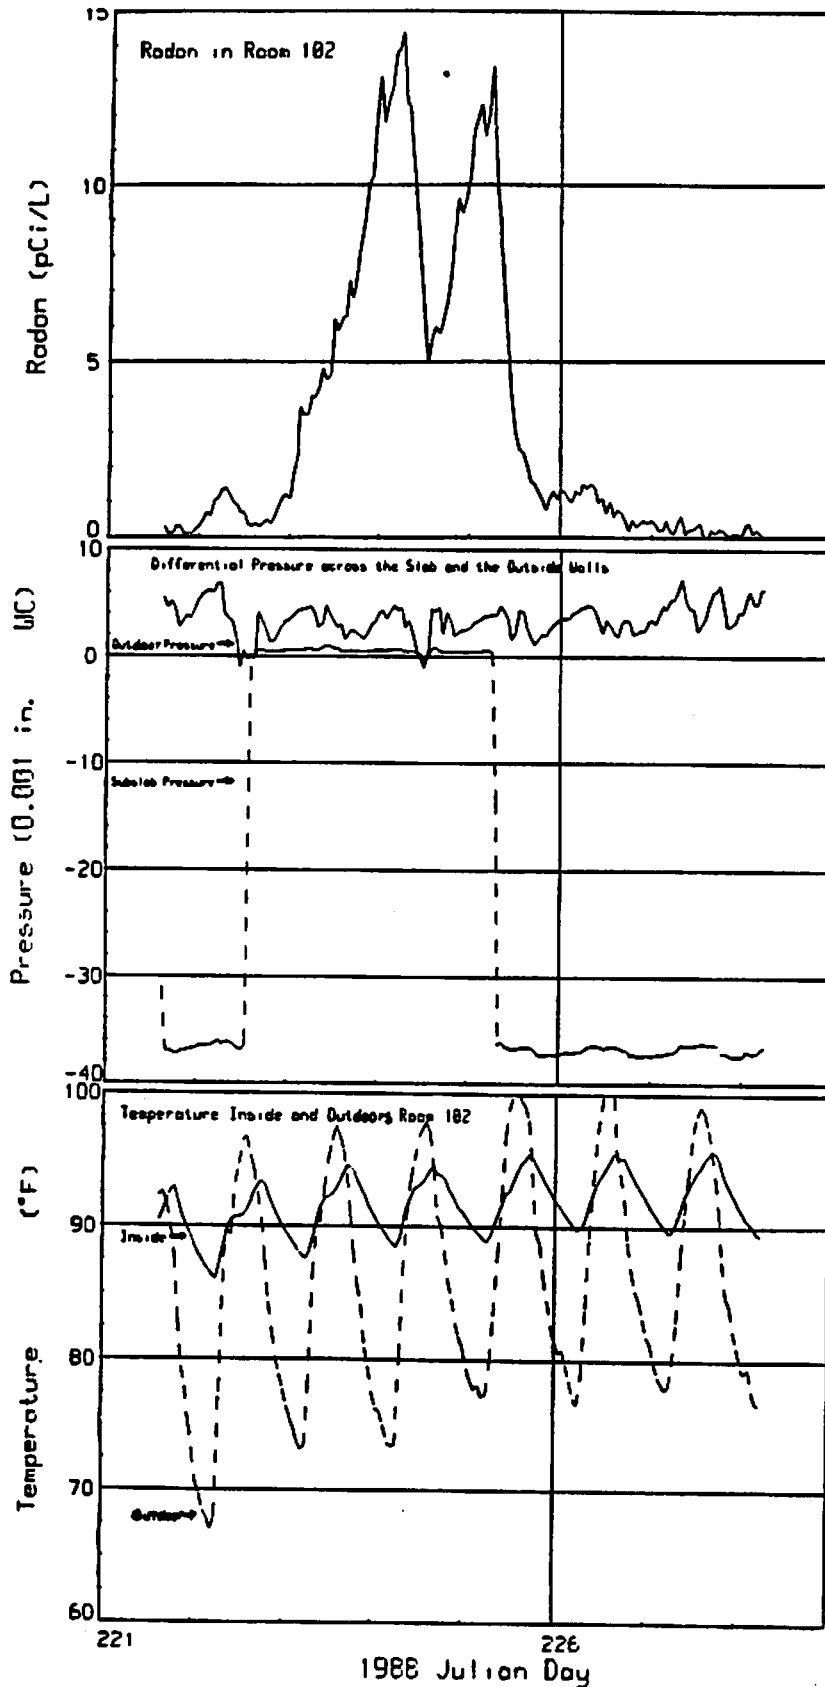
To analyze the effectiveness of a single point subslab suction system and to investigate the pressures that control radon levels in schools during hot weather, radon, pressure, and temperature were monitored continuously in one classroom, as seen in Figure 4. The classrooms were kept closed during this period of very hot weather, and there is no ventilation system in this building. When the subslab ventilation system was turned off from day 222 through day 225, the radon levels quickly rose and followed a diurnal cycle that seems to match the temperature cycle. When the outdoor temperature is coolest relative to indoor temperature, the radon levels are highest. This can be expected from the stack effect, as discussed in Case Study B. Although a small positive pressure was measured across the slab during this period, it does not show significant diurnal variation. The differential pressure across an outside classroom wall does not show much correlation with the radon levels, except for a sharp dip in the middle of day 224 that may be due to wind.

Figure 4. Effect of Single Point Subslab Depressurization on Radon Levels (Case Study D).
