WELL VENTS, A SIGNIFICANT SOURCE OF INDOOR RADON: A CASE STUDY

ABSTRACT

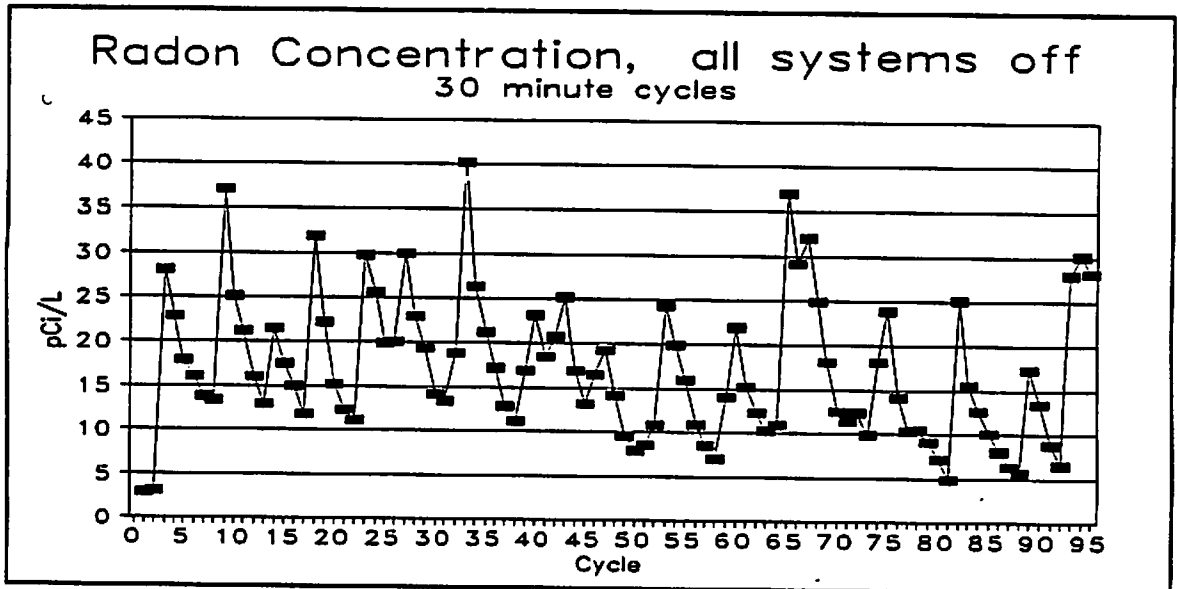
Figure 1. Radon Levels with Both SSD/BWD Systems Inoperative, 30 Minute Cycles

The above information implied that the cause of the exacerbated radon in air levels was located in the work room area. Therefore, two Pylon® AB-5 continuous radon monitors were utilized to study radon fluctuations in this area. One of the monitors was set up upon a work bench about 1.3 m high and the second was set up on a dehumidifier (non-operating) about 0.8 m high. It was decided to observe radon levels in this area with both SSD/BWD systems operating, only one (of each of the) SSD/BWD systems functioning, and with both of the systems turned off. Figures 1, 2 and 3 represent readings taken from the workbench site under different mitigation conditions.

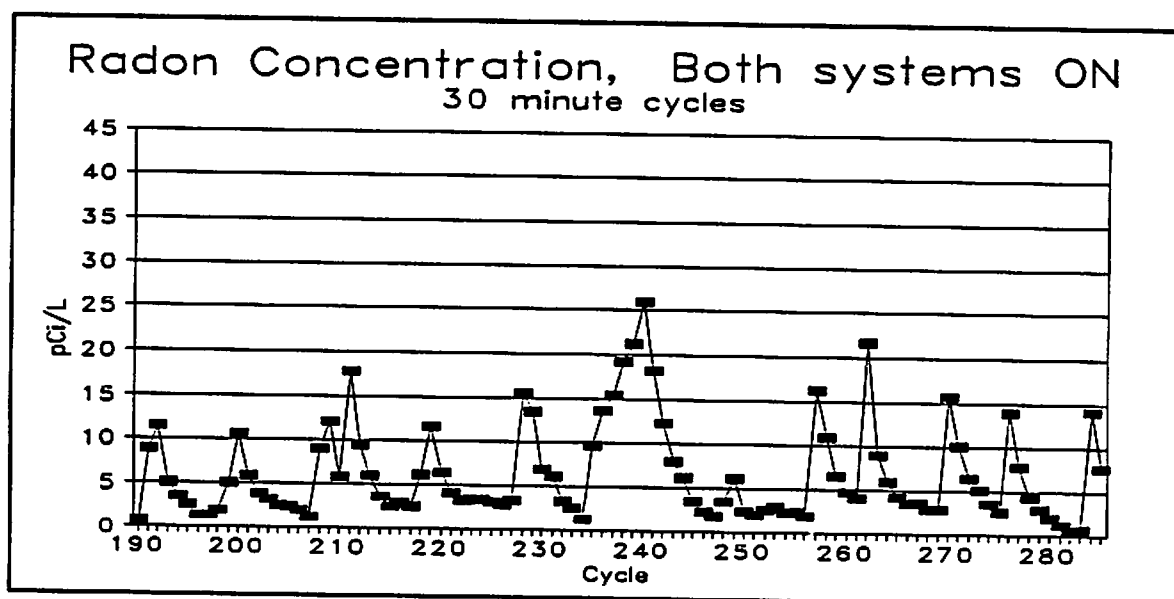
Figure 3. Radon Levels with both SSD/BWD Systems Operating, 30 Minute Cycles

Although the nature of the fluctuations in radon levels present in the basement work area were documented with these readings, the precise cause of the infiltration was not yet determined. A sniffer test of air bled from the hydro-pneumatic pressure tank indicated a high radon concentration in the tank's air volume. Therefore, charcoal radon monitors were utilized by placement in various basement areas along with sealing two of these monitors directly to the pressurized water tank with plastic sheeting and duct tape. The two monitors attached to the pressurized water tank were taped directly over air inlets present upon the tank. The results seen in Table 2 were obtained with these monitors:

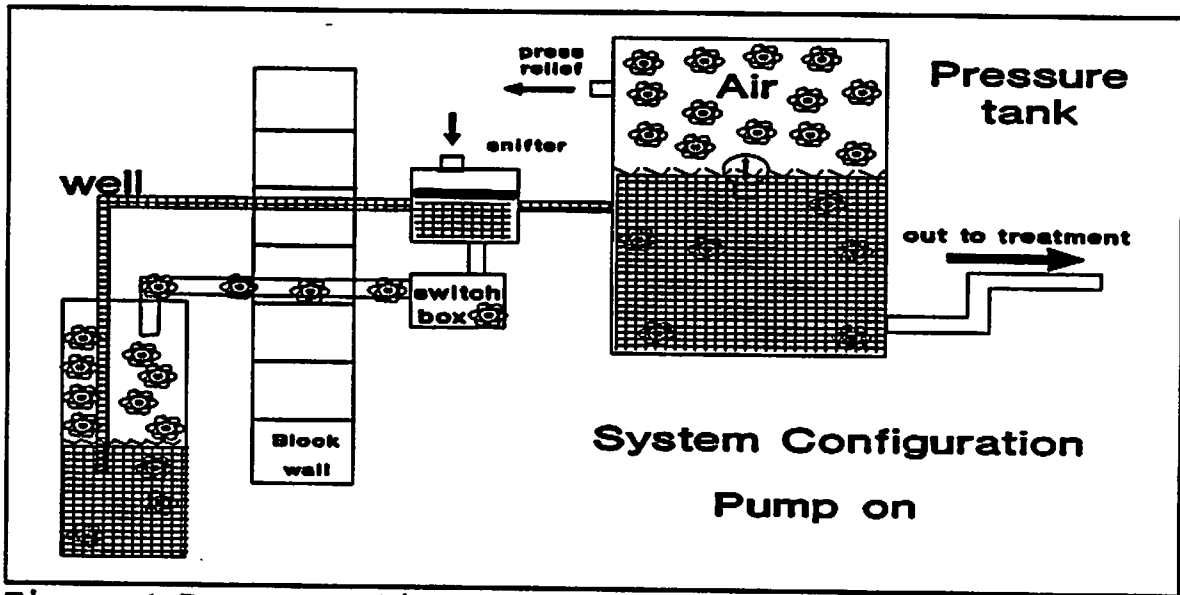
Figure 4 Pump Operating

Upon cessation of pumping, a snifter valve, located near the switch box, allows basement air to enter the well water supply line acting like a vacuum breaker. Water in the line is replaced by house air back to the water level in the well. When pumping resumes, the air which now contains substantial quantities of radon gas is pumped into the pressurized storage tank. Ultimately, that radon laden air is purged from the tank to the indoor air via the pressure relief valve on the pressure tank.

In an effort by the contractor to correct the situation the relief valve on the tank air was removed so that it did not off-gas into the basement area. Subsequently, a Pylon® AB-5 radiation monitor was set in the vicinity of the pressurized water tank to continuously record radon concentrations. The intermittent peaks characteristic of brief introduction of high concentrations of radon gas continued.
