COMPLEX RADON MITIGATION OF A LARGE BUILDING

By
David Wilson, Oak Ridge National Laboratory, Oak Ridge, Tennessee, USA
and
Stanley Ng, Pacific Division, Naval Facilities Engineering Command, Pearl Harbor,
Hawaii, USA

ABSTRACT

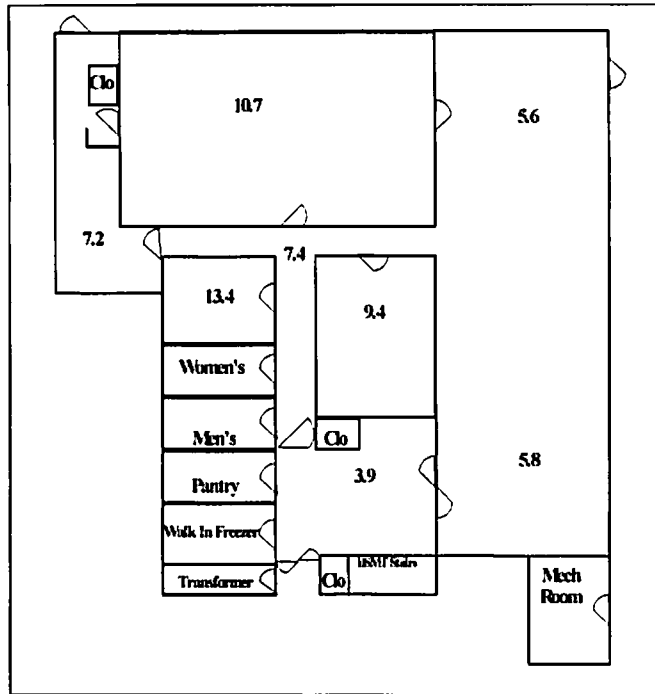
Figure 2. Long-term radon results in pCi/L

During 1997 to 1998, long-term radon testing using alpha-track detectors was performed within all routinely occupied rooms. Of the seven rooms tested, six were determined to have elevated radon levels, ranging from 5.6 pCi/L to 13.4 pCi/L (Figure 2). In 1999, short-term follow-up testing (electret) was repeated in the seven rooms, the basement, and both bathrooms. These

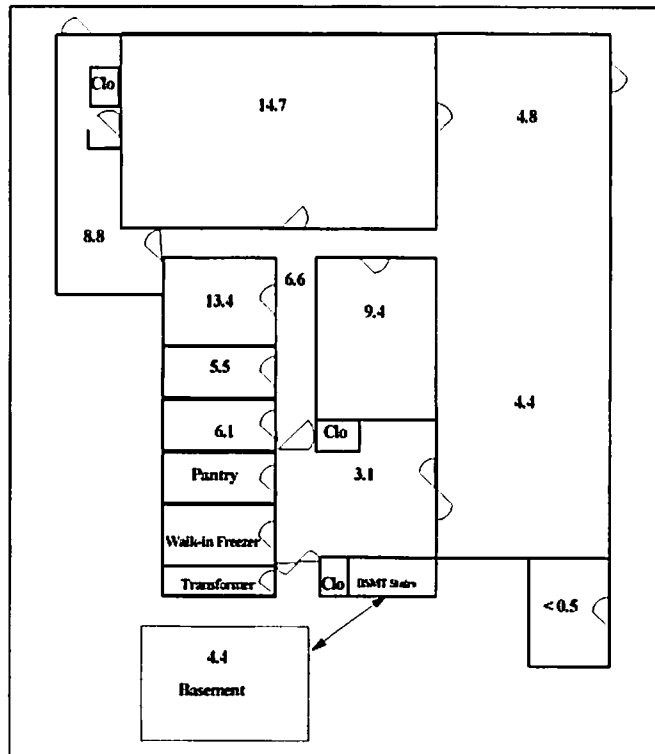
Figure 3. Short-term radon results in pCi/L

follow-up tests confirmed the original long-term test data and identified three additional rooms for radon mitigation (Figure 3).

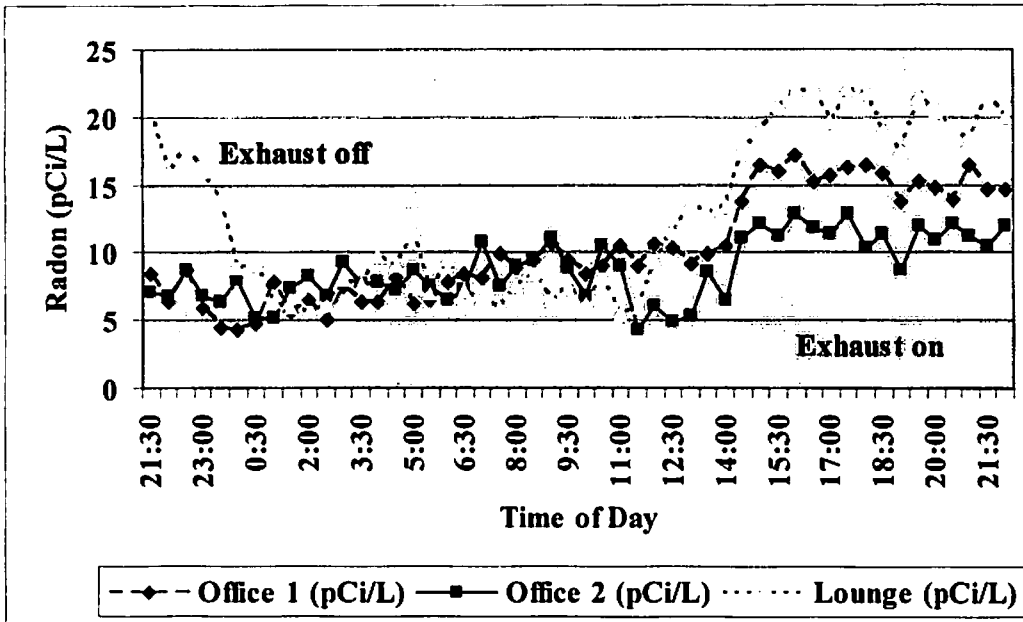
Figure 4. Continuous radon levels in three rooms as a function of exhaust

With respect to the other air exhaust systems, a systematic study was performed as a function of “on” versus “off” for each of the air exhaust systems. Individually, none of the non-kitchen exhaust systems created a significant negative pressure problem. However, when all were turned on, the combined DP relative to outdoors was (-) 14 Pa. If the 10,000-CFM kitchen exhaust fan was also activated, the building’s DP increased significantly to (-) 80 Pa. For the bathrooms a DP of (-) 6 Pa to (-) 8 Pa was measured with the doors closed. However, the doors were typically left open during business hours. Therefore, the potential impact of the pressure imbalance in these rooms was minimal. Interviews with the building manager and workers confirmed that the typical configuration during normal business hours was to have all exhaust fans operating and there was no convenient way to change this practice. Therefore, it was concluded that the pressure imbalance would have to be worked around or negated before radon mitigation could be achieved.

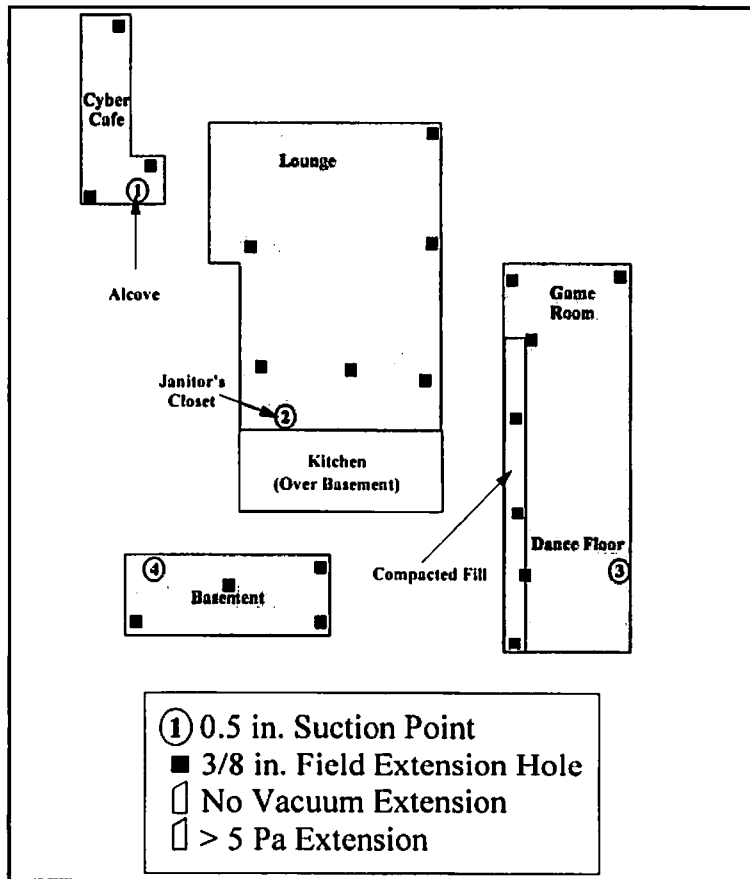
Figure 5. Subslab field extension

Because of the renovation history of the building, subslab diagnostics were performed on each of the three slab-on-grade subslabs and the basement slab to determine if active soil depressurization (ASD) was feasible (Figure 5). Field extension data collected with the air conditioning turned on and no exhaust systems operating [(-) 5 Pa] determined that a three-fan, three-suction point system (Figures 6, 7, 8, and 9) would cover 100% of the slab-on-grade subslabs. The diagnostics were then repeated at (-) 14 Pa (all exhaust systems except the grill), and the coverage dropped to about 60%. Coverage with all exhausts systems turned on [(-) 80 Pa] dropped subslab coverage to an average of <5%. With the marginal coverage at (-) 14 Pa for the slab-on-grade subslabs, it was estimated that three additional suction points would be needed. Two of these additional penetrations would be located on the exterior of the building and would not cause a problem. However, because of the usage of space and the mostly open floor plan, one of the suction points would need to be near the middle of the dance floor. Therefore, this option was discounted as well.

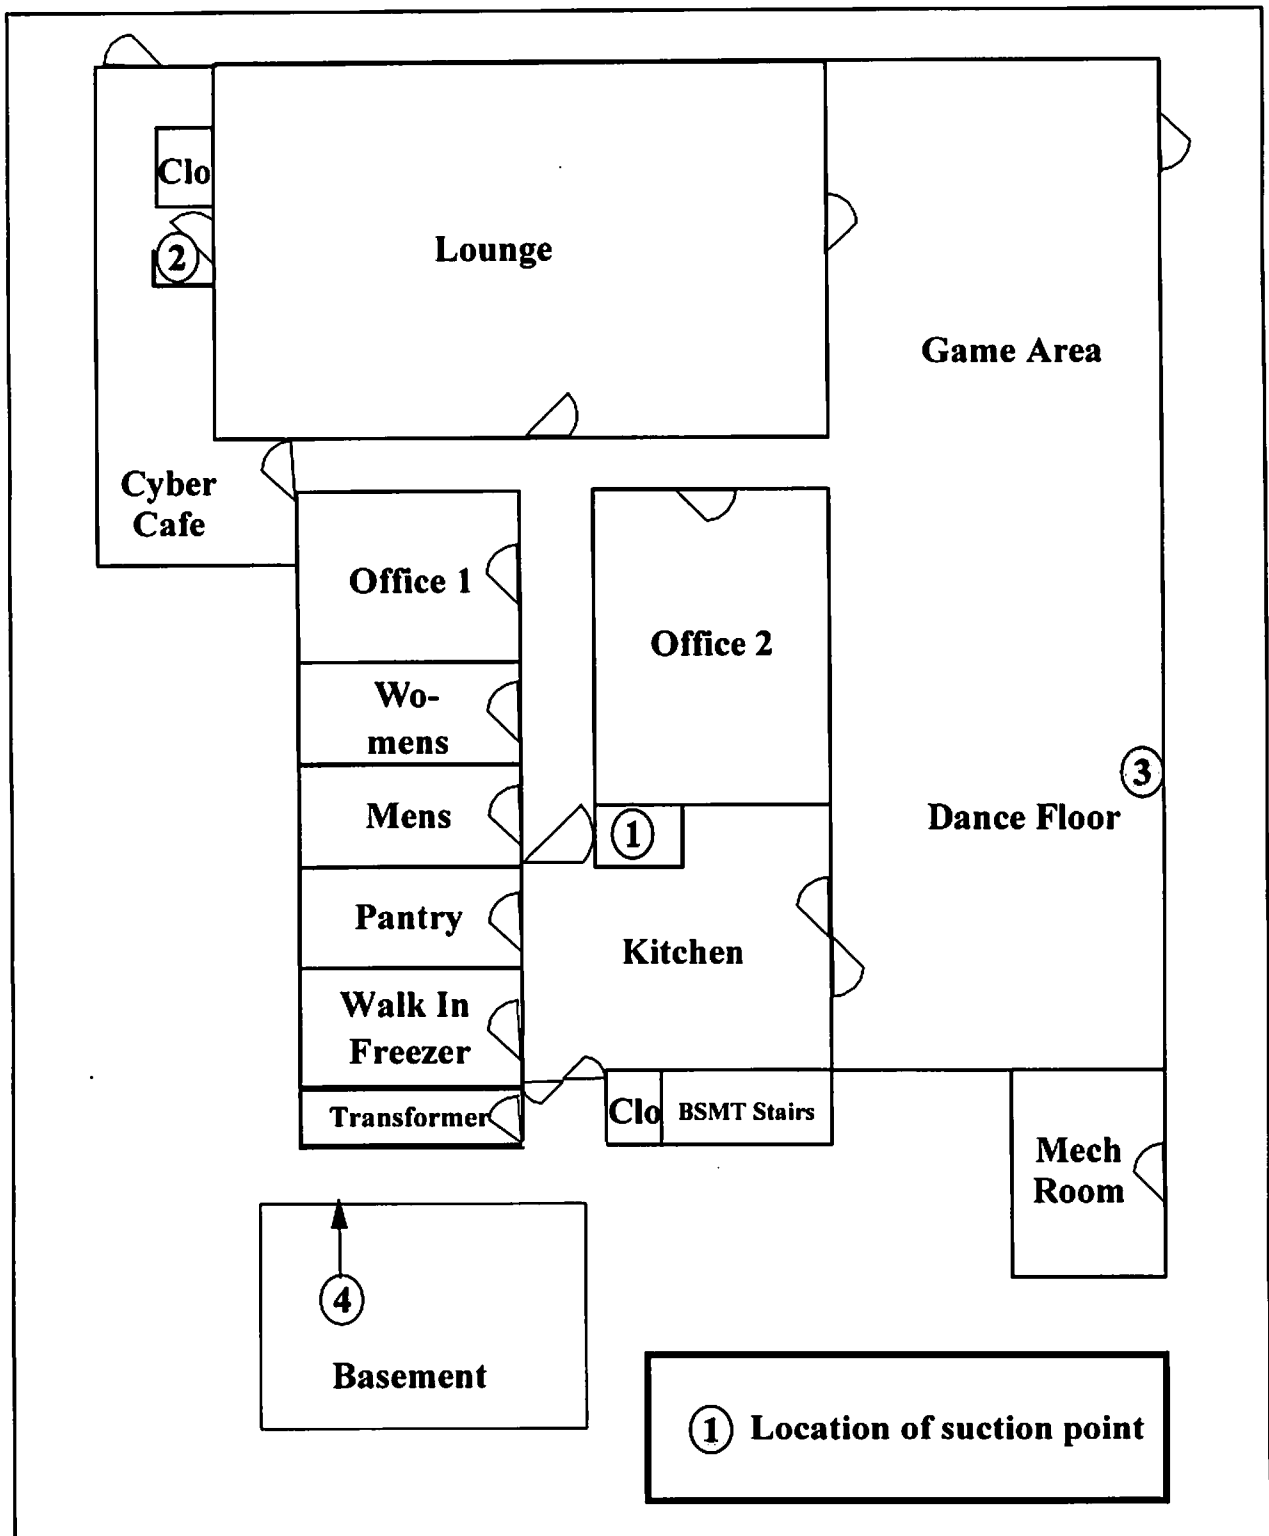
Figure 6. Suction point location

The three-fan (GP 501), four-suction-point ASD system was installed as originally proposed (Figure 6). As predicted by the subslab diagnostics, at (-) 14 Pa, with all exhausts turned on except for the grill, only 60% of the subslabs were covered. Postmitigation testing found that only conditions in the Cyber Café were mitigated. CRM measurements performed in three rooms identified as having elevated radon levels showed that room conditions were mitigated if the exhaust systems were turned off (Figure 10). Additional subslab diagnostics determined that mitigation could be achieved if the shell pressure could be reduced to (-) 8 Pa or less. After consulting the blower door curves generated during earlier diagnostics, it was estimated that only 800 CFM of additional fresh air would be needed to achieve this pressure.

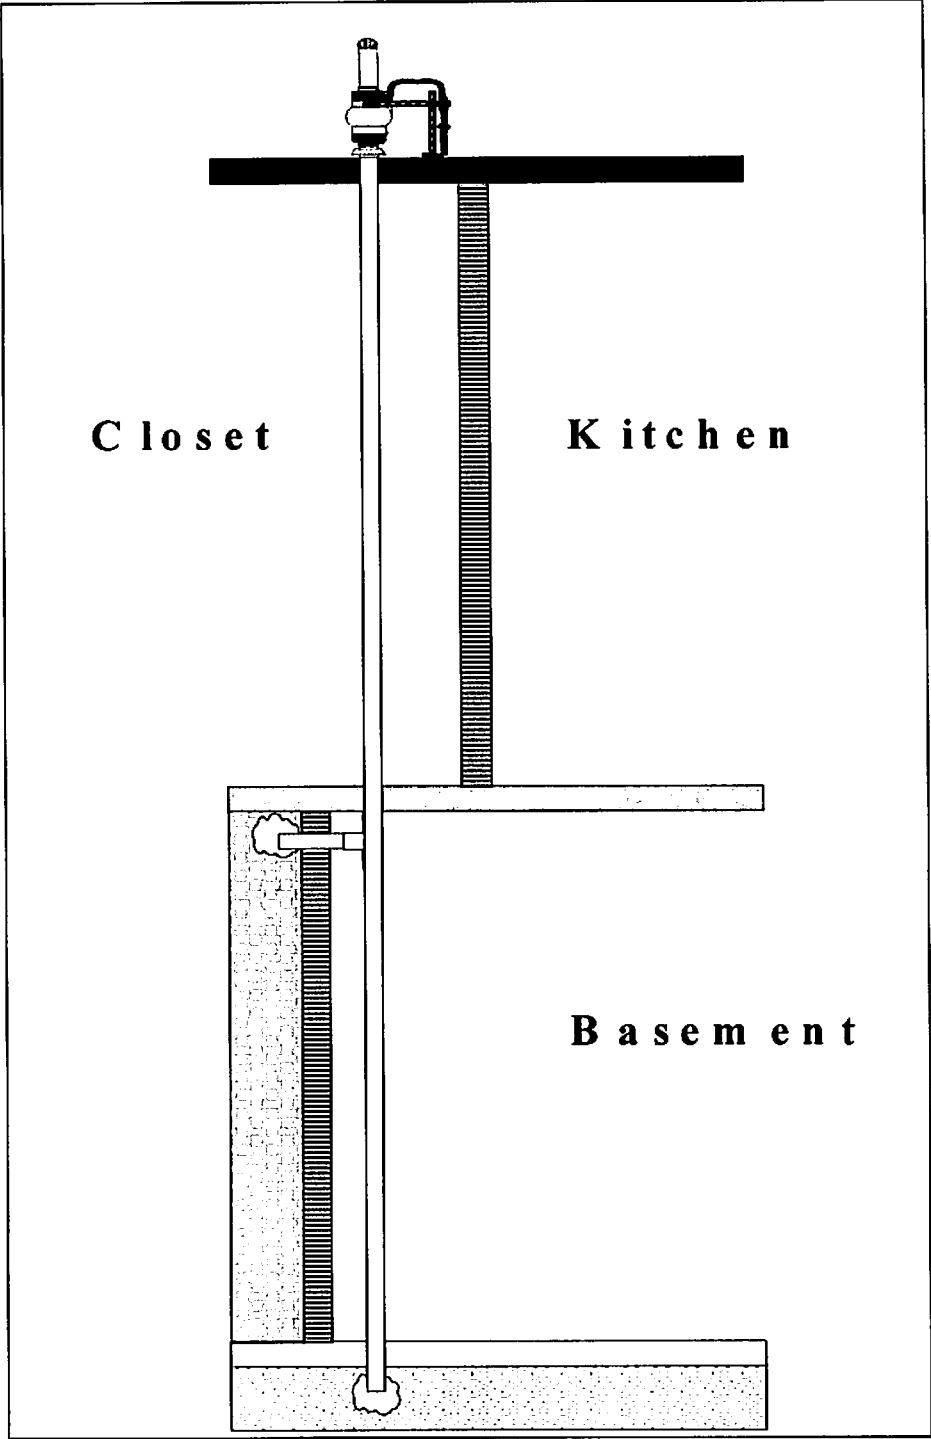
Figure 7. ASD System 1

The partial basement, which was under only the kitchen, was not conditioned, had no external exhausts, and had a single exit to the outside. In addition, inspection of the basement ceiling found that all the pipe penetrations from the kitchen were well sealed. DP tests relative to the outdoors found that the basement was consistently (-) 2 Pa regardless of the DP in the kitchen above. In addition, subslab diagnostics in the basement found excellent communication under the entire subslab (Figure 5). With respect to system design, the basement suction point could be manifolded to the slab-on-grade ASD System 1 (Figure 7).

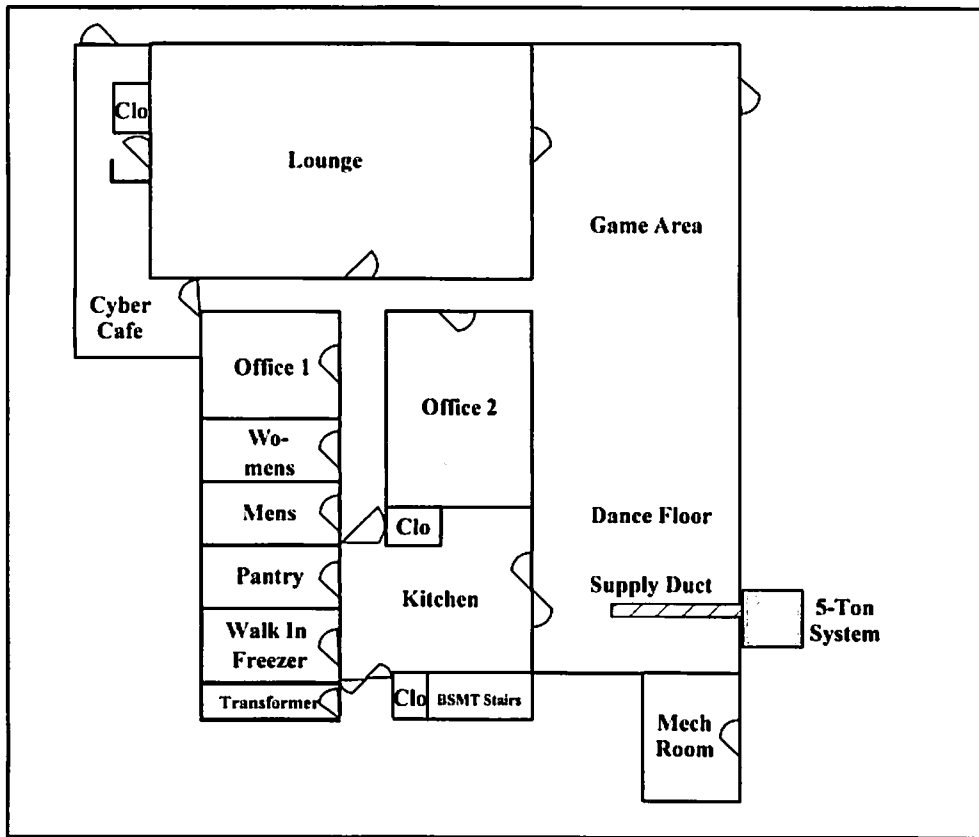
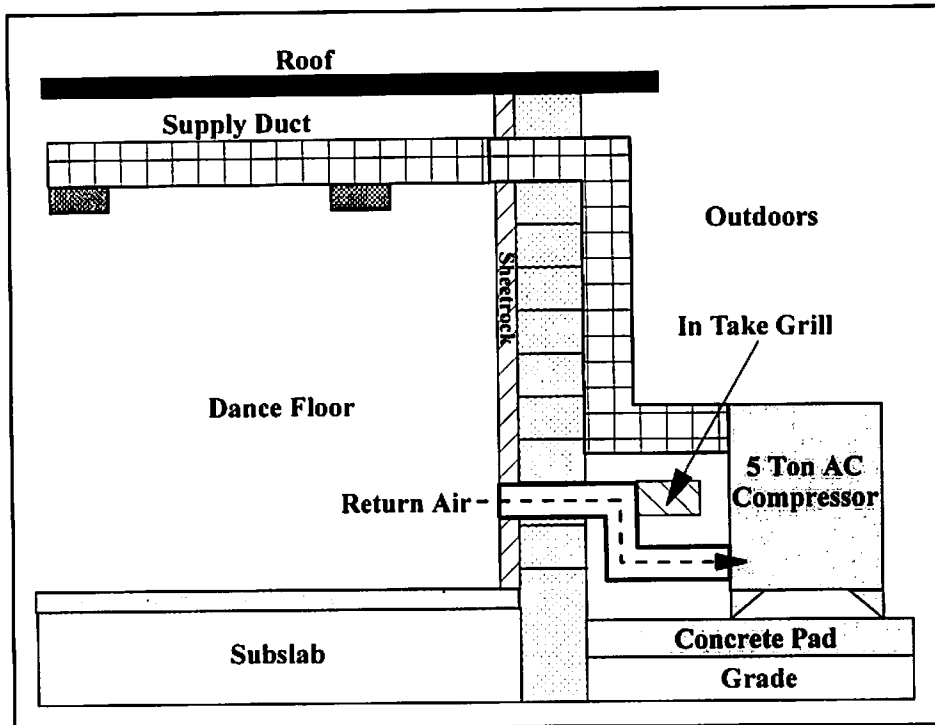
Figure 11. Location of the 5-ton supplemental air makeup system

Figure 12. Supplemental air makeup

the estimated 800 CFM of fresh air needed, concern was expressed whether a 3-ton unit would have sufficient reserve capacity to condition additional air if the original projections were optimistic. Mindful of the fact that the building needed an additional cooling, a 5-ton compressor was selected. This choice provided additional cooling and a reasonable “cushion” if estimates were wrong. The system design included auto sensors that would shut the system down if a fire occurred or if the supply air stream exceeded 78°F or 50% humidity. Because of comfort factors, the location of the discharge point for the 2000 CFM of air (total system capacity for 5 tons) became an issue. Long, complex duct runs that would evenly distribute the conditioned air throughout the building would degrade system performance. Therefore, the shortest duct run possible to the point of highest load would be ideal. Examination of the building’s activities identified the dance floor as the most likely location to meet these criteria. The location required only 20 ft of supply duct and was the place of highest physical activity in the building. Installation and activation of the 5-ton system (Figure 11 and 12) reduced the negative pressure within the building to (-) 7 Pa, which was within the desired range.

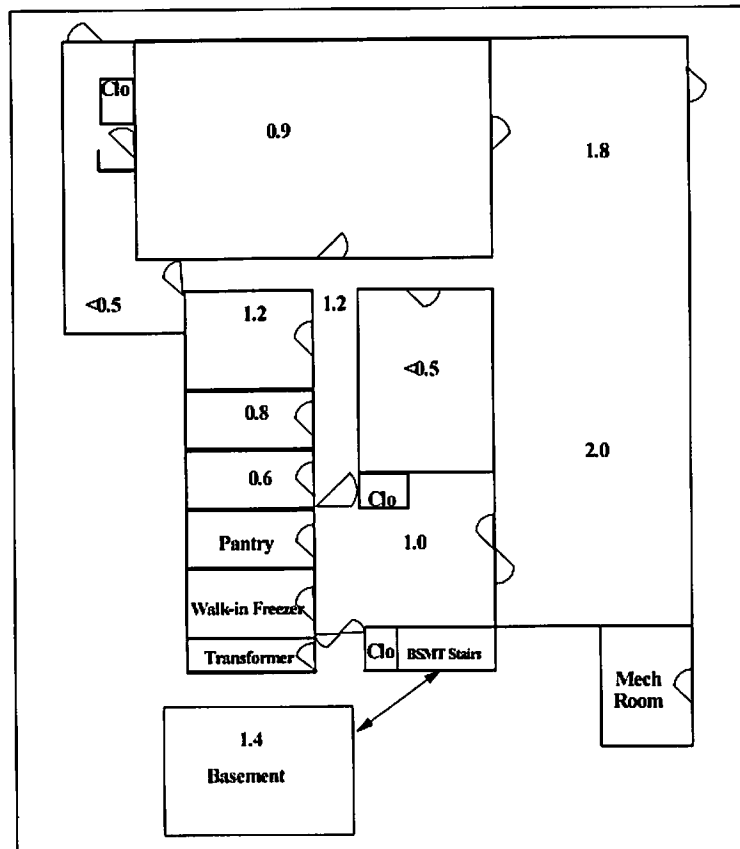
Figure 13. Postmitigation results in pCi/L

Postmitigation testing of the building with the passive kitchen louvers open, all three ASD systems operational, and the 5-ton supplemental makeup air system (800 CFM) operational found that radon levels within the building had dropped significantly (Figure 13). As an added benefit, the changes made to the building (e.g., passive louvers and the added cooling) significantly improved the overall comfort factor of the building. For one, these improvements eliminated the need to preload cool the building prior to opening. Second, condensation problems within various rooms of the building were eliminated. Third, for the first time, the two preexisting mechanical systems in the building actually achieved the desired thermostat setting and cycled off, meaning potentially lower energy and maintenance costs.
