## USING ASD TO MITIGATE CO2 METHANE AND BENZENE

Presented at the 2003 - AARST - 13<sup>th</sup> Annual International Radon Symposium in Nashville, TN

Bill Brodhead WPB Enterprises, Inc. 2844 Slifer Valley Rd., Riegelsville, PA 18077 <u>Bill@wpb-radon.com</u> www.wpb-radon.com

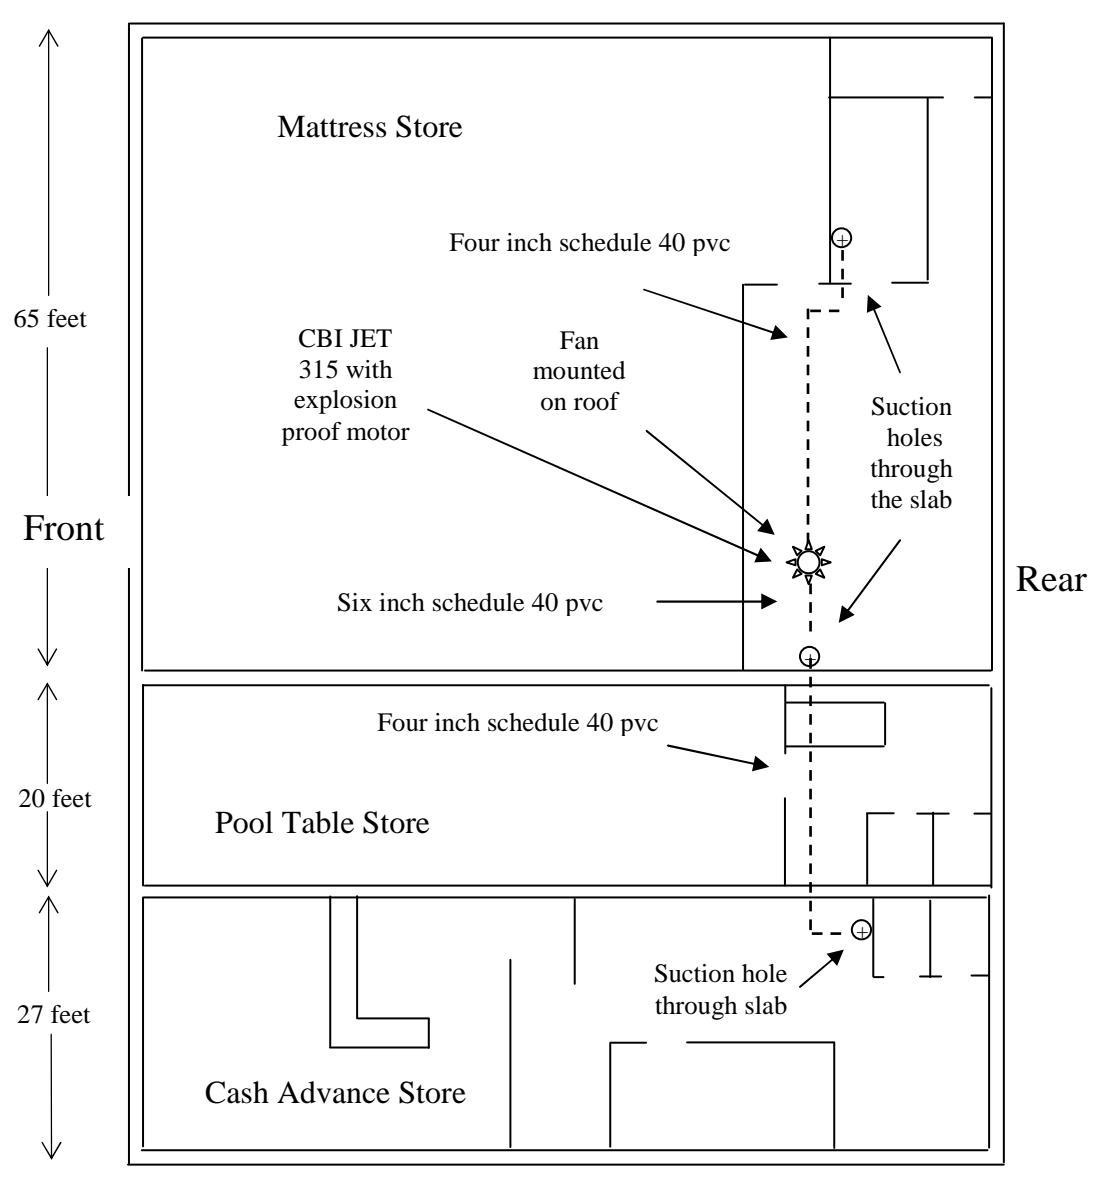
A three hole suction system was designed using an explosion proof fan installed on the flat roof. A CBI Jet 315 upblast exhaust blower with a 1/3 hp explosion proof motor was choosen for the fan. The local fire marshal was contacted to get approval for the fire-stop collars to be used as the vent pipe penetrated the firewalls between the stores. See the accompanying drawings.

The final system performance indicated a flow rate of 570 cfm. The far cash store u-tube read 9/8 of an inch of water column. The exhaust on the roof had 2200 ppm of methane in the exhaust (4 % LEL).

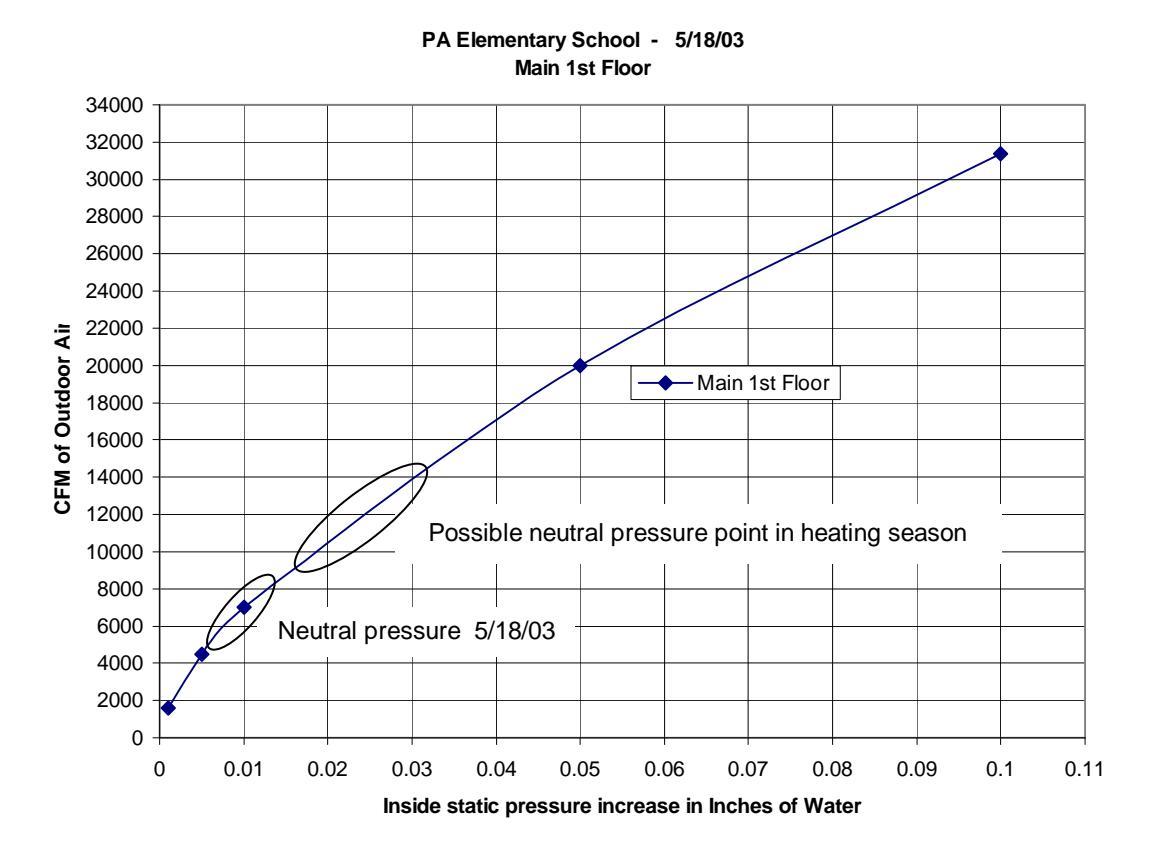
The blower doors indicated that it would require over 10,000 cfm of outdoor air to pressurize the main section of the building in the winter. The graph below indicates the amount of air needed to create pressure in the main portion of the building. The multi-purpose room would require an additional 4000 cfm of outdoor air in the winter.
