ENVIRONMENTAL RADON: OCCURRENCE, CONTROL, AND HEALTH HAZARDS

Chapter Three

THE INDEX HOUSE: PENNSYLVANIA RADON RESEARCH AND DEMONSTRATION PROJECT POTTSTOWN, PENNSYLVANIA, 1986-1988

MARGARET A. REILLY

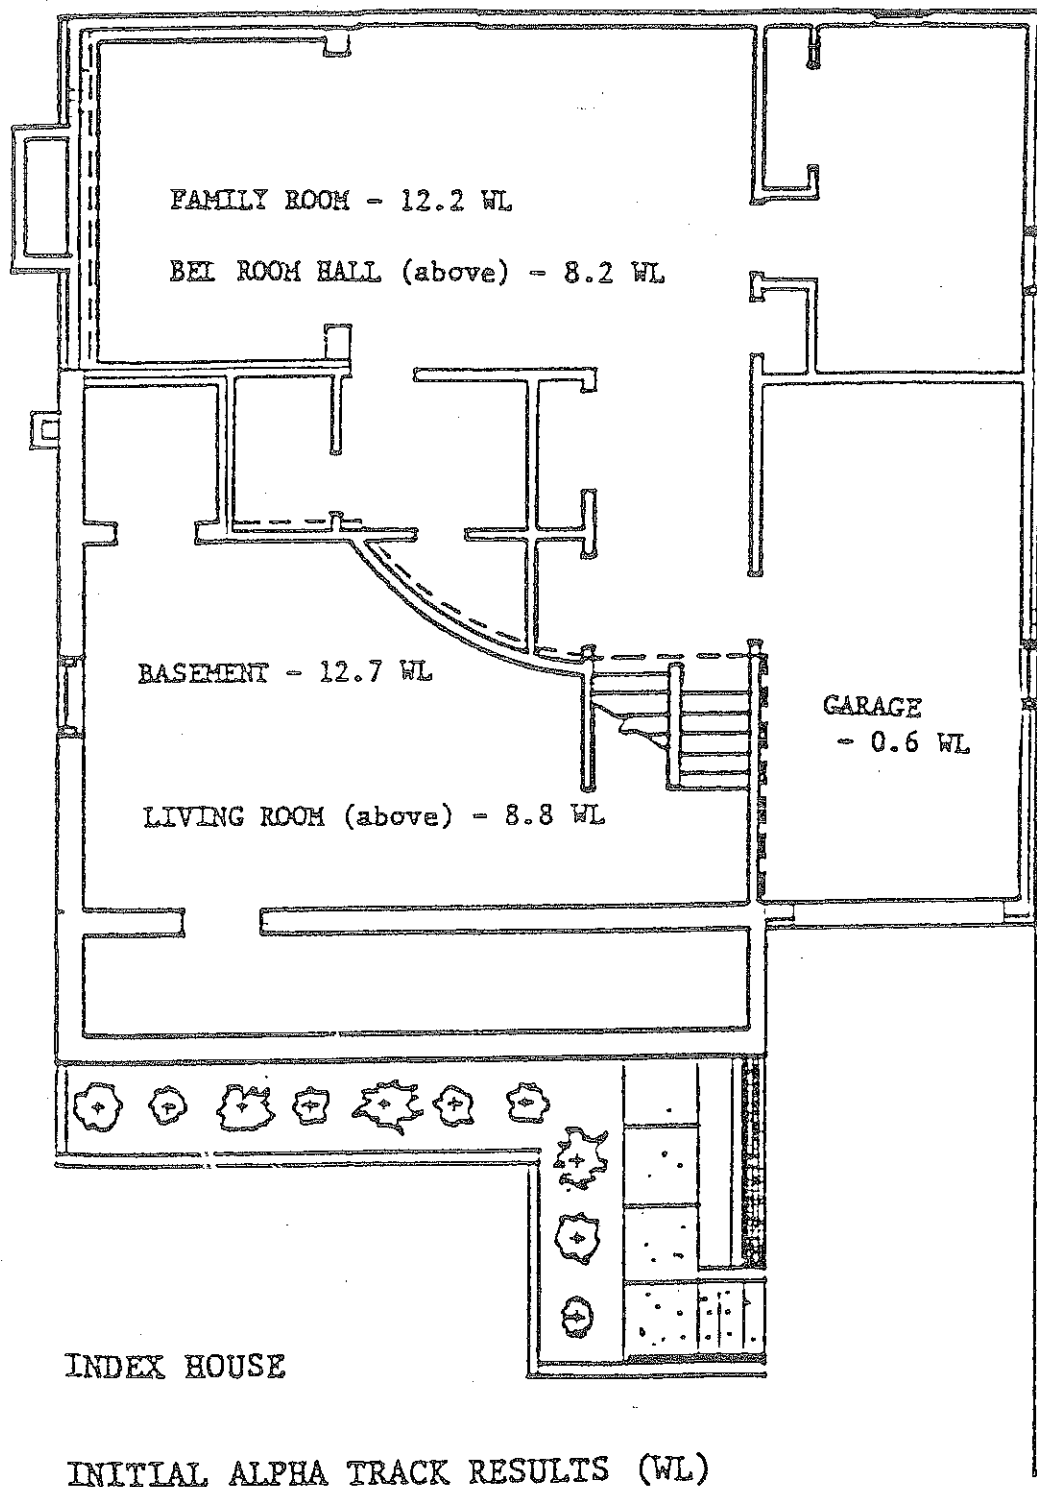
The results of that initial survey, presented in Figure 1, were disturbing even with our limited level of understanding at the time. Radon decay product concentrations well in excess of 10 Working Levels were found in the house. Duplicate measurements yielded equal or even higher results, in some cases approaching 20 Working Levels. Due to the limitations of the sampling and counting arrangements which had been assembled on short notice, some uncertainty could be assigned to the absolute values observed, but the order of magnitude was certainly correct.

FIGURE 1. Floor plan of the Index House, showing initial alpha-track radon measurements expressed in Working Levels, assuming 50% equilibration.

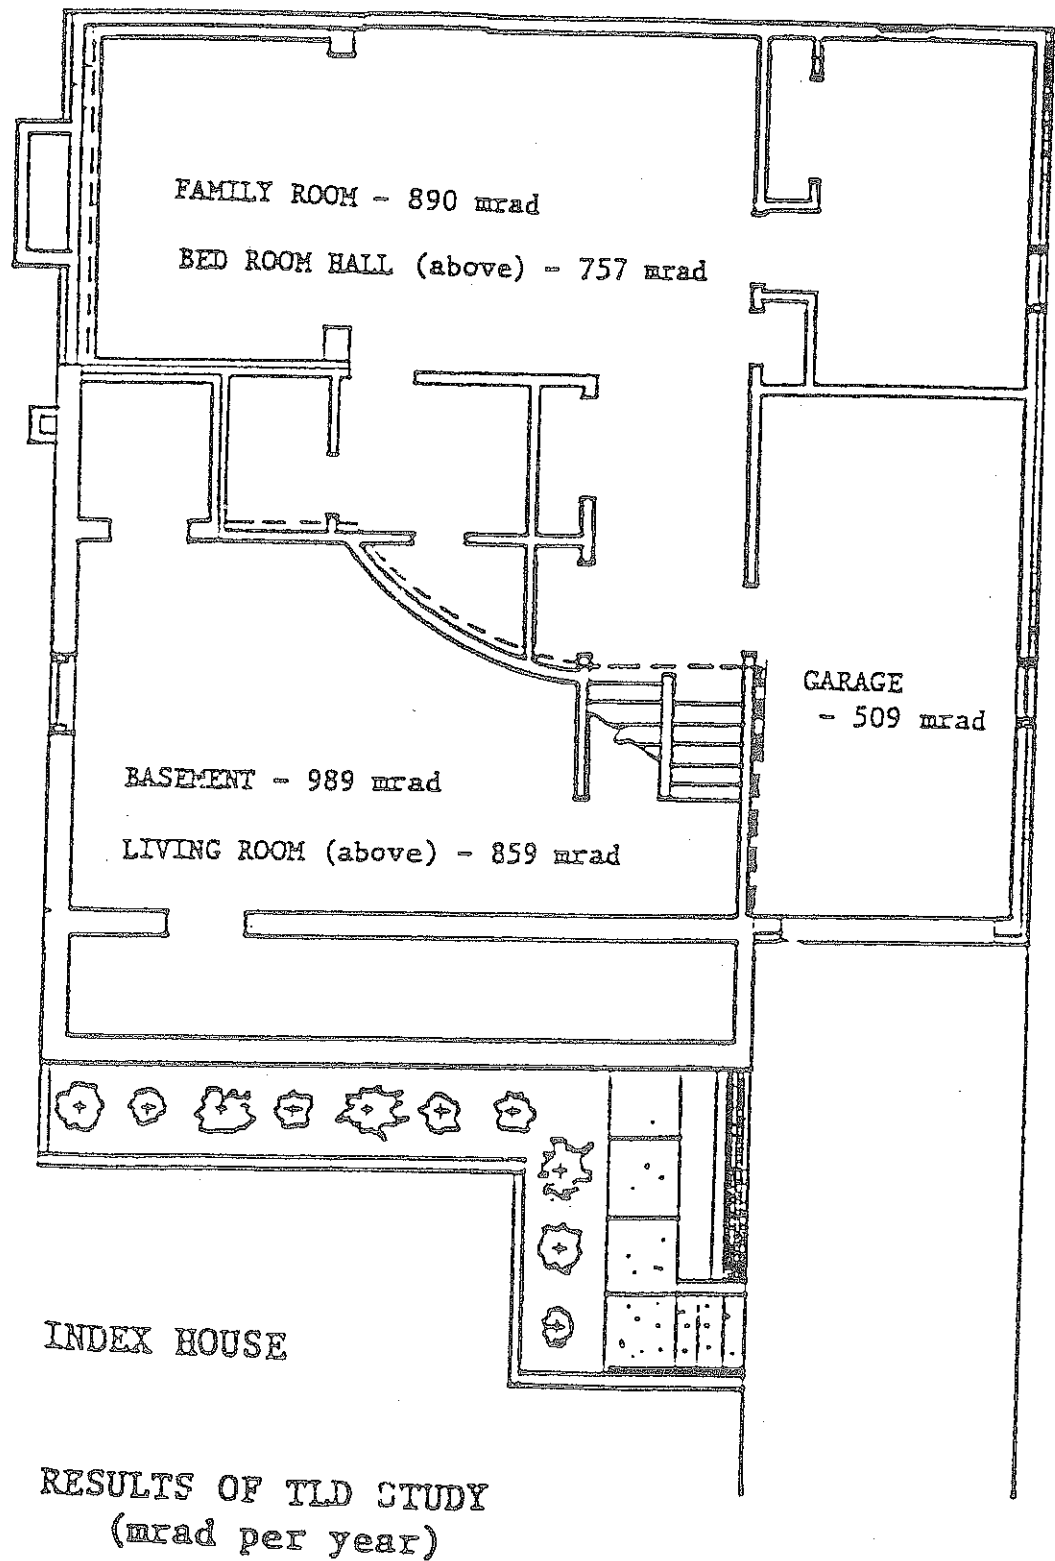
FIGURE 2. Floor plan of the Index House, showing TLD results, normalized to one year exposure in millirads.
