## **DRAINING WATER PAST RADON FAN MOTORS** **INSTALLED OUTSIDE**

Presented at the 2004 – AARST – 14<sup>th</sup> Annual International Radon Symposium in Newport, RI

Bill Brodhead

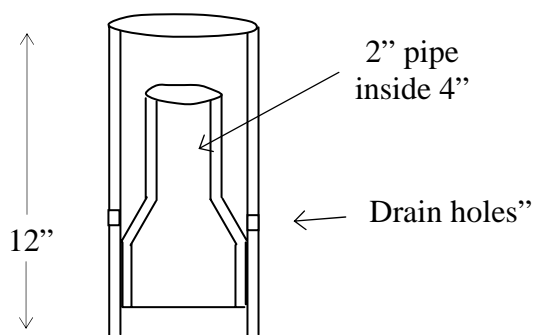
There are two commercially available by-pass drains. The oldest commercial by-pass drain is manufactured by PDS and called the "Hydro-Sep". This drain is actually a 2" to 3" schedule 40 PVC adaptor glued into a schedule 40 - 4" PVC pipe. Holes are drilled around the perimeter of the 4" pipe to allow water to drain out directly over the fan. The velocity of the air flow actually prevents sub-slab exhaust air from escaping out the drain holes. The water, however, drains out directly onto the fan below it. WPB has not installed this by-pass drain because in the winter this drain would likely cause large icicles to hang from the fan housing. Although this would not harm the fan, it would appear as a malfunction to the homeowner. In addition the 2" inner chamber would reduce the fan capacity to move air in high flow situations.

Figure 1 - PDS Hydro-Sep

Graph 2 above displays the reduction in airflow caused by the different by-pass drains. The Hydro-Sep produces a very pronounced air flow reduction because of its internal 2" size. The WPB 3 to 4 by-pass starts to show some flow restriction above 50 cfm. The restriction is double the restriction of normal 4" piping at 125 cfm which is approaching the maximum airflow of most radon systems because of the other system restrictions. The Dilts and Fan Guard produce only a small pressure difference even at an airflow of 125 cfm. The HP190/HP175 by-pass created no pressure loss.

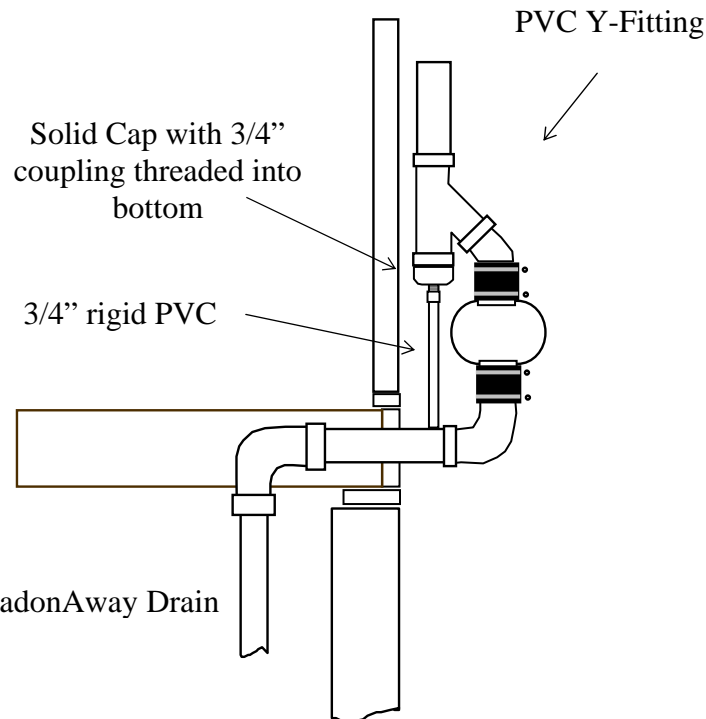
A by-pass drain design is recommended in the RadonAway RP Series Installation Instructions. The instructions recommend installing a by-pass drain if there is the possibility for excessive condensation in the exhaust duct above the fan. The installation instructions explain that excessive internal condensation is due to a combination of sub-slab moisture, cold climate, long lengths of duct and duct materials that conduct heat easily, such as thin PVC piping and aluminum. A description and drawing of a fan drainage assembly is included in the instructions. See Figure 2 below. The RadonAway drain uses a reverse Y fitting above the fan to capture exhaust condensation and rain water intrusion. The water is drained back into the piping below the fan. The literature mentions that the drain may need to be insulated to prevent freezing. The aesthetic draw-back with this design is that it holds the fan assembly about 3 1/2" or more away from the building as compared to other designs.

Figure 2 - RadonAway Drain

The RCI Fan Guard, WPB 3 to 4 and the HP190 captured all the water coming down the pipe for both high and low flow. Surprisingly, the Dilts drain also capture 100% of the water at both flow rates. The RadonAway drain did well at low flow ( 97% diverted at 33 cfm ) but at high flow ( 114 cfm ) it only captured 22 oz out of 42 oz ( 52% ). An additional test was run to determine the efficiency of the RadonAway by-pass design at an in-between flow rate of 71 cfm. This time it captured 95% of the water coming down the exhaust pipe. Since most radon systems have flow rates below 100 cfm this design is still a good method for diverting water around the fan motor.

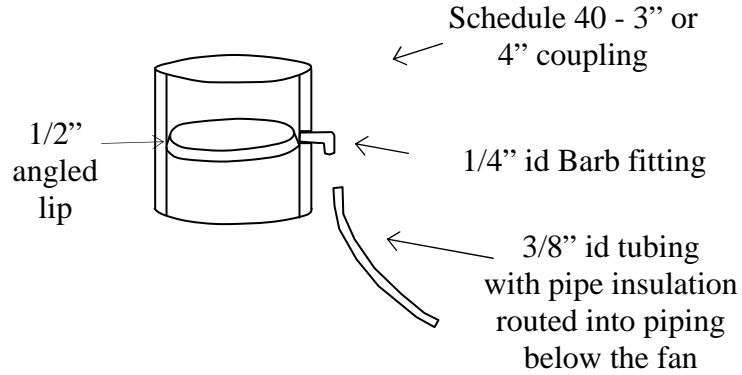
Another possible by-pass drain, manufactured by RCI, is called the “Fan Guard”. This drain is fabricated with a 3” or 4” schedule 40 PVC coupling. The Fan Guard is placed directly above the fan. On the perimeter of the inside edge is an angled plastic ring that catches water. A barbed drain fitting is threaded into the side of the coupling to drain the water that has accumulated in the ring back into the radon system below the fan. If schedule 40 PVC is not used, a transition to other piping is needed.

Figure 3 - RCI Fan Guard schematic

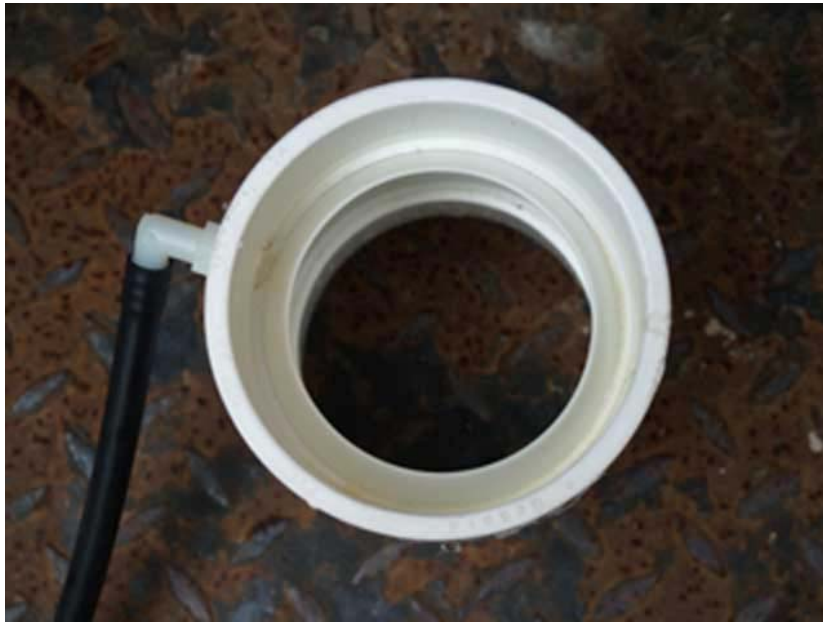
Photo 1 - Top view of Fan Guard

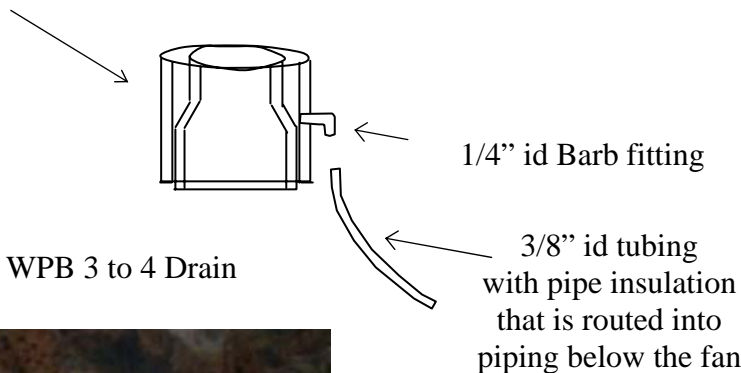
A fourth possible by-pass drain is a cross between the Hydro-sep and the Fan Guard that I call the WPB 3 to 4 Drain. This drain can be made on site by gluing a schedule 20 - 4" to 3" coupling into a 4" schedule 40 straight coupling. A 1/4" id barb fitting is then threaded into the 4" schedule 40 coupling to catch water that accumulates between the 3" and 4" portions of the coupling. A drill and tap combination is available from RCI to easily create a threaded hole in the coupling.

The brass barbed fitting is a 3/8" barb with a 1/4" male NPT thread. The tubing can be clear 3/8" vinyl tubing since it will be covered by the pipe insulation. The pipe insulation needs to be rated for outdoor use and is 1/2" id with 3/8" wall thickness. Common interior pipe insulation is not suitable because it will degrade in sunlight.

Schedule 40 - 4" coupling  
with schedule 20 4" to 3"  
coupling 4" coupling

Figure 4 - WPB 3 to 4 Drain

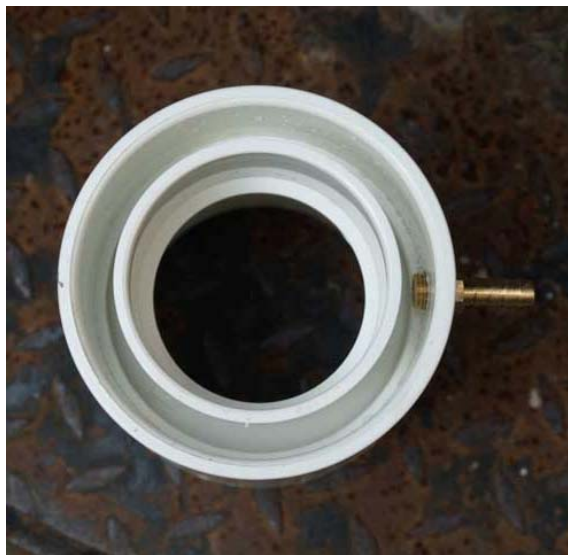
Photo 2 - Top view  
of 3 to 4 drain

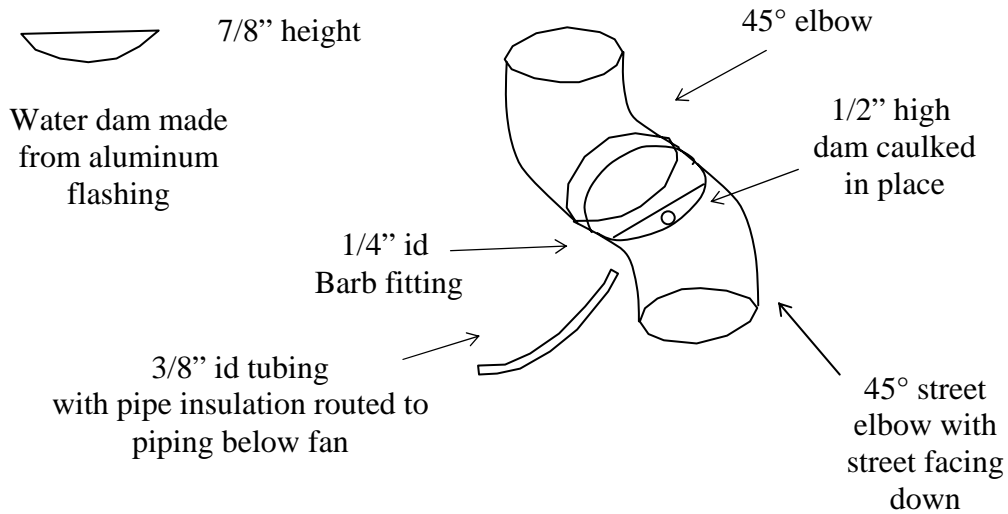
A fifth by-pass drain, designed by WPB system installer Mark Dilts, uses a small piece of flashing to create a water trap inside a 45° elbow. The flashing is held in place with urethane caulking. A 1/4" id barbed fitting is threaded into the elbow just above the dam. Insulated tubing is used to drain the collected water back into the system below the fan.

Figure 5 - Dilts Drain schematic

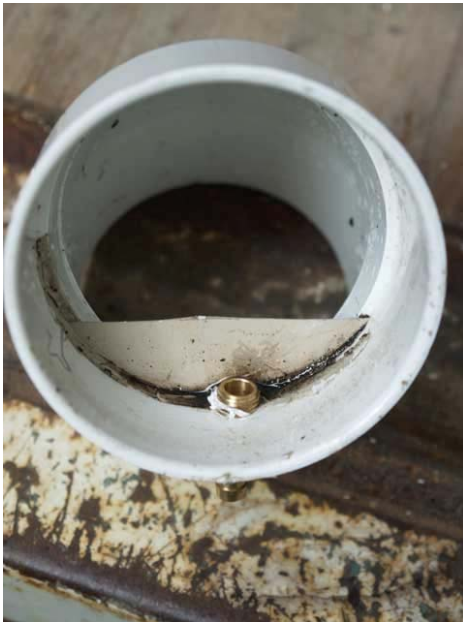
Photo 3 - Dilts water dam

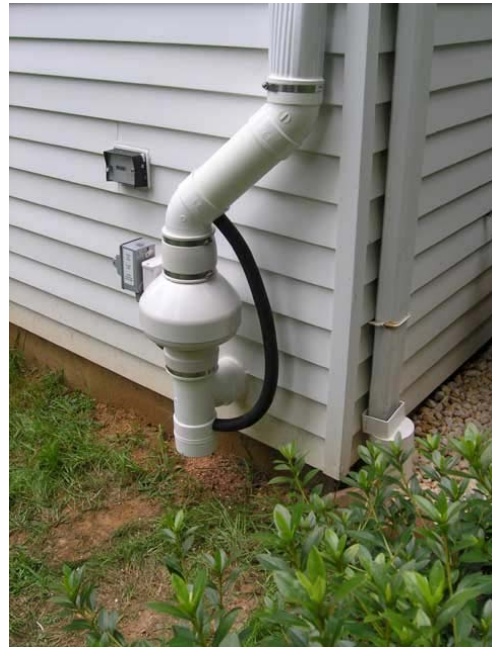
Photo 4 - System with Dilts by pass drain

WPB now uses the Dilts by-pass drain with the insulated tubing routed into the lower section of a Tee fitting installed below the fan with four 1/8" drain holes in the bottom of the cap. See photo 4 above.

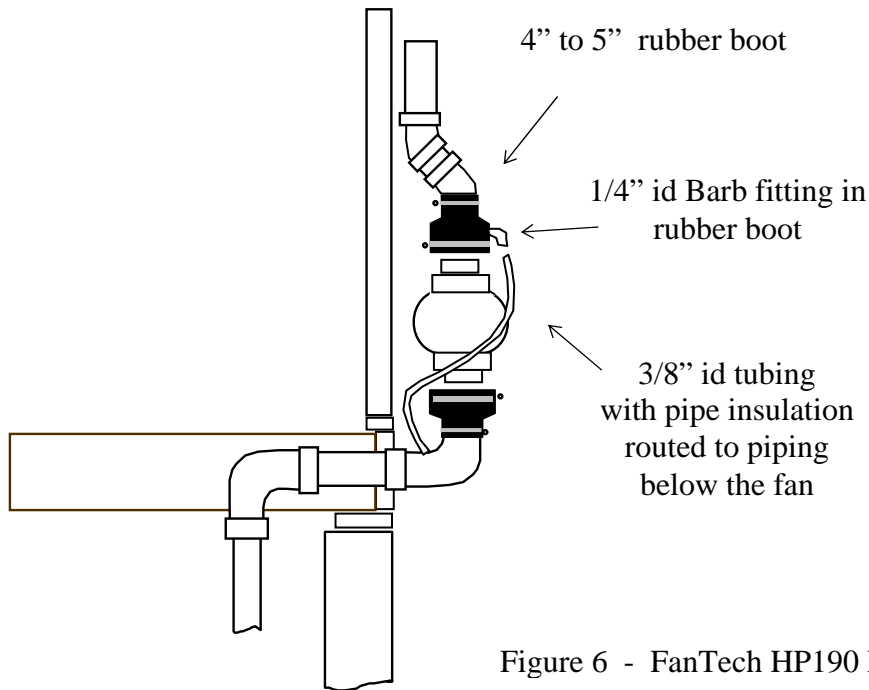
The Fantech HP190 and HP175 fans have a reducer from 4 7/8" to 3 7/8" on the inlet and outlet side of the fan. If a 4" to 5" rubber boot is used, a 1/2" drain lip is created inside the boot. A 1/2" hole drilled into the side of the rubber boot, just above the lower hose clamp allows a 1/4" id barb fitting to be threaded into the boot. Insulated tubing can then be routed from the barb fitting into the PVC piping below the fan.

Figure 6 - FanTech HP190 Drain

WPB uses the HP190 for outside fan replacements so that a drain by-pass can be added without changing the original piping.

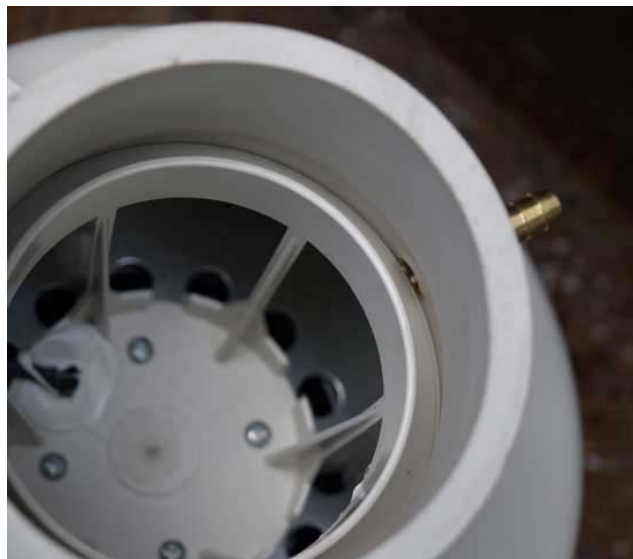
Photo 5

Top view of  
HP190 drain  
in the  
rubber boot

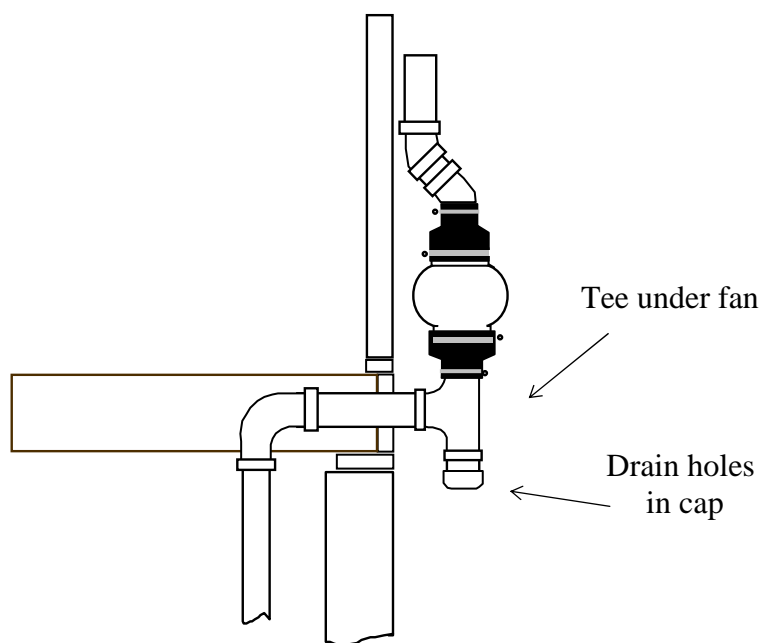
An alternative drain location used by some mitigators is to install a tee fitting under the fan to capture condensation and then draining this condensation by drilling a drain hole in the cap. This design does not by-pass condensation around the fan motor but it does drain the moisture collected in the exhaust piping out of the system. The concept is that this approach will dry out the moisture under the slab rather than allowing the moisture to return back to the sub-slab as the previous drainage systems do. This drying out may help maintain better communication under the slab.

Figure 7 - Below Fan Drain

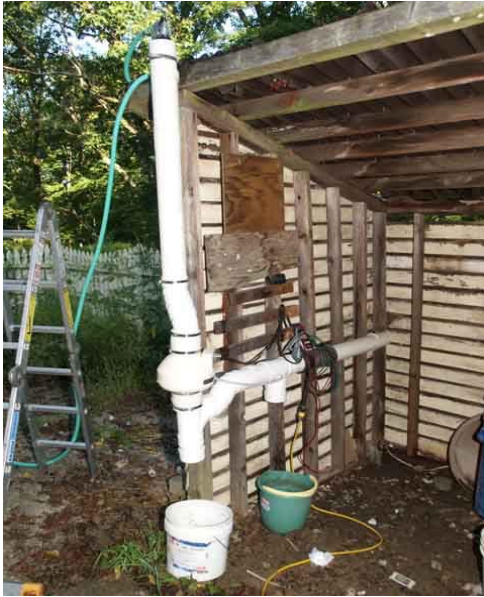
The size and location of drain holes in the cap were tested under two airflow/vacuum conditions, high flow-low pressure (113 cfm & negative 83 pascals or almost 3/8" water column) and low flow – high pressure (31 cfm & negative 387 pascals or a bit more than 12/8" water column). An RP145 radon fan was used for the test. See photo 6 below. In each case water was sprayed into the exhaust piping above the fan. See Photo 7 below. A portion of the water was blown up and out of the exhaust pipe but most of the water ran down the exhaust pipe, past the fan motor and then collected in the bottom of the tee. A damper was installed on the piping intake to control

Photo 6 – Drainage test setup

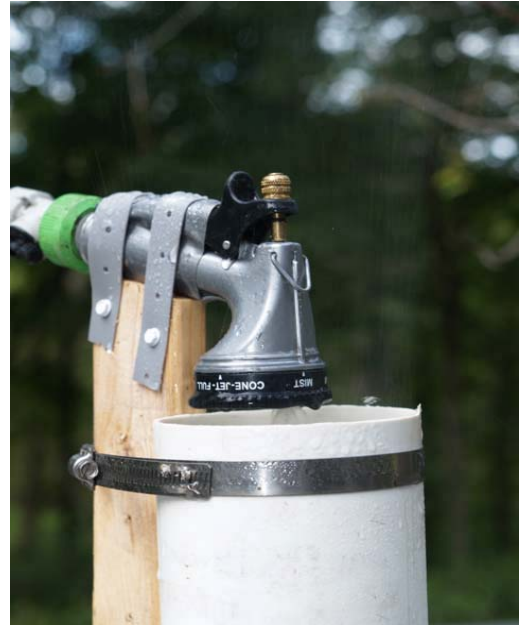
Photo 7 - Nozzle spray into exhaust

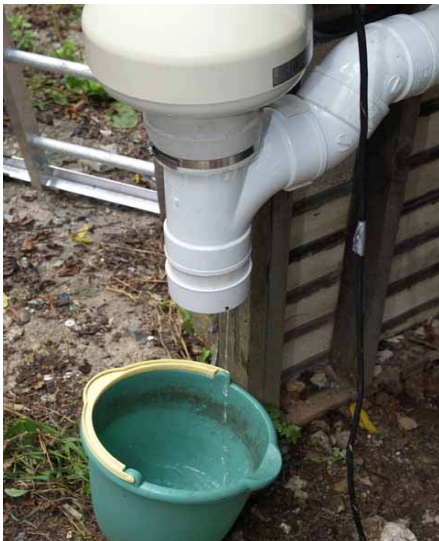
the airflow and negative pressure in the tee. Different holes were drilled in the solid cap below the tee to determine if gurgling would occur. The negative pressure under the fan causes air to be sucked into drain holes causing a bothersome gurgling noise. See photo 8 below.

Photo 8 – Drain hole test

At high flow and low negative pressure a 3/8" drain hole or smaller would not gurgle. At low flow with strong negative pressure, which occurs often with radon systems, gurgling was a serious problem. This is because air is being sucked up through the water column in the cap. The difference in oil columns of a u-tube is actually the height of water held in the drain cap before water can flow out of the drain hole. When the radon fan is turned off, the water held in the cap by the negative pressure is drain out. Any hole larger than 3/16" would cause gurgling at low flow – strong negative pressure. A 3/16" drain hole may be the best choice to minimize gurgling but there are often accumulations of dead bugs found in radon fans when they are being replaced. These bugs could easily block the drain. A slot hole 3/16" by 9/16" created by drilling three holes and then rocking the drill bit back and forth in the holes may allow drainage when bugs accumulate in the system.

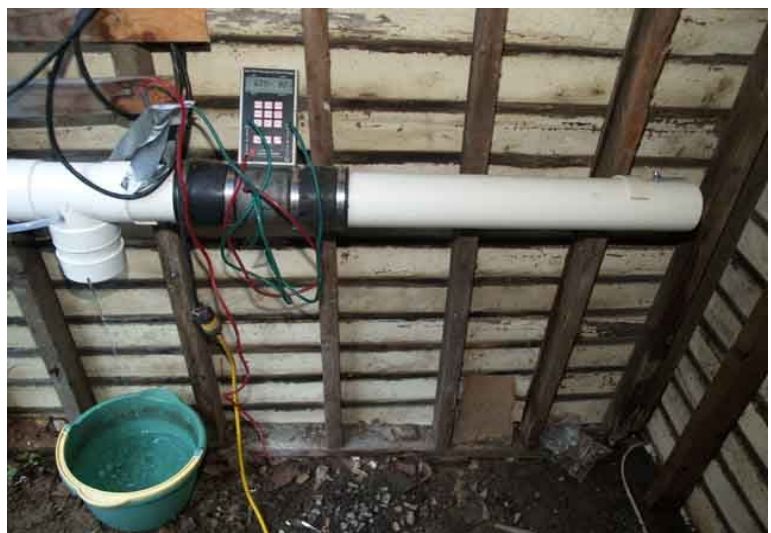
Photo 9 – Flow grid

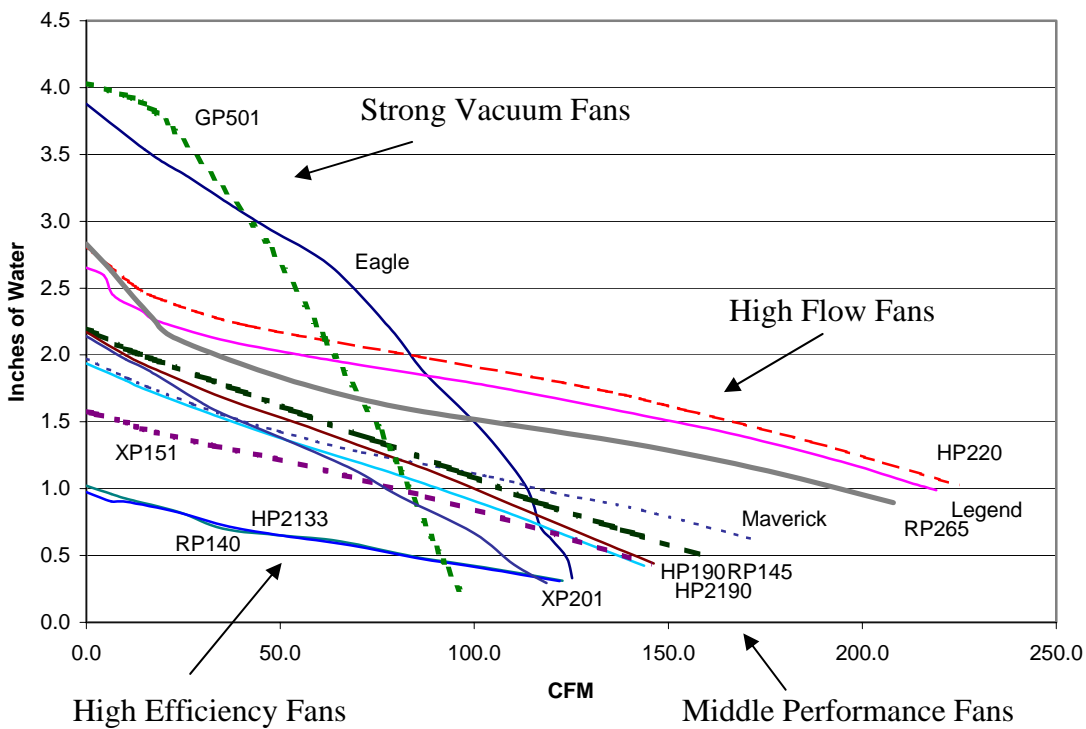
### Fan Test with 10 feet of 4" pipe

Some of the by-pass drain designs can restrict airflow. All of the drain systems were tested to determine their airflow restriction. The performance of 13 common radon fans were first bench tested to graphically display the difference between these fans. See Vacuum Fans use around

120 watts of power and produce around 4" of static pressure but their maximum airflow can actually be less than the 20 watt High Efficiency Fans. Using a Strong Vacuum Fan when high airflow is need could give no better performance than a 20 watt High Efficiency Fan, and it adds the material cost, operating cost and system noise. The High Efficiency Fans are well suited to houses with good gravel base. High Flow Fans move 50% more air than the Middle Performance Fans while using twice as much power. High Flow Fans use about 120 watts of power and tend to be considerably noisier than the Middle Performance Fans and High Efficiency Fans. The Middle Performance Fans typically use 40 to 90 watts of power. They produce 1.5 to over 2 inches of static pressure while still being capable of moving up to 150 cfm of airflow. The middle performance fans are typically used by most radon mitigators.

Graph 1 - Fan Performance of 13 common radon fans.

The fan performance test indicates that there are groups of fans that are very close in performance and can be interchanged if one particular fan model is not giving the expected fan life.

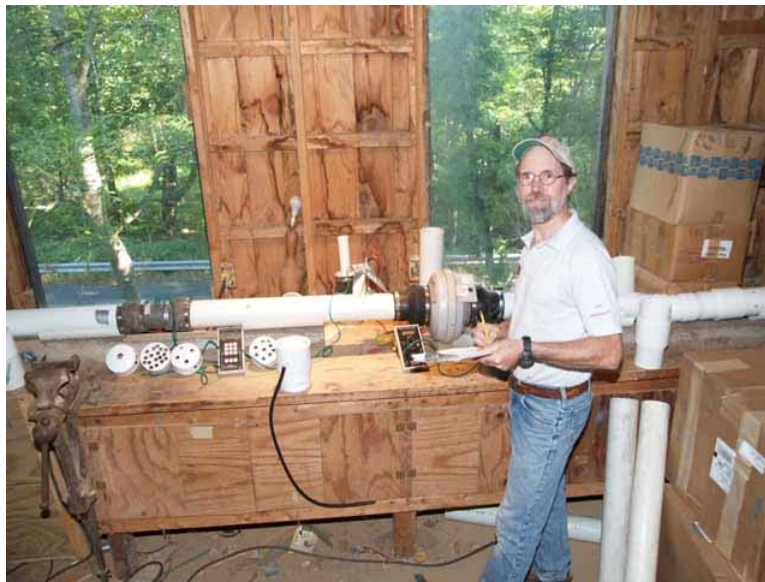
Photo 9

Author  
bench  
testing  
a fan

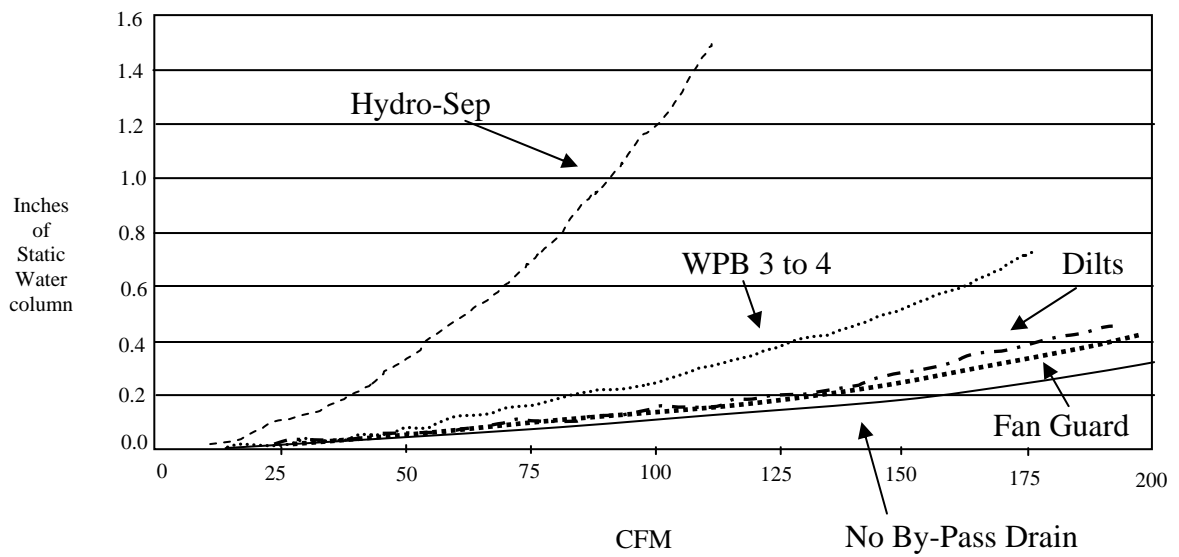
**Pressure Drop from By-Pass Drains**

Graph 2 - Drain By-Pass Airflow Restriction

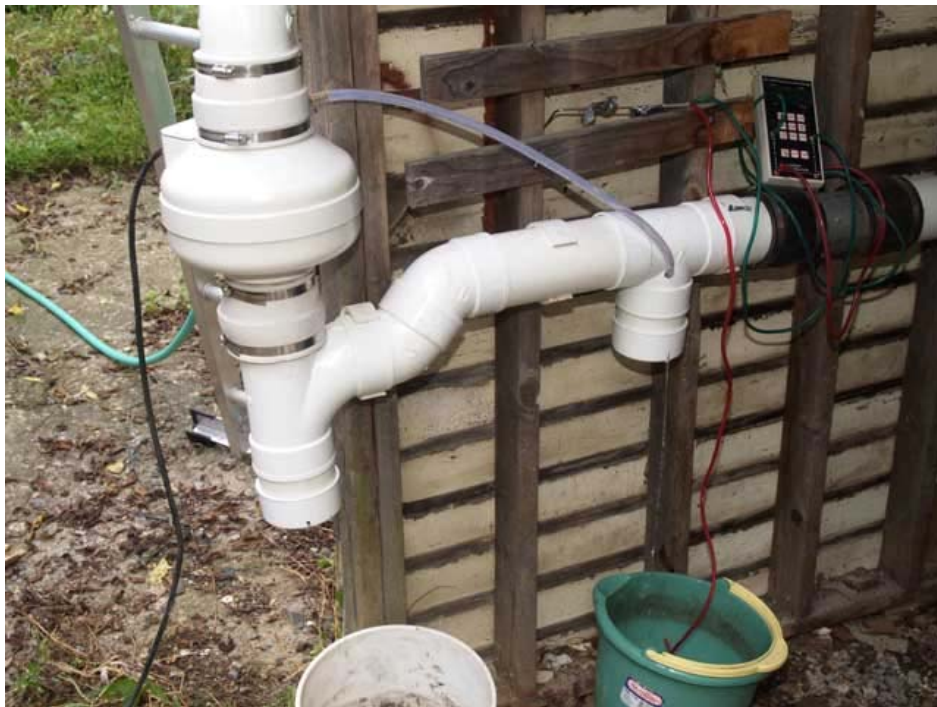
Each of the drain types was tested to determine how efficiently they would catch water running down the exhaust pipe at high airflow and low airflow. After each drain design was set up, the spray nozzle was allowed to run for three minutes with the fan operating. 36 to 40 ounces of water went down the exhaust pipe. The water captured by the drain was diverted to a Tee fitting closer to the system intake. The fan had a tee installed under it with a capped fitting that would catch any water passing down through the fan. See Photo 10. To ensure no water got past this drain the tee below the fan was set 4' below the tee closer to the intake that was catching the by-pass water. The quantity of water captured in each tee indicated how efficiently each design worked.

Photo 10 – HP190 by-pass drain test

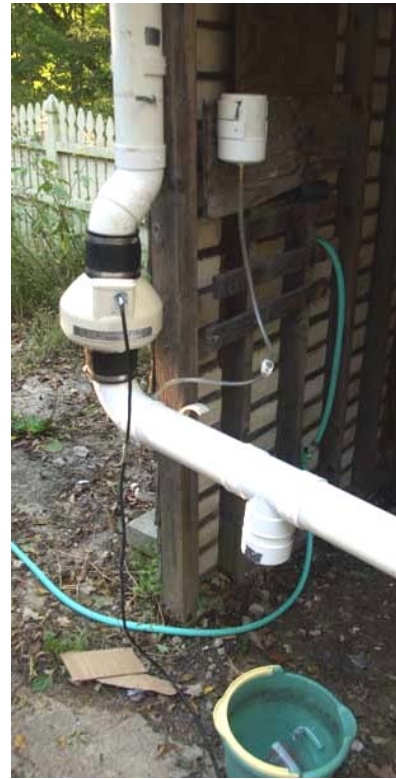
A measured amount of water ( 40 oz ) was placed into a 6" tall 4" pvc pipe container with a drain tube attached to the bottom. See photo 11. The water was allowed to slowly drain into the pipe just under the radon fan. The flow was restricted so that it took over an hour for all the water to drain into the pipe. The pipe had a 1/4" to the foot slope to a tee fitting, 13 inches away. The water collected in the tee was carefully measured after the draining had completed. There was exactly the same amount of water collected in the tee as when the water was drained directly into another container for both the high flow test ( 139 cfm ) and the low flow test ( 64 cfm ). This indicates that all the water appears to be draining back into the sub-soil.

Photo 11 – Drainage test

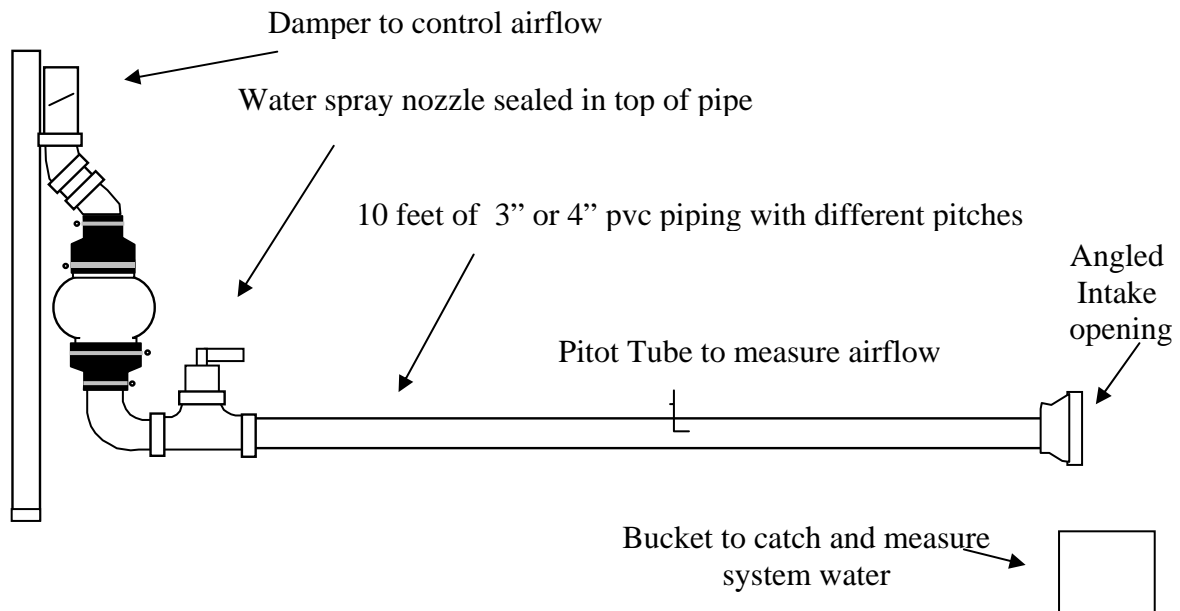
A test was set up to determine how much water would accumulate in 4" PVC piping under different airflows and different pitches. See the Figure 8 below. The spray nozzle was turned on with the airflow adjusted for high flow or low flow. When water would stream out of the intake opening, the nozzle would be shut off. Once there was no more water draining out of the intake opening, the fan would be turned off. Any water draining into the empty bucket under the intake opening would be the amount of water being held by the velocity of the fan. Table 9 lists all the results.

Figure 8 - Slope test

Ten feet of 4" round pipe will hold 835 ounces of water. Even with a level pipe and airflow of 143 cfm, which is a velocity of 1640 feet per minute, there was only 57 ounces of water held in the pipe. If you assume the water was equally tapering up towards the fan which would put twice the average height towards the fan it would equal 114 ounces or 14% of the volume or 1/2" of water. Once the air velocity drops below 100 cfm the water accumulation is insignificant.

Notice in the 4" columns of Table 9 below that the maximum airflow of around 170 cfm is able to be achieved with even 1/8" pitch. Only when the pipe is level does the maximum airflow get reduced to 143 cfm. Notice in the 3" pipe columns the maximum airflow starts off at 108 cfm and only drops about 10 to 15 % to 92 and 96 cfm at the 1/4" and 1/8" pitch levels. When the pipe is level however the airflow has dropped to a maximum of 66 cfm which is a 40% loss.
