USING ASD TO MITIGATE CO₂ METHANE AND BENZENE

Presented at the 2003 - AARST - 13th Annual International Radon Symposium
in Nashville, TN

Bill Brodhead
WPB Enterprises, Inc. 2844 Slifer Valley Rd., Riegelsville, PA 18077

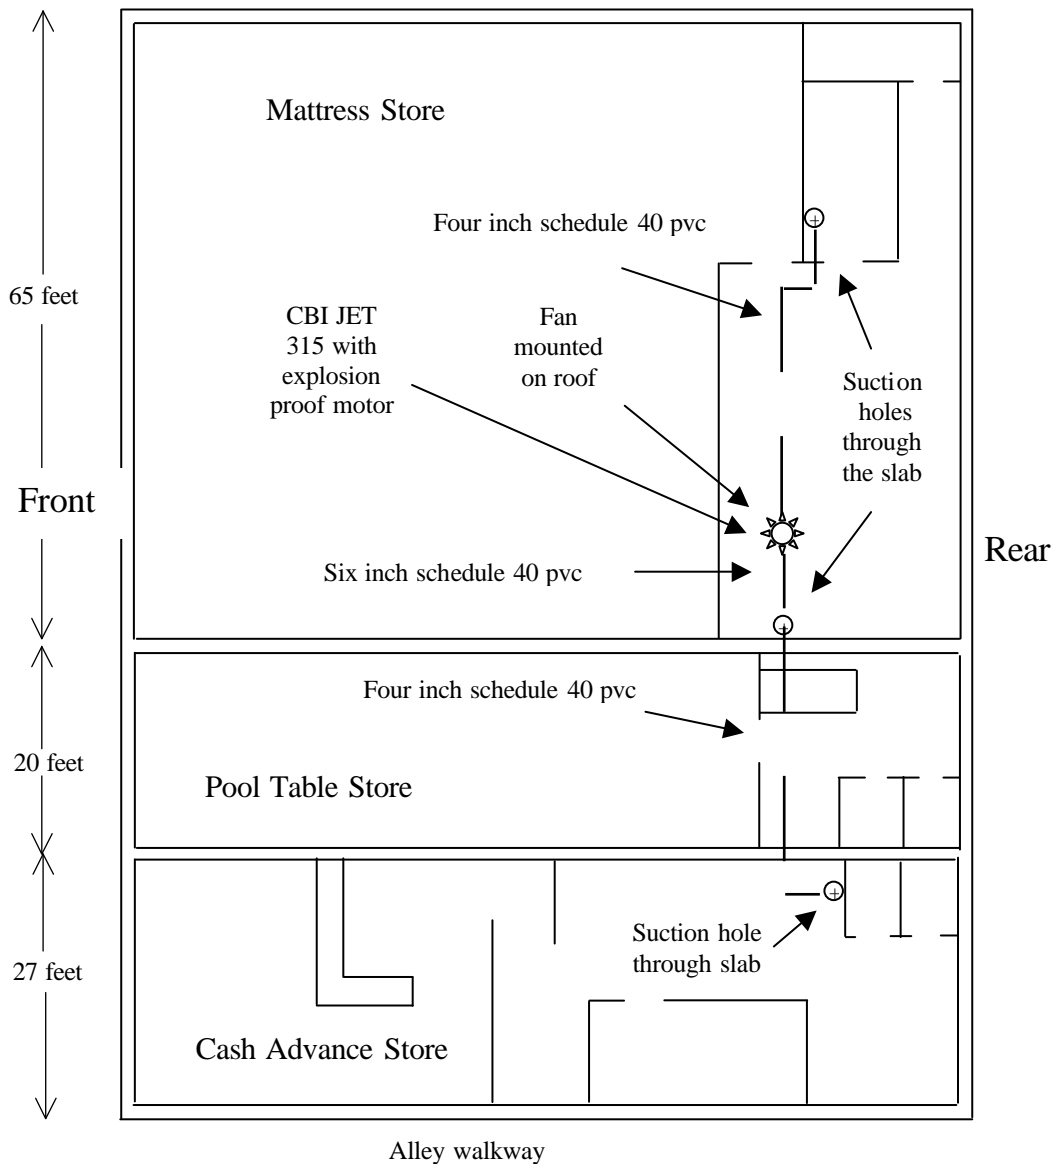
A three hole suction system was designed using an explosion proof fan installed on the flat roof. A CBI Jet 315 upblast exhaust blower with a 1/3 hp explosion proof motor was chosen for the fan. The local fire marshal was contacted to get approval for the fire-stop collars to be used as the vent pipe penetrated the firewalls between the stores. See the accompanying drawings.

In order to minimize the risk to store occupants and to the system installers, WPB installed the ASD piping and the roof mounted fan first. A new curb base was built on the roof and the CBI jet 315 fan installed. The electricians wired the fan the same day. The roofers flashed the roof the following week. After the roofers had completed the flashing, WPB used a wet diamond bit core drill to make all the suction holes through the slab. An environmental company was hired to make methane measurements during this phase of the work. There was 5000 ppm of methane in the pool table store back bathroom the day the final phase was completed (10% LEL). The main stores had very low levels of measurable methane in the air (0 to 500 ppm). The suction holes, after they were initially cut through the slab, had from 1400 to 2600 ppm of methane in the holes.

The final system performance indicated a flow rate of 570 cfm. The far cash store u-tube read 9/8 of an inch of water column. The exhaust on the roof had 2200 ppm of methane in the exhaust (4 % LEL).

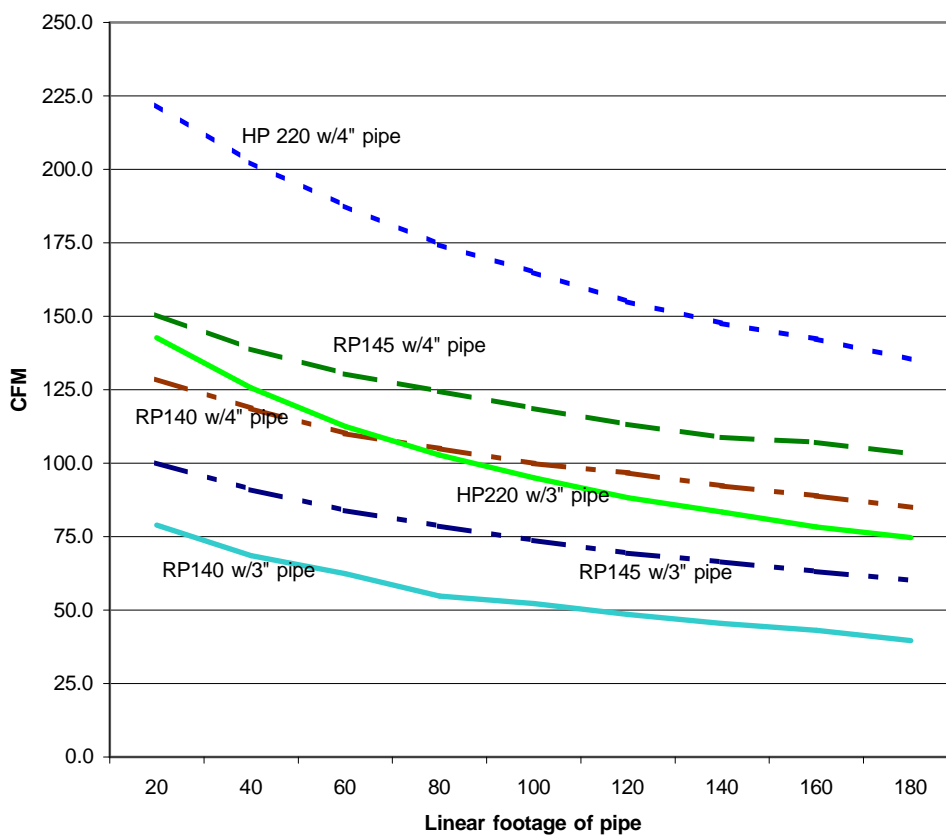
Maximum Fan CFM capacity with different open Pipe

Designing radon mitigation systems for buildings with soil gas other than radon uses the same basic principles as a radon system. During all of the work done for the Office of Surface mining and during the methane installation, measurements were being made to ensure the safety of the workers installing the system. In the case of methane, specialized explosion proof fans need to be used. The systems also needed to be sized to handle the amount of airflow required to obtain a pressure reversal under the slab. The following graph illustrates the maximum airflow obtained with different piping systems. Note that a 17 watt RP140 fan can move more air through 100 feet of 4" pvc pipe than a 120 watt HP220 fan can move through a 3" pipe. If these systems are installed on a commercial building, a mitigator must have a thorough knowledge of the buildings HVAC components, operation and influence. A mitigator must also be able to size the radon piping to minimize pressure drop so that an appropriate fan can be used.
