# **INFLUENCE OF OUTDOOR RADON LEVELS ON INDOOR RADON LEVELS**

Bill Brodhead

## **ABSTRACT**

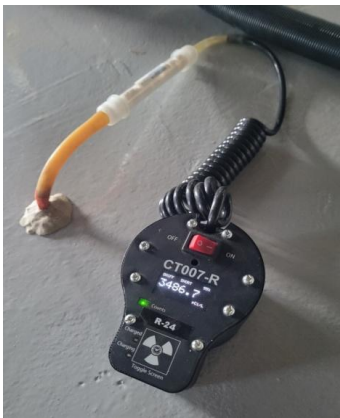
Figure (3): Grab sample with CT007-R

The radon levels under the slab were measured with Pylon scintillation cell grab samples taken in five locations under the slab by the Pennsylvania Department of Environmental Protection (PA DEP) radon division. On the same day, the Environmental Instruments of Canada CT007-R was used to make similar sub-slab radon measurements at three PA DEP test locations. The results of those measurements are included in Figure 2. The variation in results between the PA DEP grab samples and CT007-R was likely due to sampling technique as well as variability of the radon monitors. The sampling method required minimizing the portion of time the sampling test holes were open to the basement air because the strong negative pressure in the sub-slab would backflush the sub-slab radon concentration with low radon basement air. Another concern with making direct sub-slab sniffer measurement is that the presence of thoron will lead to erroneous high values for radon concentration. Radon system exhaust in Pennsylvania and New Jersey had been measured to be greater than 80% thoron at some locations. (Brodhead, 1993) The CT007-R has a thoron-measuring function which should be used when making direct soil measurements to determine if a significant amount of thoron is present in the soil. In this study, a separate Pylon scintillation cell was used and set to 30-second intervals to measure the fall-off of counts when sampling had been completed. No significant fall-off occurred indicating there was very little thoron in the sub-slab air. If thoron were present, the CT007-R reading would have biased significantly higher than the PA DEP grab samples, which did not appear to be the case.

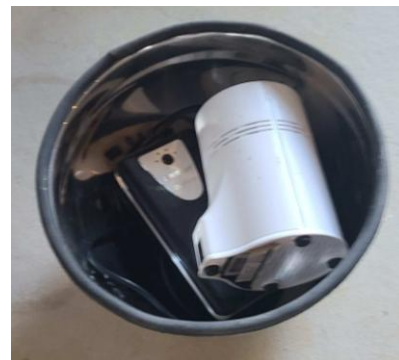
Figure (4): EcoTracker and battery placed in metal bowl

Flux measurements of the slab were made using Ecosense EcoTrackers, placed under a three-liter stainless steel bowl with a 20,000 AH 5 volt battery and 5 volt to 12 volt inverter cable to power the EcoTracker. The edge of the bowl included an EPDM rubber gasket to provide an airtight seal. A weight was placed on the bowl to compress the gasket. The test needs to be run from 6 to 24 hours to obtain enough in growth to analyze the results. See pictures of the flux monitors in Figure 3, Figure 4 and Figure 5. The results of the flux tests both before the slab was coated with RadonSeal and after are displayed in Figure 6.

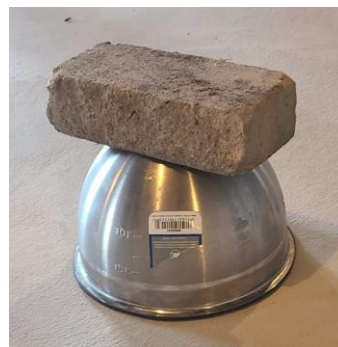
Figure (5): Flux test run for minimum of 6 to 12 hours

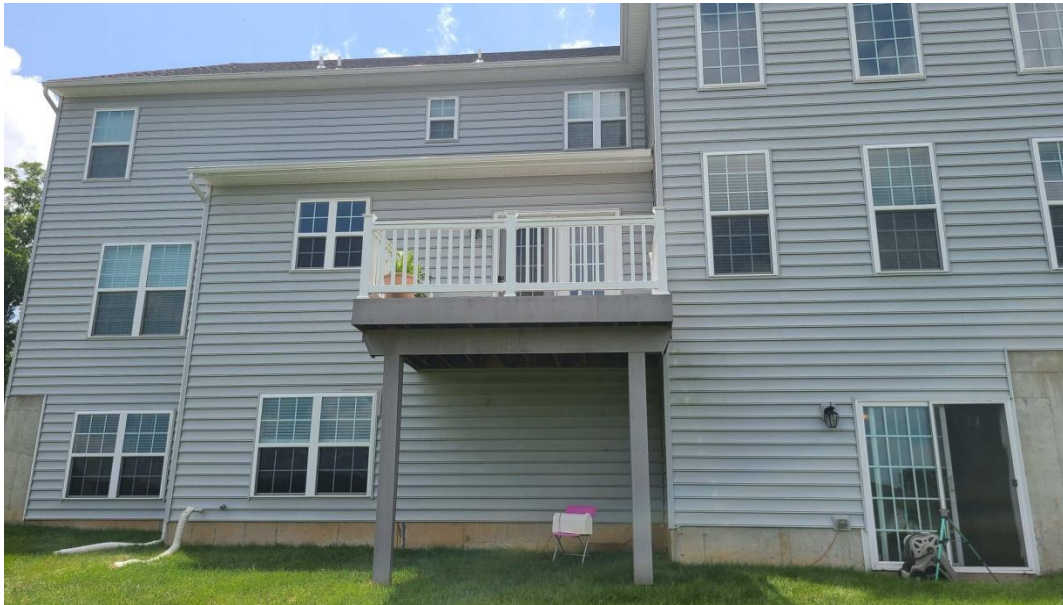
Figure (7): Rear of Study House - Outdoor levels measured at: 20" above grade under the deck and 10' above grade, on the upper deck

The radon levels outdoors at this development have often exceeded indoor radon levels by a factor of 2 or 3 in the middle of the night when there is little or no wind. The elevated outdoor radon levels had been measured in the past and were found to be inversely correlate with wind speed (Brodhead ref 2). Increasing wind causes low outdoor radon levels and little or no wind allows radon levels to build up outdoors. Generally, no wind periods happen at night. The initial outdoor radon level testing at the study house was done in the rear of the house about 20" off the ground. A second outdoor measurement was made ten feet above grade on the upper main floor deck. The HRV was designed to draw air from beside the upper deck ten feet in the air with the concept that this location would have lower outdoor radon levels. Ecosense RadonEye RD200+ and RadonEye Pro detectors were used because they included a time clock that confirms the syncing of all the indoor and outdoor measurements. The radon monitors were placed in plastic mailboxes with holes cut in the bottom to protect them from rainfall. Additionally, the radon levels in the basement and first floor were also measured, as can be seen in Figure 8. The radon results in Figure 8 indicate little difference in outdoor radon levels between 20 inches above grade and 10 feet above grade. This indicates that when the wind stops, the radon emanating from the ground fills up the surrounding atmosphere like a swimming pool. Based on this small difference, the outdoor radon monitors used for the long term study were placed on the floor of the deck, ten feet in the air rather than at grade.

In Figure 22 the average hourly wind speed in red is plotted against hourly outdoor radon levels in blue. The wind speed recorder was located on the outer hand rail of the main floor rear deck of the study house. See Figure 7 with a picture of the rear deck.

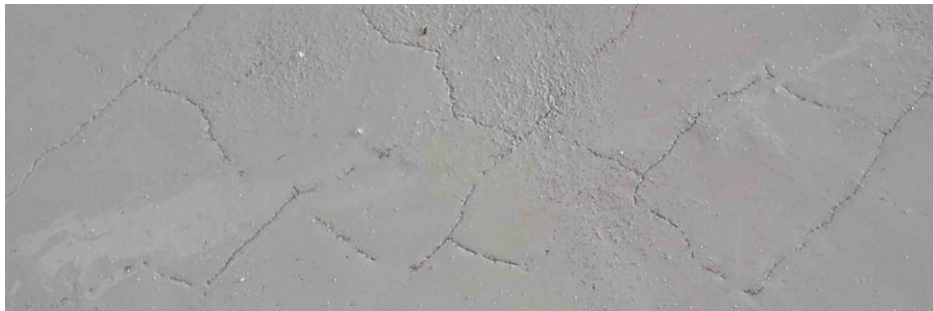
Figure (9): Cracks in single application of epoxy

The owner used multiple two-part kits of Rust-Oleum Rock Solid garage paint that were available from one of the large building supply stores. The epoxy kit required mixing the two components and applying in one continuous application. The epoxy coating was applied over the entire basement slab which had been previously double coated with RadonSeal. After it cured, there were several locations that had shrinkage openings in the epoxy coating (Figure 9).

be an insignificant contributor to the indoor radon levels. Figure 10 also displays the difference between flux measurements over paint with no cracks (solid red line) and paint that had cracks (dashed red line) as displayed in the photo of the slab in Figure 9.

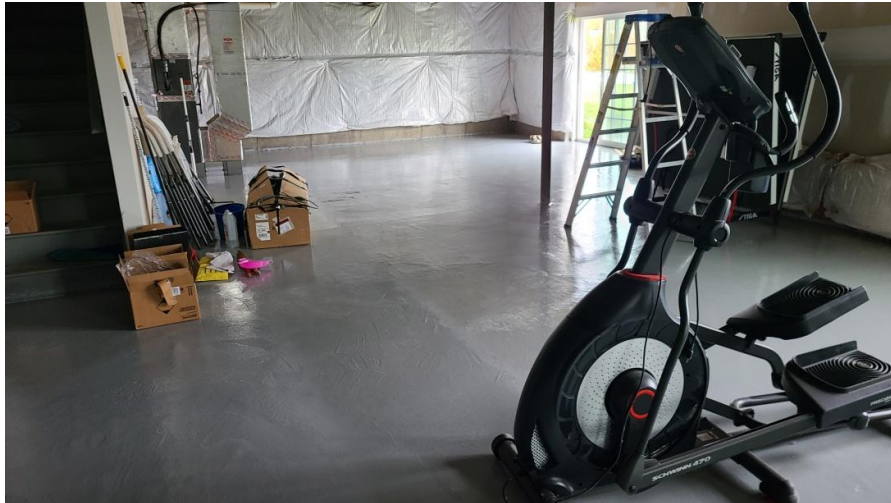
Figure (11): Study house walk out basement with epoxy painted slab

After these results, the owner installed a second coat of epoxy paint. Figure 11 is a picture of the painted basement slab. Figure 12 displays the flux measurements after the second coat of epoxy was installed in comparison to the flux tests after two coats of RadonSeal was installed. After the second coat of epoxy was installed, the basement radon levels dropped to an average of 1.3 pCi/L. It appeared that the double slab coating of epoxy had provided three times the original predicted 0.75 pCi/L radon reduction.
