## USING ASD TO MITIGATE CO2 METHANE AND BENZENE

Presented at the 2003 - AARST - 13<sup>th</sup> Annual International Radon Symposium in Nashville, TN

Bill Brodhead WPB Enterprises, Inc. 2844 Slifer Valley Rd., Riegelsville, PA 18077 <u>Bill@wpb-radon.com</u> www.wpb-radon.com

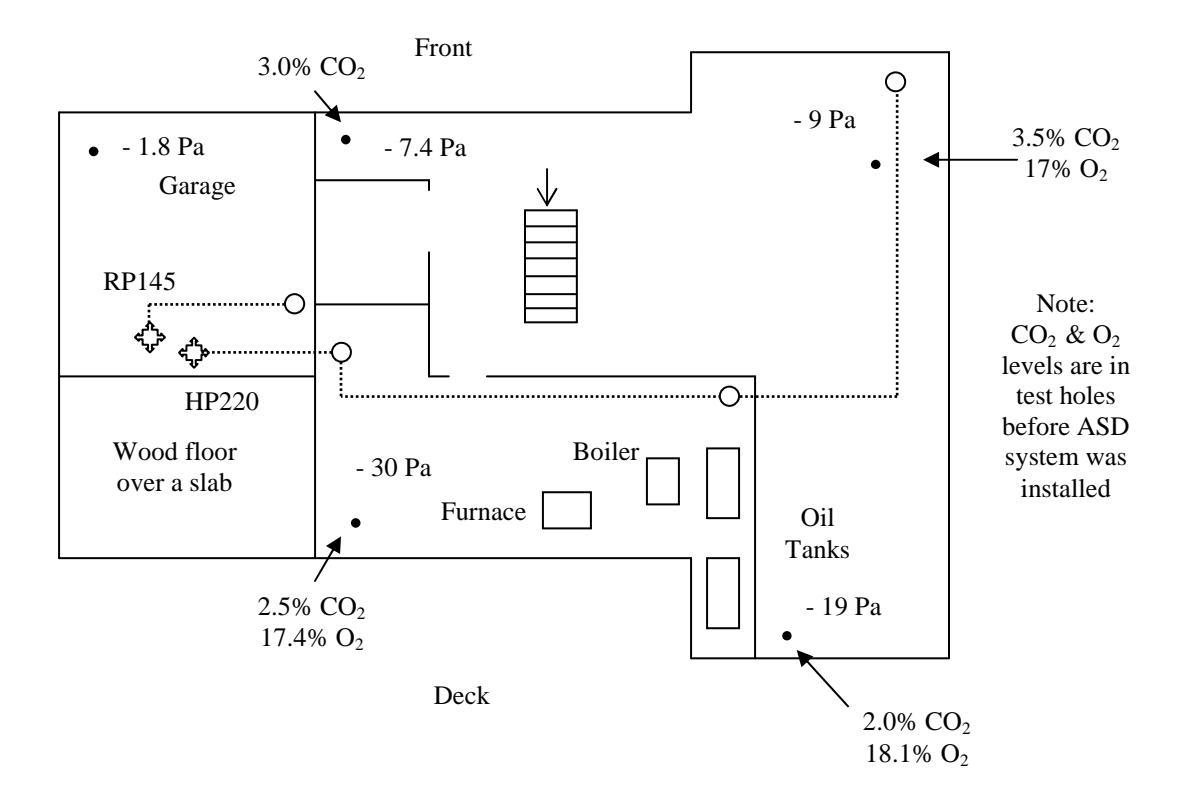
In December of 1999, WPB was contacted by the United States Department of the Interior, Office of Surface Mining, Reclamation and Enforcement about a house in Pottsville, PA that had elevated radon and CO<sub>2</sub>. The house was a 2500 square foot raised ranch that was only one year old. The radon levels were around 200 pCi/l. in the basement and 56 pCi/l on the first floor. The builder had installed a loop of perforated piping around the inside of the foundation footer in the gravel bed below the slab. The owner was initially complaining that the oil furnace would not function properly. The house is located in an area that contains old underground coal mines. The initial visit by the Office of Surface Mining found levels as high as 4% CO<sub>2</sub> near the floor of the basement with a dangerous level of only 17.1% O<sub>2</sub>. A butane lighter could not produce a flame as it approached the floor.  $CO_2$  levels of 2% were found on the first floor and 1.5% on the second floor, even though the heating system was hot water baseboard. The house was ventilated until the oxygen levels returned to 20.8%. Within three days the levels in the basement had deteriorated to 17.7% oxygen. Office of Surface Mining maps indicated mining occurred just to the north and south of the home. It was unknown if bootleg mining (non-recorded mining) had occurred beneath the home.

Probe holes were drilled around the outside of the house to locate any bootleg mines. Layers of coal were approximately thirty feet below grade. No mine tunnels were found. When the drilling rig completed a test hole about twenty feet from the house closest to the corner with the highest  $CO_2$  level (3.5%), hot air stated rising out of the shaft. The snow around the hole soon melted. The shaft was still fuming hot air a month later. Samples of the air were sent to a laboratory for analysis. The lab reported that the  $CO_2$  originated from newer wood than would have been coming from old mining timbers. It is suspected that there may have been large amounts of trees and brush buried at this location. The  $CO_2$  in the basement may or may not have been coming from this source.

Initially just an HP220 radon fan was installed. The  $CO_2$  levels disappeared and the  $O_2$  levels returned to normal on all floors. The radon levels, however, were still above the guideline at about 15 pCi/l. A second fan was installed and routed to a suction pipe in the garage floor. The second fan was an RP145. Both fans were installed in the garage attic and exhausted out the roof. All piping was four inch sewer and drain pvc. The "Pa" readings on the accompanying drawing are the final pressure readings in pascals at the test holes with both ASD fans operating. The HP220 basement system had a u-tube reading of 0.5 inches of water column and an airflow of 162 cfm. The final radon readings taken at the end of February 2000 were 0.8 and 0.3 pCi/l.

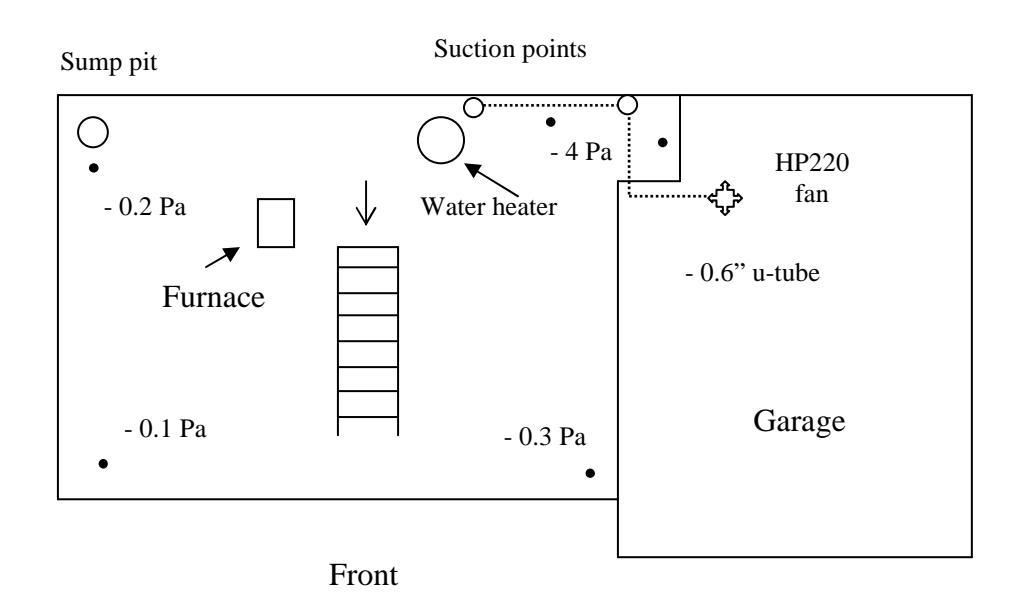
In Fall of 1999, a house in Pottsville, PA had trouble keeping the gas furnace and water heater going. The house was a new, two story, 1800 square foot, home with a full basement. The foundation walls were constructed of block. An investigation by the Office of Surface Mining found 2.5%  $CO_2$  and only 16.7% of  $O_2$  near the basement floor. Mining maps revealed an abandoned coal mine existed about 67 feet below the home.

The Office of Surface mining hired another contractor to seal the perimeter canal drain with non-shrink grout and all cracks with a special sealant. Subsequent measurements revealed that the  $CO_2$  levels had decreased but were still present.

WPB was hired in March of 2000 to install an ASD system. The system used an HP220 fan with two suction points to maximize airflow. The final u-tube reading was 6/8 of an inch water column. This indicates airflow of about 160 cfm. No CO<sub>2</sub> was present after the ASD system was activated. Sub-slab pressures away from the suction holes were weak (- 0.2 Pa) due to excessive airflow coming from the soil.

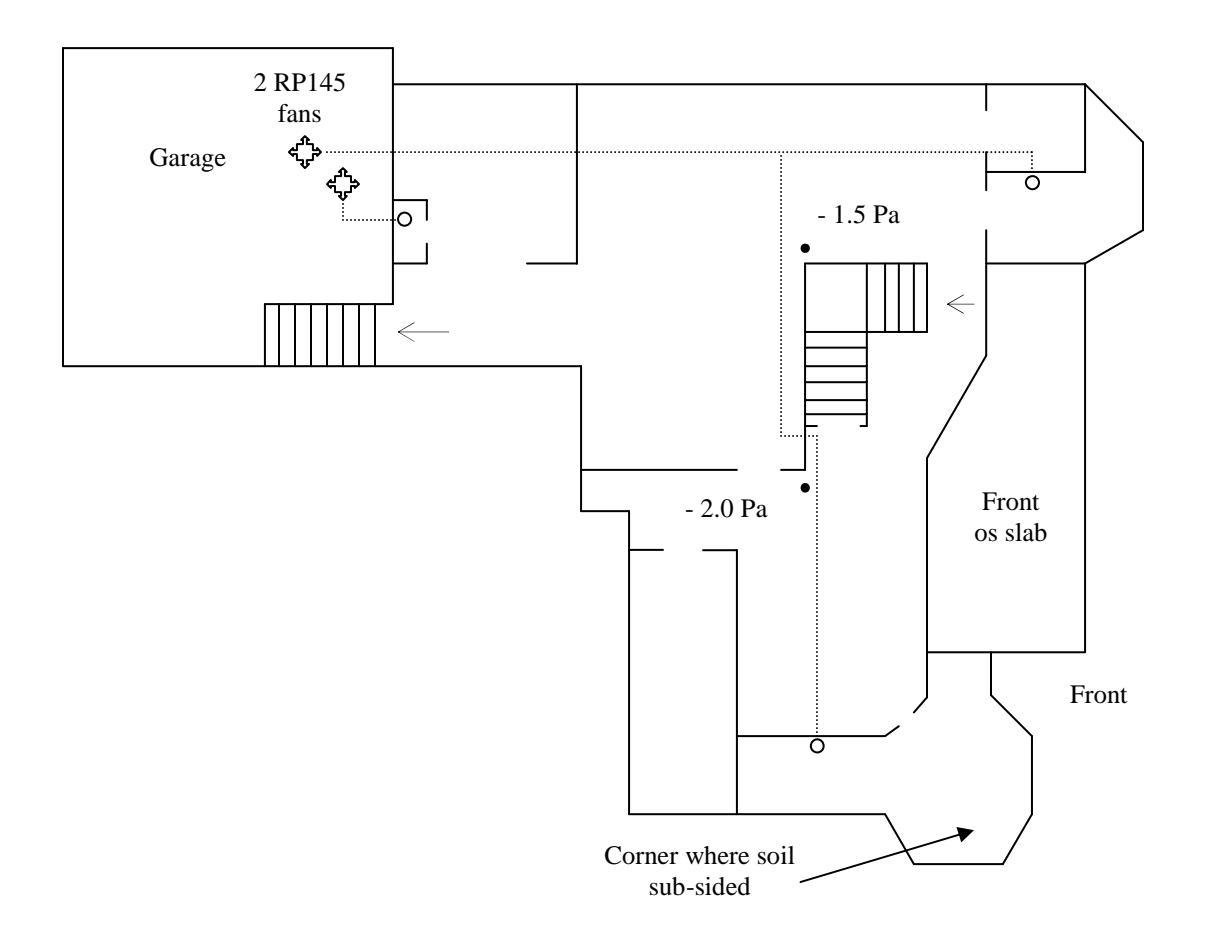
RP145 fan was installed in the garage attic and the exhaust was routed through the garage roof. The u-tube reading was 6/8 of an inch water column. This indicates there is some resistance induced by the builder installed piping system. Even with the radon fan running, there was still a positive pressure under the center of the slab of 7.0 pascals when the HVAC air handler was running. Radon measurements made after the single fan installation averaged 40.3 pCi/l in the basement.

In May of 2003 a second RP145 fan was installed in the garage attic and vented through the roof. This time, two new suction points were installed. The piping to the suction holes was difficult because of the finished basement. The u-tube installed in the garage on this second fan system also read 6/8 of an inch of water column. This restriction was due to the long piping run to the two suction holes. An outside mounted fan system would have provided better system performance but the owner did not want the fans visible on the outside. This time with two fans running, the pressure under the slab in the center reversed to a negative 1.5 pascals. Some of this performance gain was due to the warmer conditions of May. The initial radon measurements with two fans running averaged 4.7 pCi/l. A second duplicate radon test done in June averaged 1.5 pCi/l.

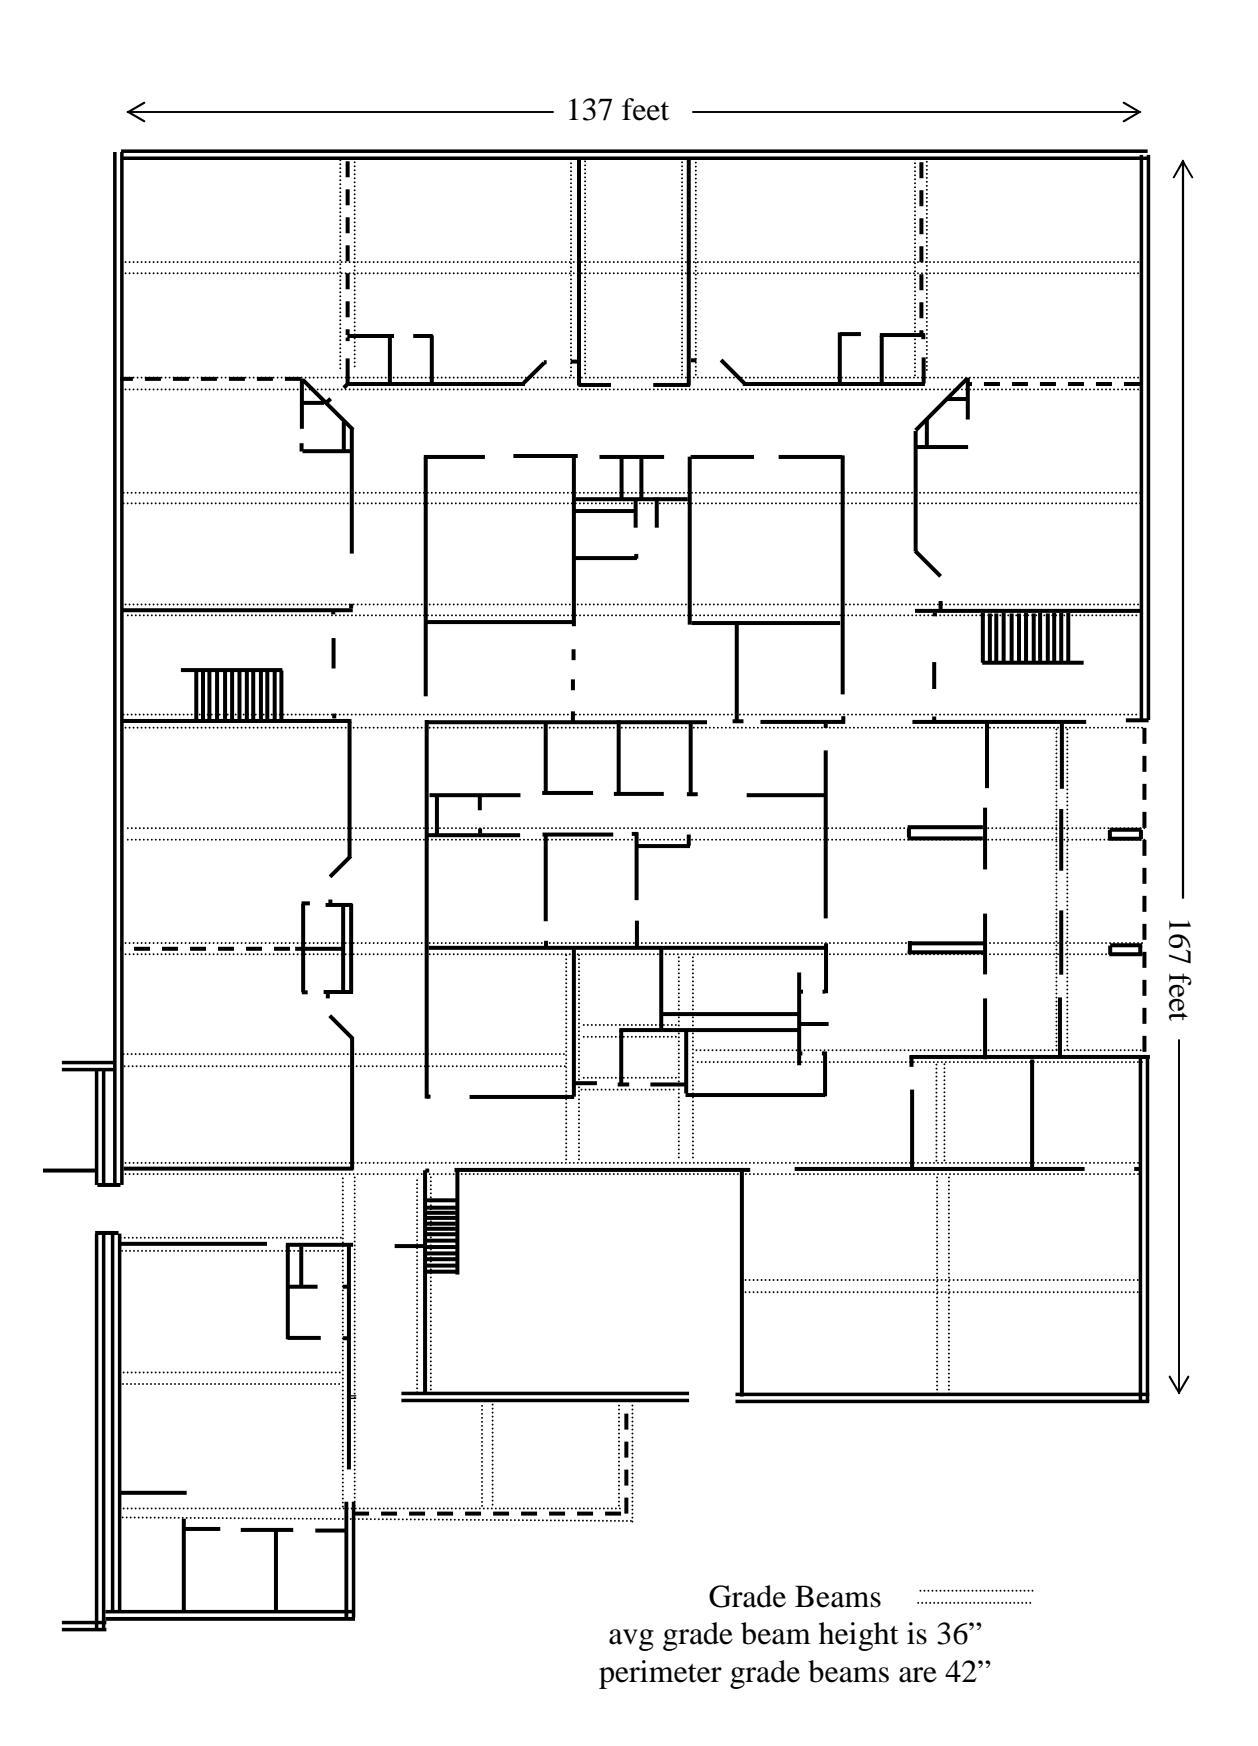
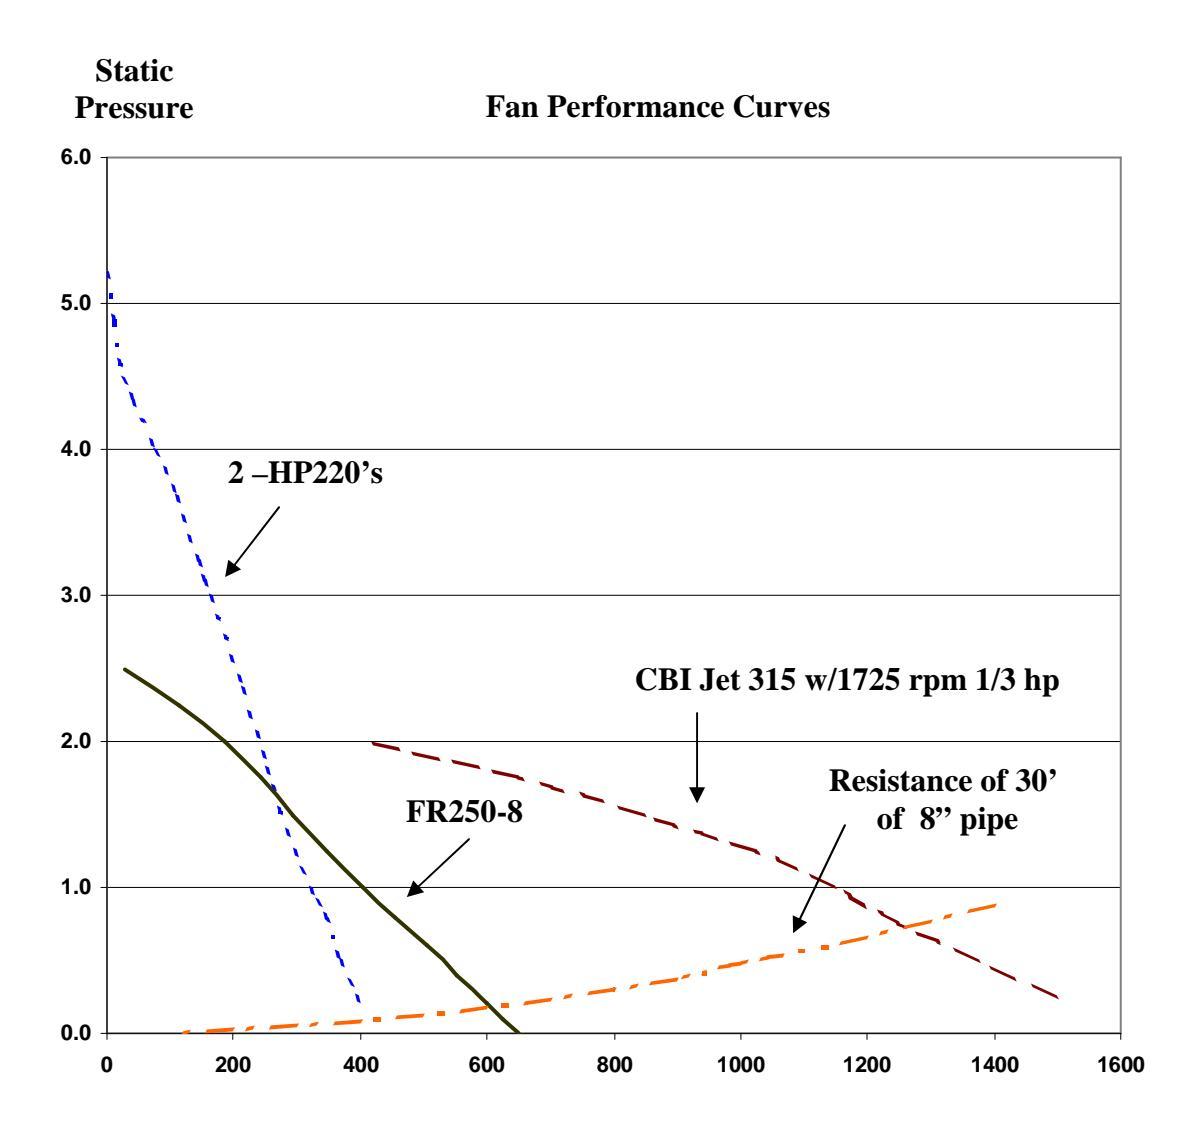
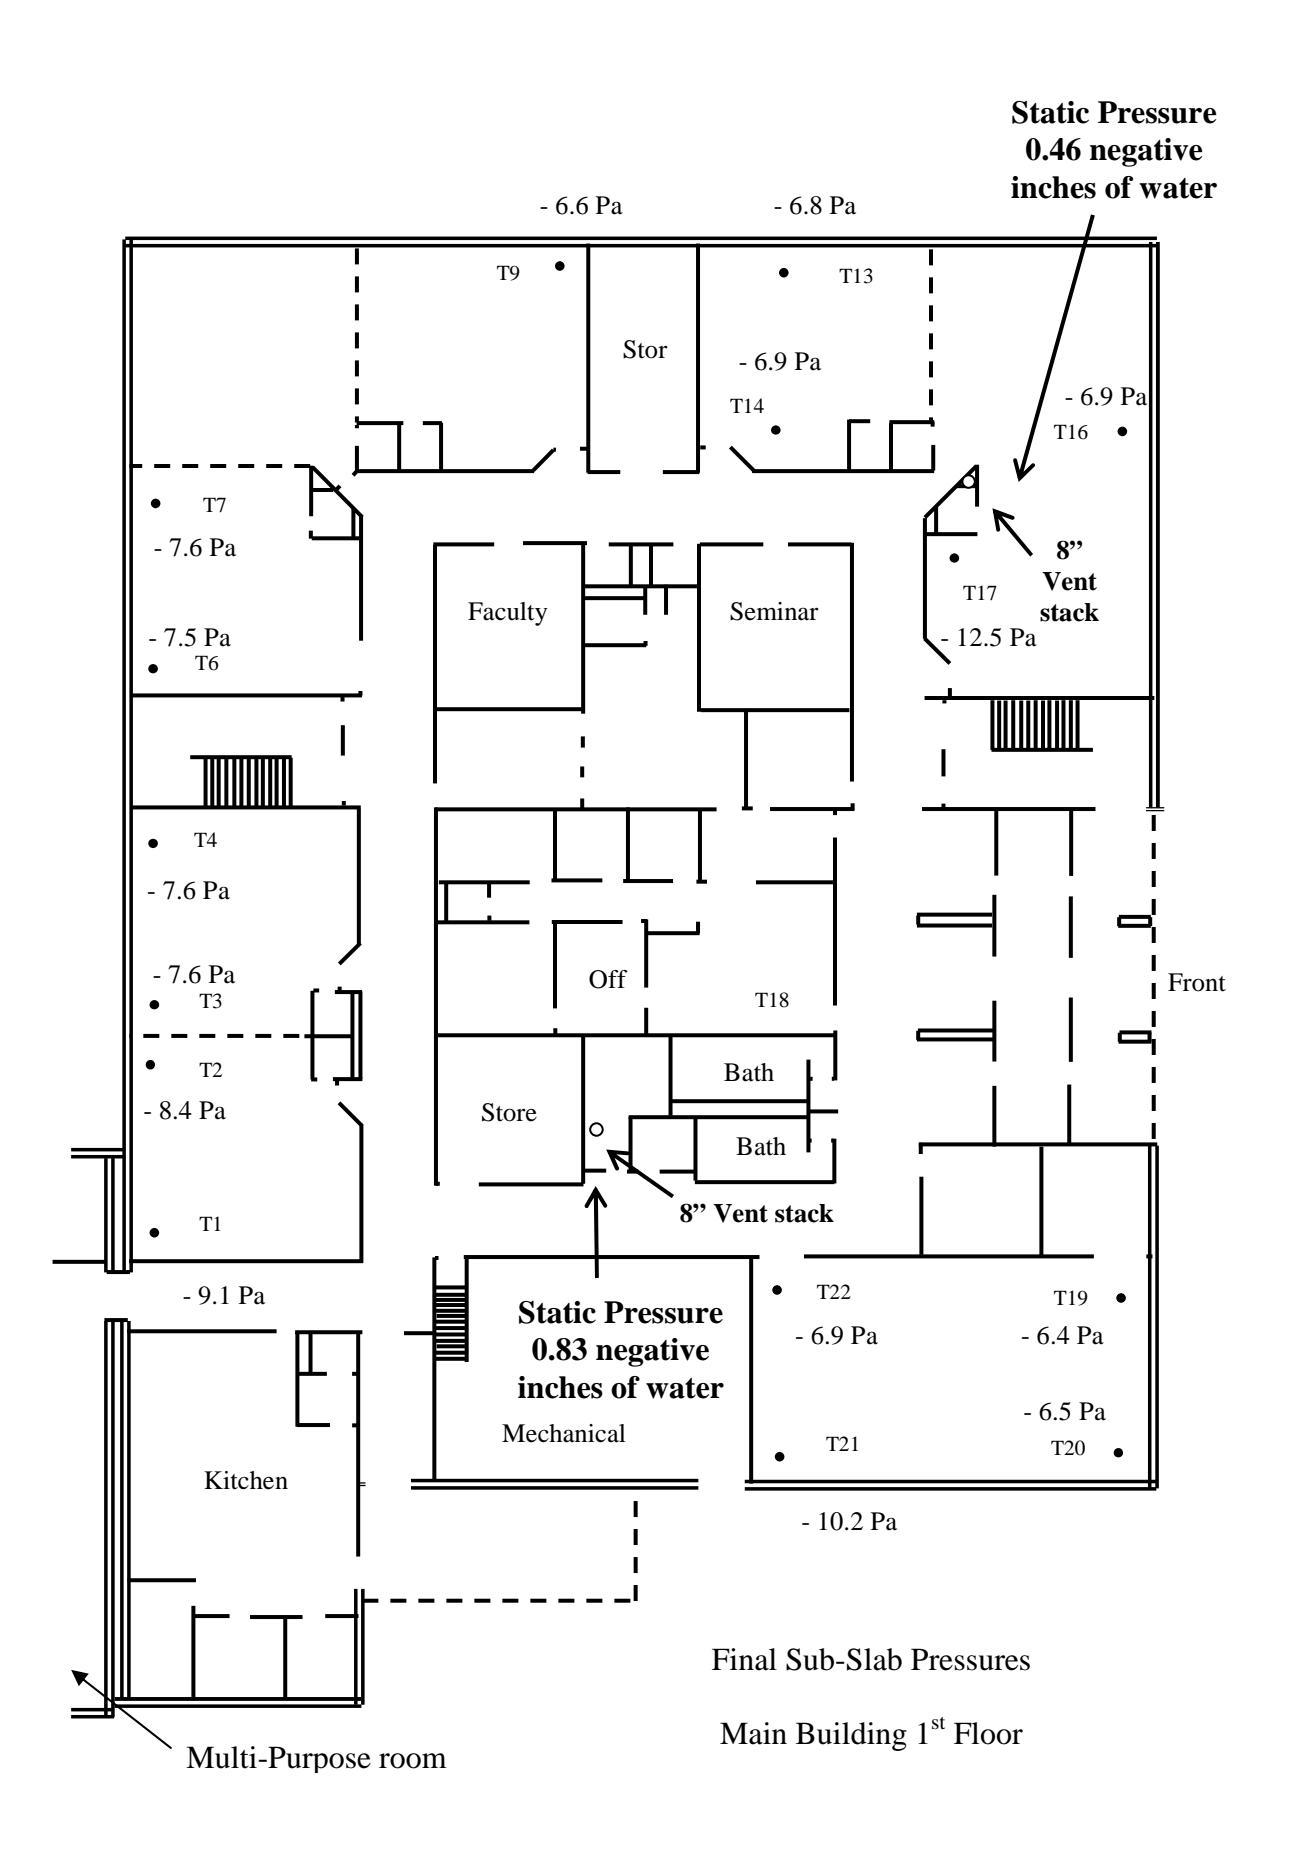
The Elementary School was constructed with a series of columns that support a network of grade beams. These grade beams are from 20 inches to 66 inches tall. The perimeter beams are mostly 42 inches high and 16 inches wide. The interior grade beams are mostly 36 inches tall. The beams are typically 16 or 20 inches wide with re-enforcing steel bars. Eight inch thick concrete plank flooring, with steel re-enforcing in the concrete ribs, was laid across this network of grade beams. A two inch cement coating was poured in place over the concrete planking. See the accompanying drawings.

It was initially unclear whether there was any communication between the grade beams. The construction of the school in 1980 included three eight inch stack pipes that were routed from the space between the grade beams to the roof. The main building had two eight inch stacks. The multi-purpose room had one eight inch stack. A curb based roof fan was installed on one of the main building eight inch stacks. WPB removed this fan and installed a CBI 315 jet fan in its place. The two remaining eight inch pipes had FR250-8 fans installed. The final sub-slab negative pressures are depicted in the final floor plan drawing below. These sub-slab pressures should be able to overcome the stack effect pressures down to 10 to 15 degrees of outside temperatures.
