RADON IN CONCRETE PASSIVE VENTING MITIGATION

Bill Brodhead*¹ and Omer Zeyrek²

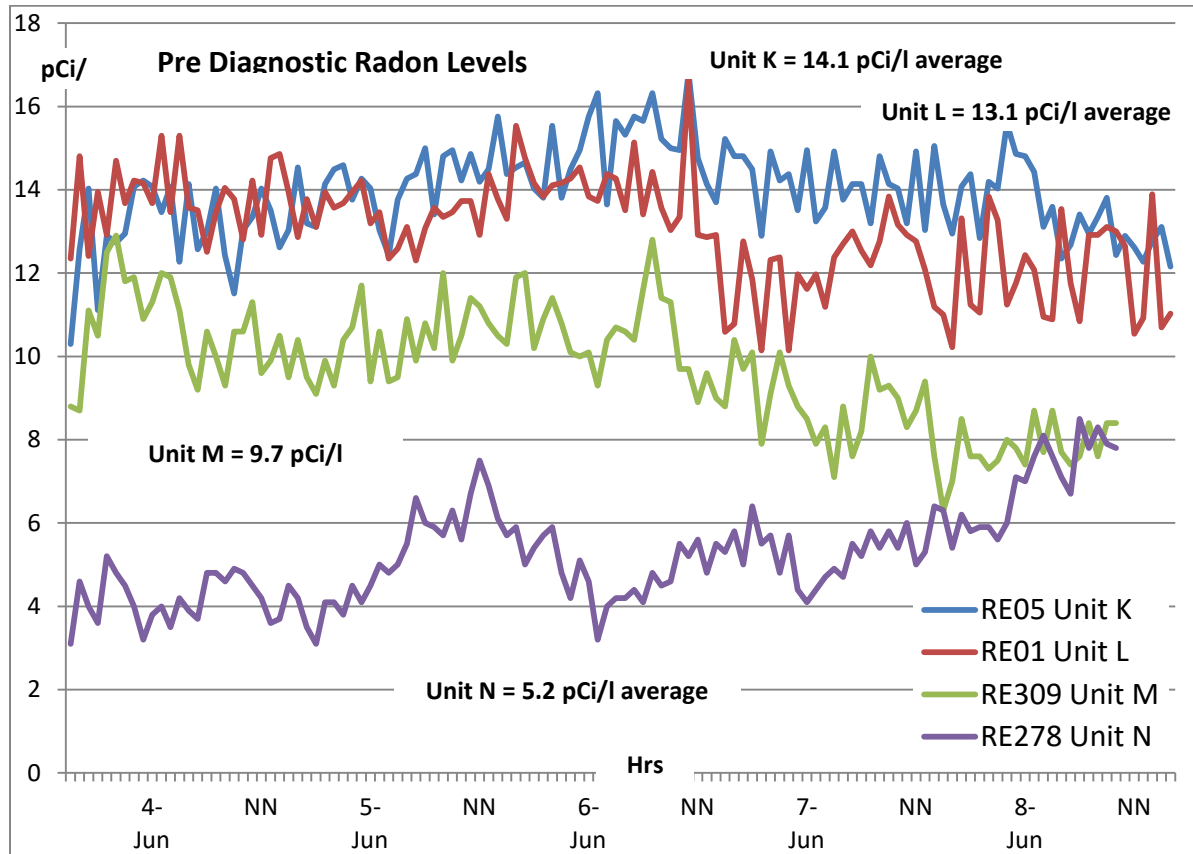
Radon levels in the four units tested were measured for four days prior to the start of adding any ventilation. The following graph displays the results of that testing. All four units had radon levels above the EPA action level of 4.0 pCi/l.

Figure (4): Pre-diagnostic unit radon levels

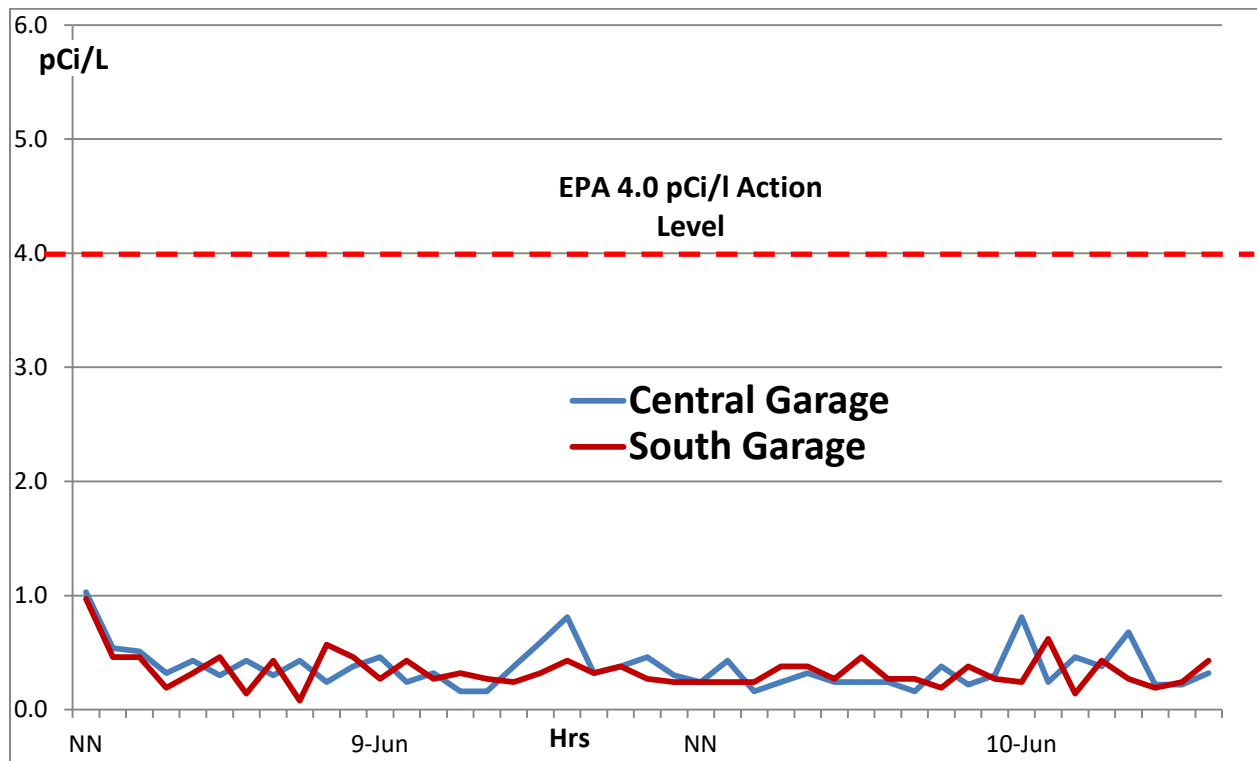
Figure (7) depicts the radon results measured in the garage as less than 0.5 pCi/l. This indicates the garage radon levels are close to outdoor radon levels. This in combination with the negative pressure in the garage shows that the garage is not contributing any significant radon to the first floor units. It would be logical to assume that any openings between the garage and a first floor unit would remove air from the unit and increase the ventilation, thus reducing the radon levels induced by the concrete. Unit L which was a ground based unit however had the second highest radon levels.

Figure (7): Garage exhaust fans

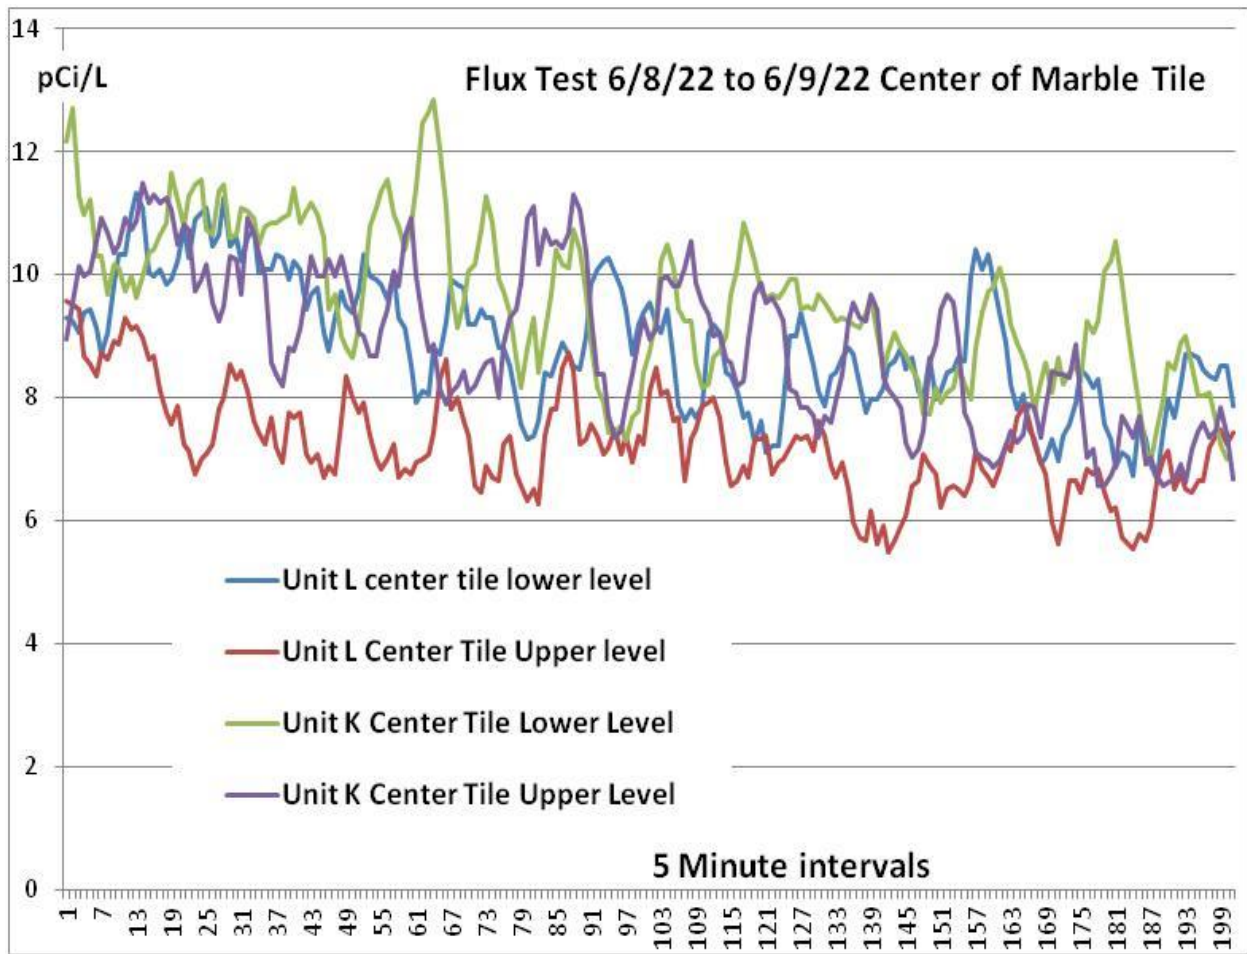
Figure (10): Flux measurements in center of tile square with no ingrowth

Figure (10) of four separate flux measurements made in the center of the tile squares shows there is no increasing radon into the bowls. The radon levels which start off as the radon levels inside Unit L and Unit K are actually decreasing because of the gradual decay of radon.

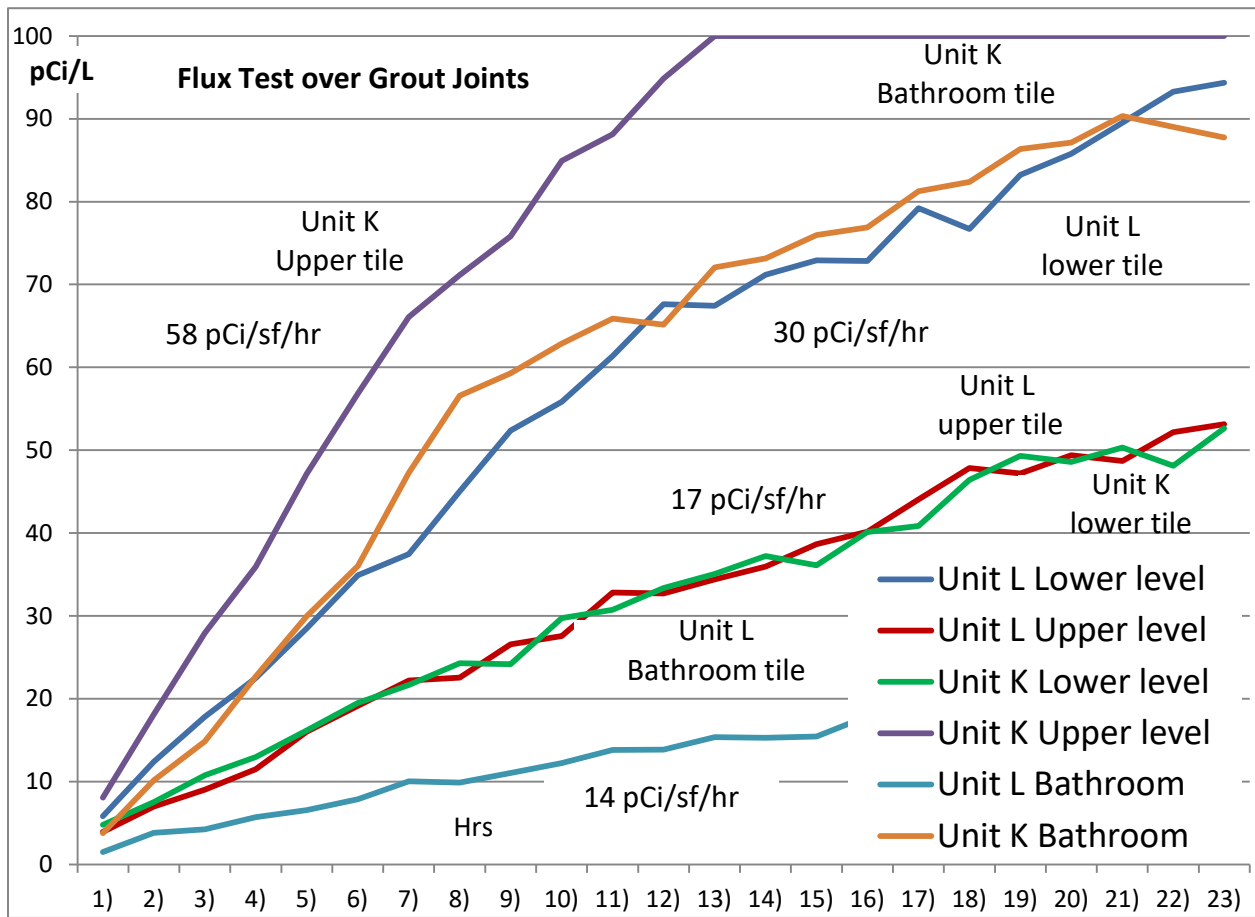
In contrast to Figure (10), the measurements of the radon ingrowth in Figure (11) are when the bowls are placed over the intersecting grout lines of the tile. The radon ingrowth is converted into pCi/square foot/hour (pCi/sf/hr) emanation rate. In previous work at an apartment complex in Doral Florida the average concrete flux rate varied from 20 to 35 pCi/sf/hr. In this case the flux measured between 14 and 58 pCi/sf/hr. Because the flux is assumed to only be from the grout lines, it cannot be considered as representing the actual square foot emanation of the slab below the tile without testing the slab without tile. Flux measurements of bare concrete outside the living space however had a similar range of flux. It appears that the tile floor did not significantly reduce the radon flux.

Figure (11): Flux measurements over grout lines

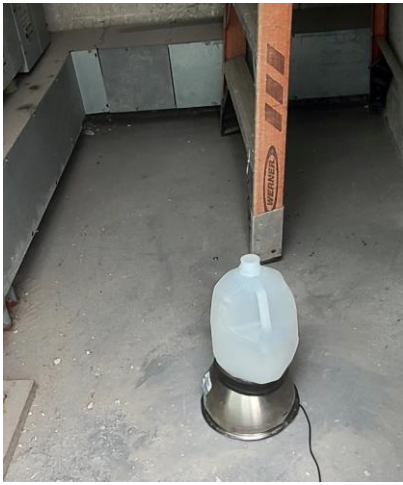
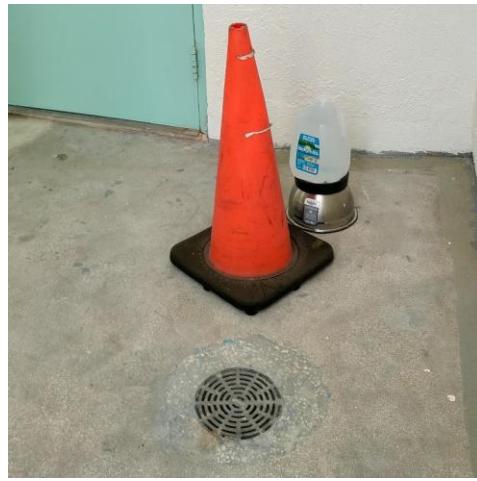
Figure (12): Flux measurements over bare concrete

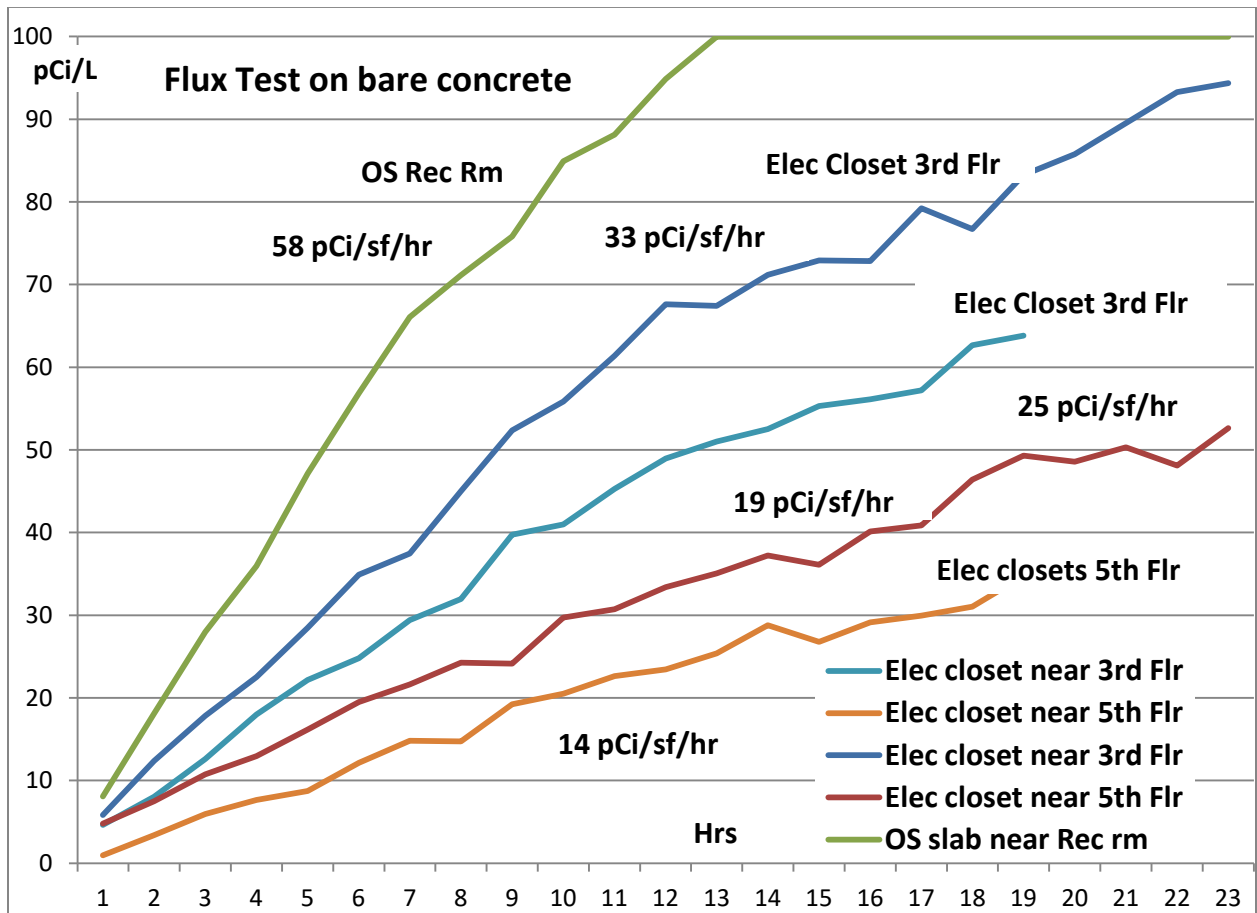
In order to get a better idea of the emanation from the concrete itself, each of the electrical closets on the third and fifth floor were measured as well as the open walk way outside the recreation room entrance door. Figure (13) depicts the results of these flux tests. The emanation rate varies again from 14 to 58 pCi/sf/hr. The variation in radon in each of the units would likewise have a similar or greater variation when combined with variation in ventilation rates. Although there is a significant variation, the emanation rate does approximate the average 20 to 35 pCi/sf/hr emanation rate that was measured at an apartment complex in Doral Florida that had similar indoor radon levels with no tile floor before additional outdoor air was added to each rental unit.

Figure (13): Flux measurements results over bare concrete

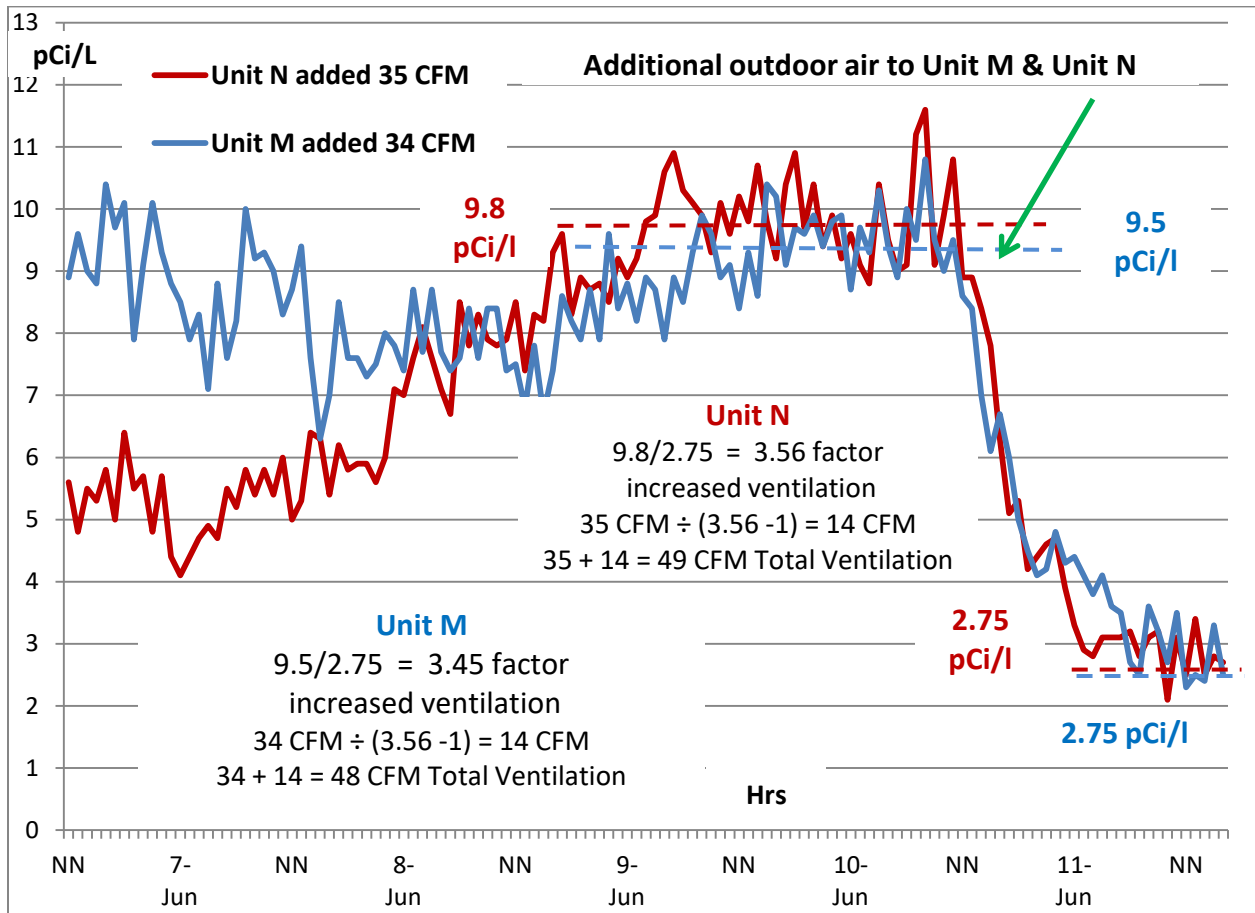
Figure (15): Ventilation increase to Unit 112 & Unit 526

The ventilation increase is plotted in Figure (15) and Figure (16). In Figure (16) the radon levels in Unit M and Unit N varied from 6 pCi/l to 9.5 pCi/l while the radon levels in Unit K and Unit L were more consistently around 12 to 14 pCi/l. Because the radon coming from concrete is considered a steady source the primary difference between these units is variation in emanation rate from the concrete and the variation in ventilation. The multiple flux measurements done in the electrical closets and hallway indicate that there can be large differences in emanation rate in different units as well as ventilation rate.

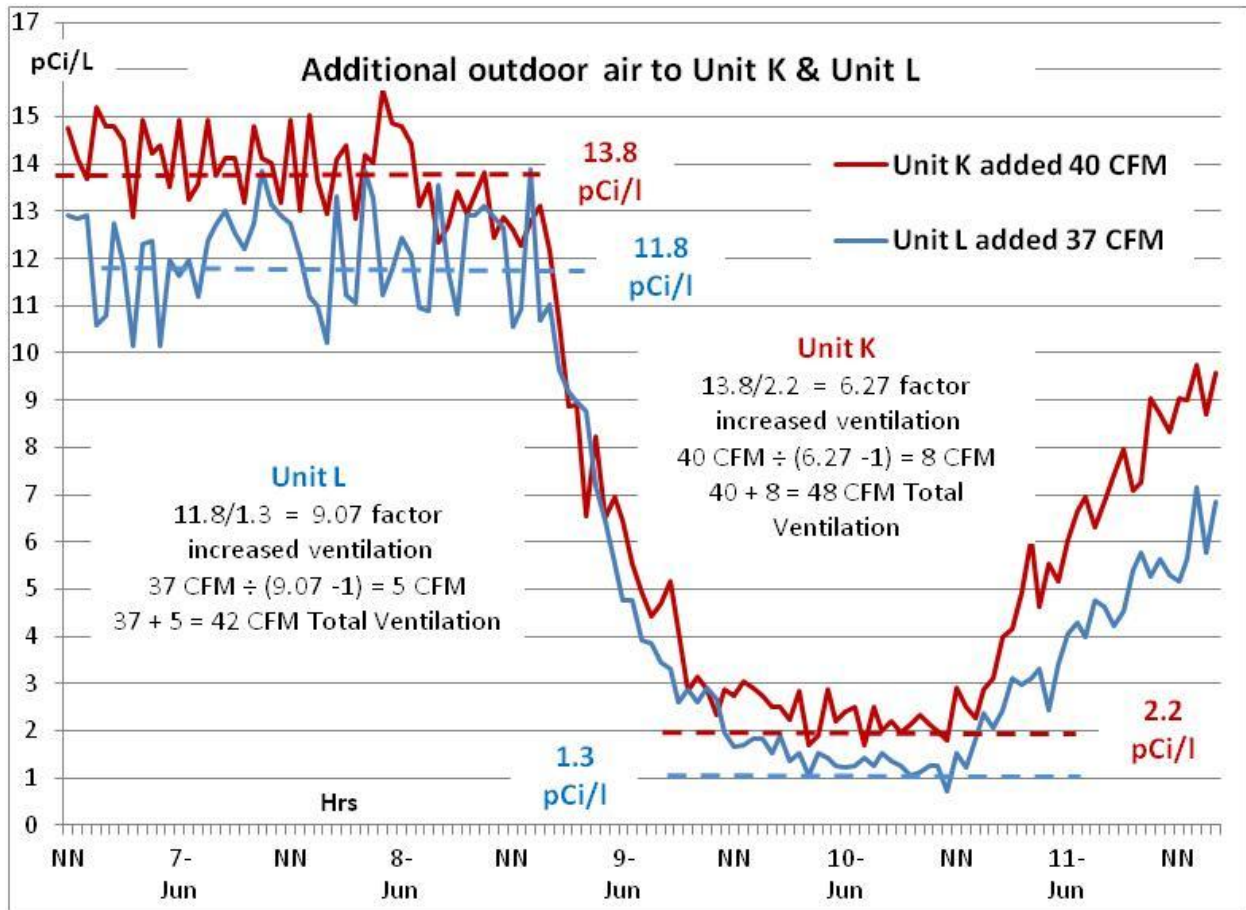
Figure (16) Ventilation increase to Unit K & Unit L

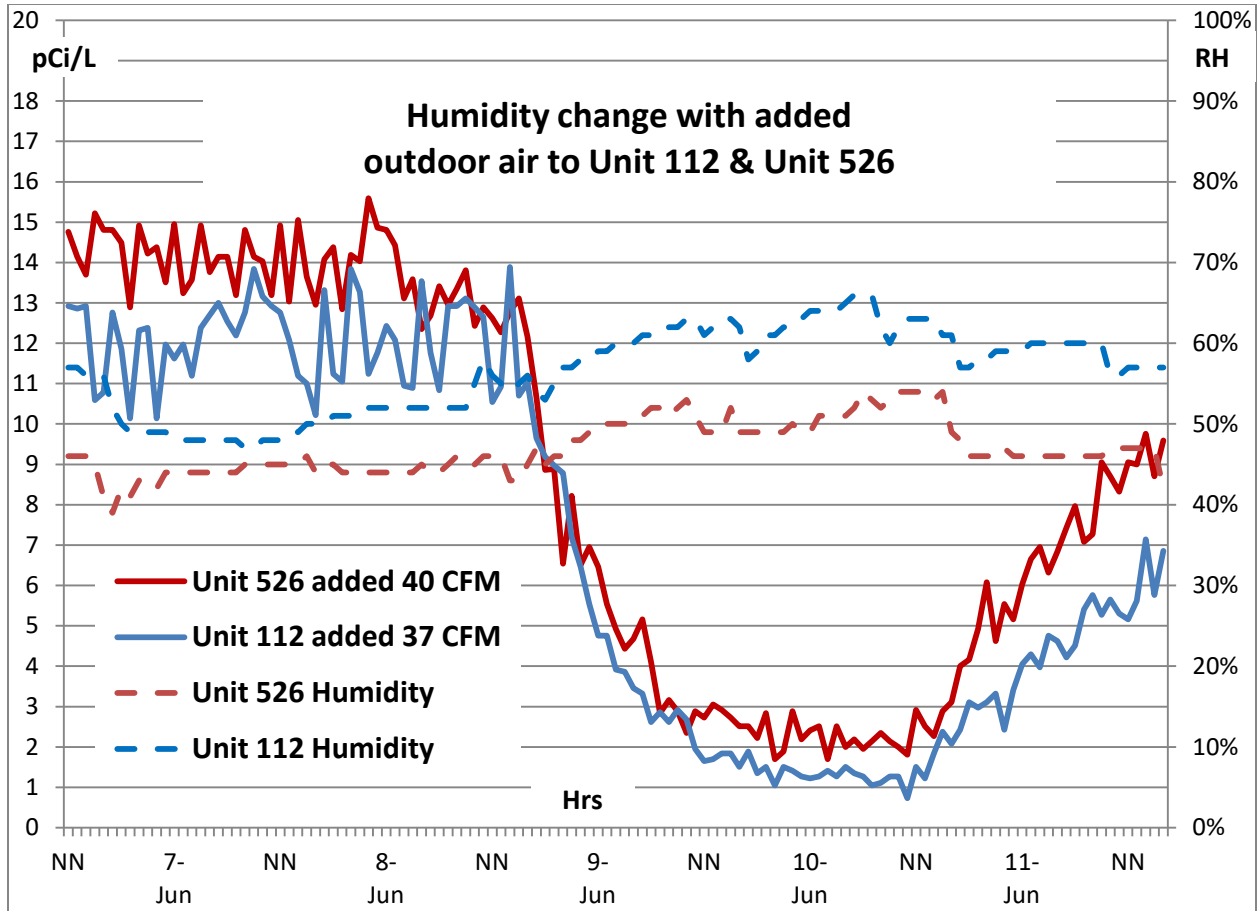
The introduction of continuous 35 to 40 CFM of outdoor air in June in Southern Florida did cause the relative humidity level to rise from 45 and 50 percent to 55 to 65 percent in two of the units. See Figure (17). In Unit K the increase was about 5 percentage points of RH. In Unit L the increase was about 10 percentage points of RH. Increasing the amount of outdoor air entering a building will likely require the HVAC system to operate additional time not only to maintain the occupants chosen temperature but also the occupant may want to have a lower temperature if the humidity is higher and provides less physical cooling. Any increase in the total run time of the HVAC will provide additional humidity reduction.

Figure (17): Measurement of humidity

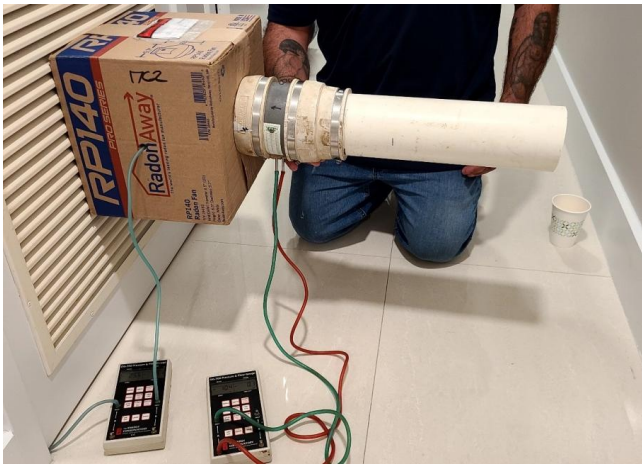
Figure (20): Testing airflow induced by negative AC closet
