COMPLEX RADON MITIGATION OF A LARGE BUILDING

By
David Wilson, Oak Ridge National Laboratory, Oak Ridge, Tennessee, USA
and
Stanley Ng, Pacific Division, Naval Facilities Engineering Command, Pearl Harbor,
Hawaii, USA

ABSTRACT

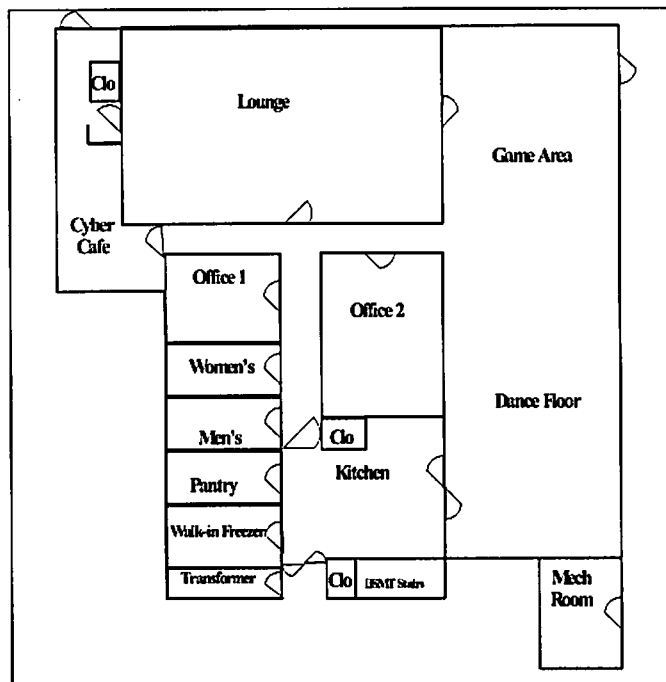
Figure 1. Home Plate floor plan

Relative to the outdoors and with all exhaust systems turned off, the game room (Figure 1) shell differential pressure (DP) was (-) 5 Pa and 0 Pa if both air conditioning mechanical systems were turned off as well. This 5-Pa loss of conditioned air was linked to leaks in the external ductwork of System 1 and the transition collar at the unit supply duct interface. Sealing around the transition collar was feasible. However because the supply duct was covered with a riveted, insulated metal wrap, finding the duct joints that were leaking would have required replacement of the entire duct. During normal mechanical operation, little variation in DP (± 2 Pa) was found in the lounge or in offices relative to the open areas of the building. This was an indication that the forced air systems were balanced. Overall, the ducting design for both air conditioning systems was found to be adequate, and both systems were found to be reasonably well balanced and maintained. The only problem noted was the absence in the design for any fresh-air makeup.

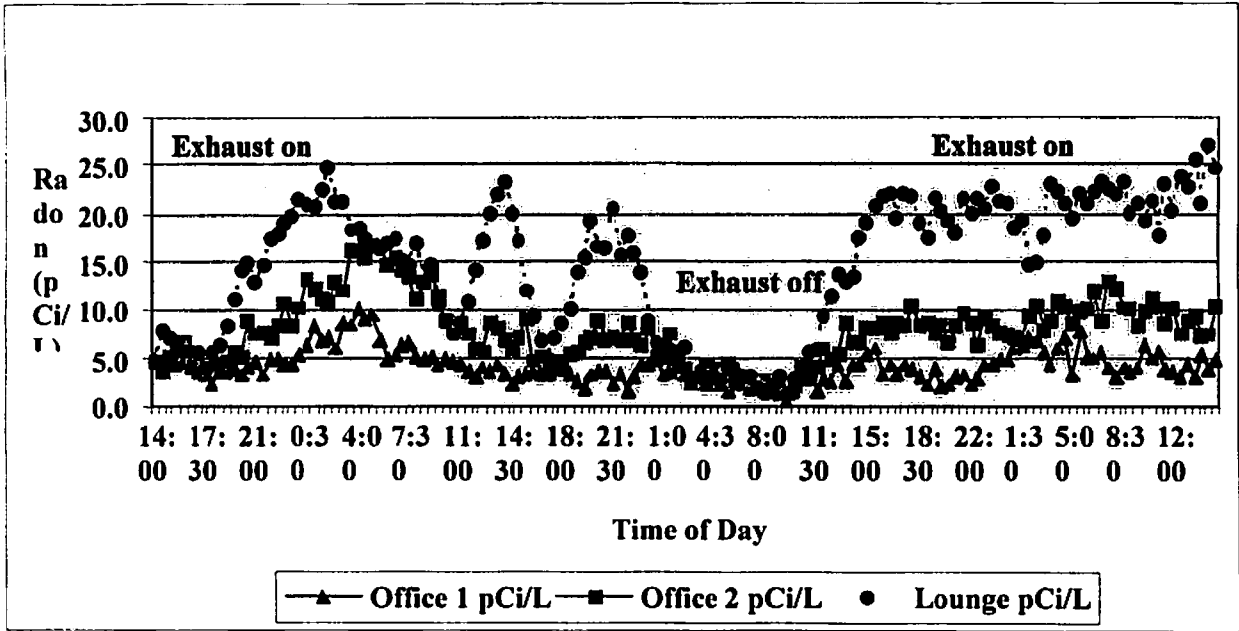
Figure 10. Radon levels in three rooms before supplemental air

The three-fan (GP 501), four-suction-point ASD system was installed as originally proposed (Figure 6). As predicted by the subslab diagnostics, at (-) 14 Pa, with all exhausts turned on except for the grill, only 60% of the subslabs were covered. Postmitigation testing found that only conditions in the Cyber Café were mitigated. CRM measurements performed in three rooms identified as having elevated radon levels showed that room conditions were mitigated if the exhaust systems were turned off (Figure 10). Additional subslab diagnostics determined that mitigation could be achieved if the shell pressure could be reduced to (-) 8 Pa or less. After consulting the blower door curves generated during earlier diagnostics, it was estimated that only 800 CFM of additional fresh air would be needed to achieve this pressure.

the estimated 800 CFM of fresh air needed, concern was expressed whether a 3-ton unit would have sufficient reserve capacity to condition additional air if the original projections were optimistic. Mindful of the fact that the building needed an additional cooling, a 5-ton compressor was selected. This choice provided additional cooling and a reasonable “cushion” if estimates were wrong. The system design included auto sensors that would shut the system down if a fire occurred or if the supply air stream exceeded 78°F or 50% humidity. Because of comfort factors, the location of the discharge point for the 2000 CFM of air (total system capacity for 5 tons) became an issue. Long, complex duct runs that would evenly distribute the conditioned air throughout the building would degrade system performance. Therefore, the shortest duct run possible to the point of highest load would be ideal. Examination of the building’s activities identified the dance floor as the most likely location to meet these criteria. The location required only 20 ft of supply duct and was the place of highest physical activity in the building. Installation and activation of the 5-ton system (Figure 11 and 12) reduced the negative pressure within the building to (-) 7 Pa, which was within the desired range.
