1994-25

WASHINGTON STATE PASSIVE STACK STUDY

Jan E. Fay and Ray Tekverk
Faytek Incorporated
Coeur d'Alene, ID

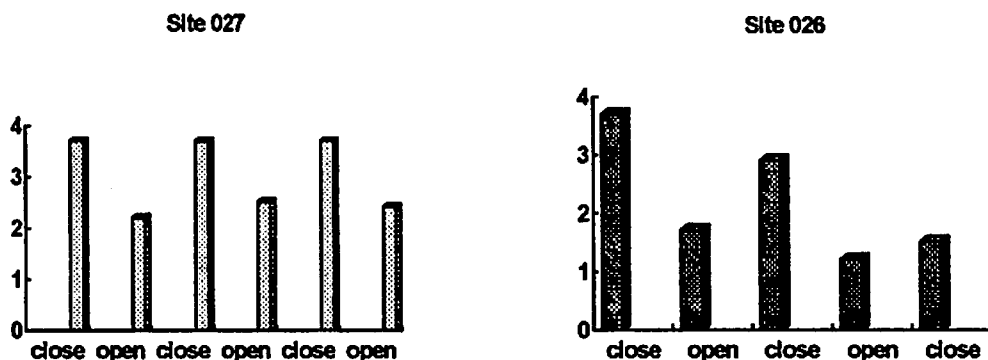
Below are two examples of houses where the variations in radon levels under alternating stack conditions appear to be significant. Radon levels are graphed in picoCuries/Liter, and the stack condition (opened or closed) is noted on each measurement.

While lower radon levels under open stack conditions were observed in quite a few of the early test houses, in many of the cases the fluctuations were either so small that they are not conclusive, or the number of test rounds to date is small enough that statements on performance would be premature.
