CONSTRUCTION AND TESTING OF A SIMPLE RADON CHAMBER

Lyle Rathbun Rathbun.L.C@gmail.com

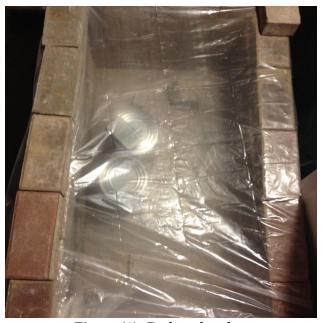
When several four-days tests yielded variable results, the first chamber location was abandoned. The bricks, granite and rock chip, along with a new, larger plastic sheet were moved to the garage. The plastic sheeting was placed on the floor and the chamber was built atop it in the same pattern as the initial effort. The loose ends of the sheeting material were pulled tight over the brick "castle," twisted and tied near one end of the chamber. Additional bricks were placed on the plastic atop the bricks forming the outline of the chamber, Figure (1). The radon chamber did not contain an airlock. The tied end (horsetail) had to be loosened to insert and remove measurement devices.

Figure (1): Radon chamber

Two radon chambers were constructed. Each enclosed a 300 liter volume and were constructed in similar fashion: Red clay house bricks (8-in. x 2.25-in. x 4-in)., containing an estimated 1.4 pCi/g of ²²⁶Ra each, were stacked to outline a rectangular pattern on a concrete floor and covered with a clear 0.003 in.-thick plastic sheeting material. In the first chamber, the concrete floor was open to the chamber. The plastic sheeting was held against the floor only by the weight of the bricks. The overlaps of the sheeting were not sealed. In the second chamber, bricks were completely enclosed by the plastic sheeting.
